# MANLY DAM WALKING TRACKS AUDIT

for  
**Northern Beaches Council**  
May, 2017

CONTROLLED DOCUMENT  
**“Manly Dam Walking Tracks Audit”**

**FINAL ISSUE**

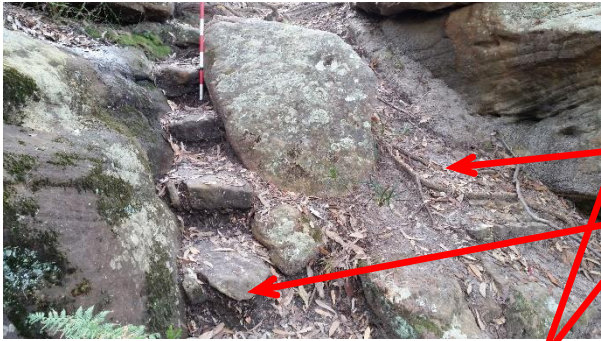
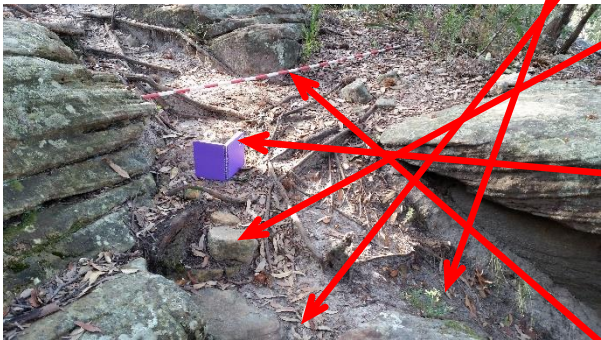
**Site ID: NT - 7(N)**

**Location:** 338078 6260633 Gutter to 250mm deep between rock outcrops, 600-800mm wide, multiple exposed and protruding roots to 300mm high, drainage flows down track from crest at top.

Upper step on crest (facing NW) will catch/block drainage flows down track from upslope, install waterbar and/or cut outlet gutter off corner of steps to discharge flows past/above rock outcrops on low side.

**(Medium - for passability and sustainability/impact issues)**

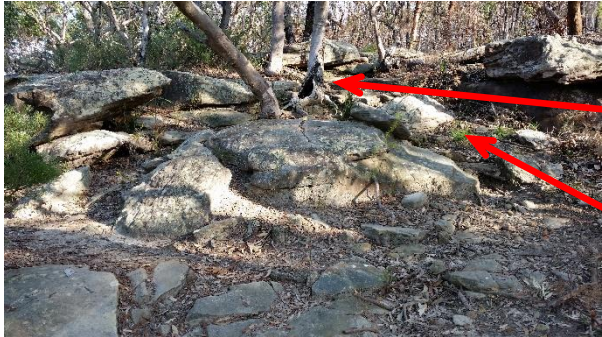
**Site ID: NT - 8(B)**

*Location:* 338068 6260639 Well-used track joins from upslope (from S/SE), splits around large outcrop and boulders on upslope side of trail, 2 small metal directional arrows on rock (indicating Nature Trail running NW-SE). Track leads up to end of Bangaroo Street.

Install waterbar on W braid of "Bangaroo St Track" to catch/divert flows from informal track and upslope before reaching trail.

**(low)**

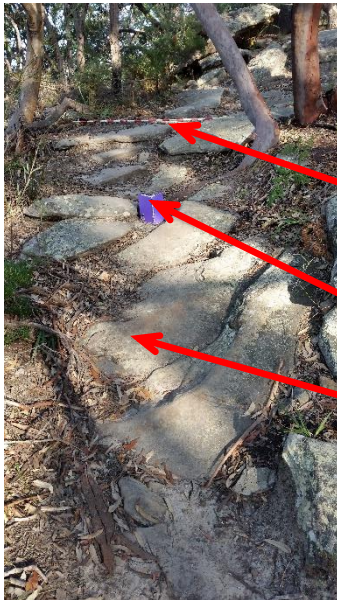
**Site ID: NT - 8(C)**

*Location:* 338064 6260644 Sloped angled low rock outcrops and embedded rock on 7m slope, 9° gradient, loose sands, drainage flows down from informal track junction upslope.

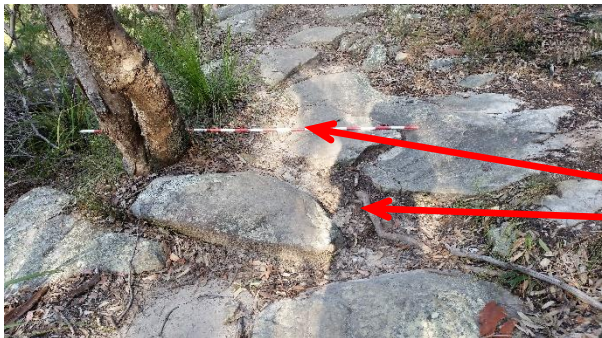
**Site ID: NT - 8(F)**

**Location:** 338039 6260668 Rock slab and angled boulder upslope, and rounded outcrop below with fish “engraving” and carved graffiti (under “fish” and elsewhere). Older style small interpretation panel re Aboriginal Engravings, dislodged. Walker traffic over, or close, to engraving. Cliffline with sloping edge to 8m drop only 2m off track on low side (hazard), some evidence of walkers detouring around rock slab/outcrops closer to cliff edge (following drainage path), also attracted by views to sculpted overhang in cliff face nearby. Small metal directional arrow on tree stump.

Install caution/warning re cliff edge on low side of track (similar style to new warning sign at Site NT – 7(H), or simpler totem style warning).

If fish “engraving” is not genuine, then remove (track alignment and walker traffic over an unprotected Aboriginal cultural heritage sites sends inappropriate message re site protection/management) and cut/level tread in rounded outcrop.

If fish “engraving” is genuine, then realign track to below engraving with rock armouring/flagging to provide track and viewing area below art site, barrier/protect site from walkers/damage and remove graffiti as appropriate . May need barrier or safety railing on low side of track at viewing area (to prevent “distracted” visitors wandering too close to cliff edge while focused on site).

Block/barrier (rock rubble) drainage path on low side of rock slab, to not “read” as a detour and prevent walkers detouring too close to cliff edge.

**(HIGH – for safety issues and Aboriginal cultural heritage site management).**

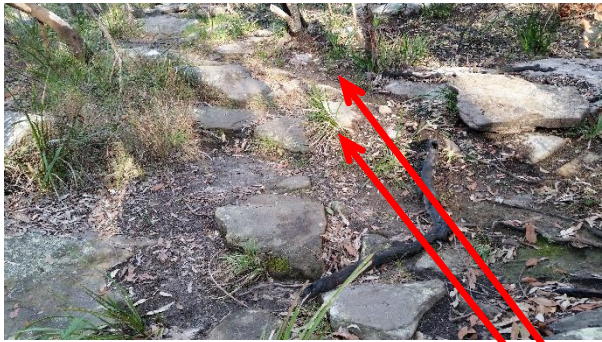
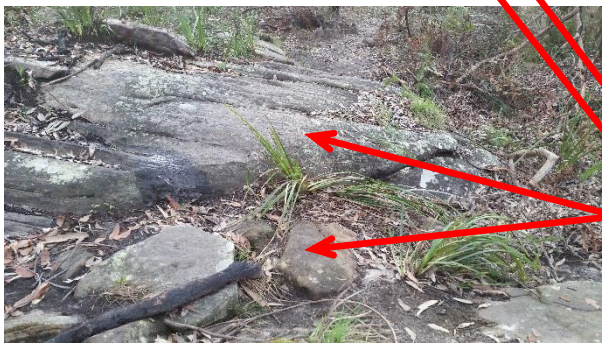
**Site ID: NT - 8(G)**

**Location:** 3380-28 6260669 Dip to small drainage line with regular flows, rock outcrops and “natural” steps to SE and large rock outcrop to NW, large flat flagstone placed (?) in centre of bed. Cliffline close to low side of track, and start of section of track (running for approximately 25-30m to SE) where cliff is in close proximity to track.

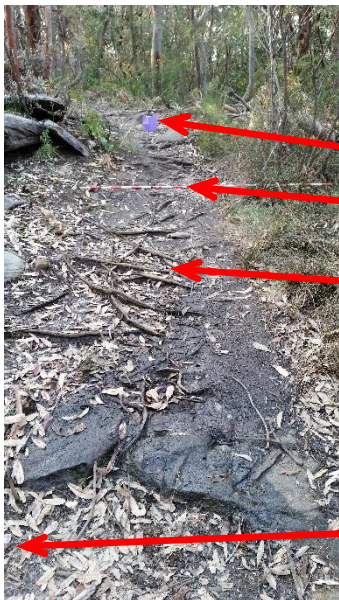
**Site ID: NT - 8(I)**

*Location:* 338005 6260701 Widened track, to 1,800mm, on sloping curve with protruding and loose rocks, drainage flows down inside of curve and walkers detouring/widening on outside of curve, rock outcrops on inside of curve and sloped rock outcrops at top of curve.

Pull-in track (both sides) and define outer/low edge, and block/barrier (rock rubble).

**(low)**

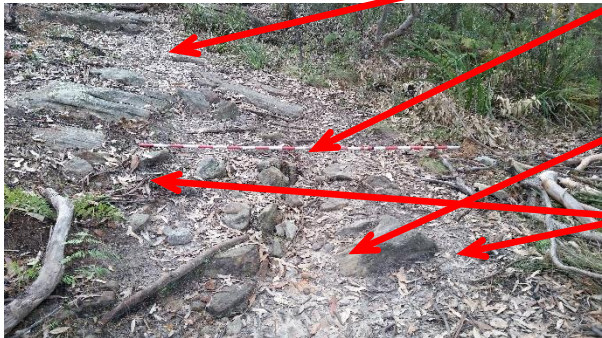
**Site ID: NT - 8(J)**

*Location:* 337994 6260720 Seepage/ponding area, 6m long, in dip between low rock outcrops.

Open windrow on low side.

**(Medium – for sustainability/impact issues [to control track widening])**

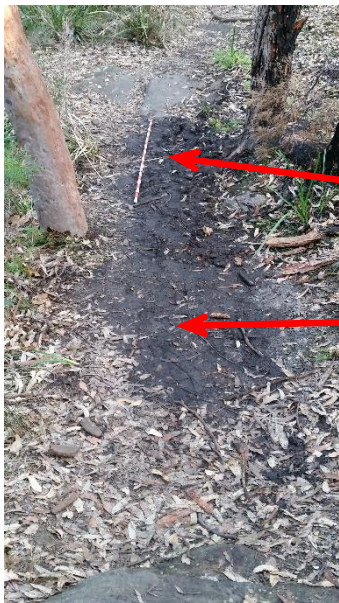
**Site ID: NT - 8(K)**

*Location:* 337990 6260748 Rock ledge (low side) and large boulder (high side) at top of short 6m slope at 9° gradient, gap/gutter between ledge and boulders with protruding roots and drainage flows down track, rounded embedded boulders at bottom of slope.

Fill/compact tread above upper step, upslope to start of gap.

Block/barrier (rock rubble) low/outer side of boulders.

**(Medium – for passability issues)**

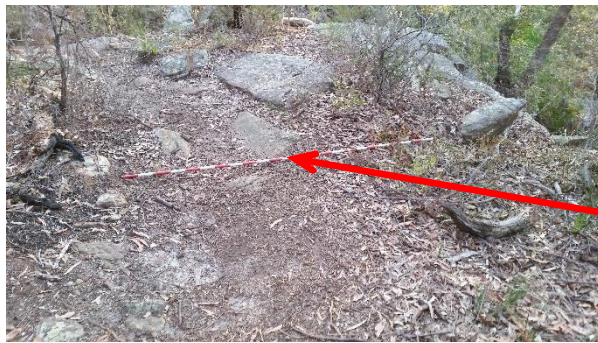
**Site ID: NT - 8(N)**

**Location:** 337949 6260767 Compacted sand/gravel track, slightly dished, with low rock outcrops.

Waterbar, built onto in-situ outcrops (to divert flows off track before slope to track junction downslope)

**(low)**

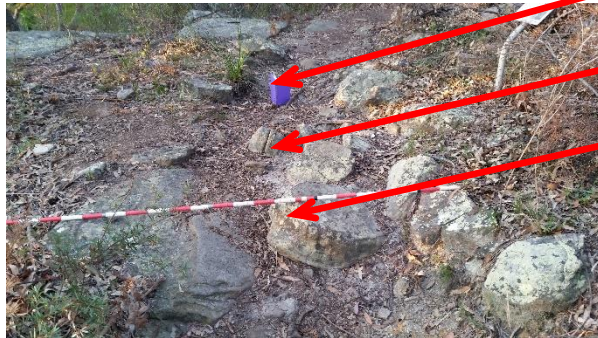
**Site ID: NT - 8(O)**

**Location:** 337947 6260766 Protruding rocks and rock outcrop (and placed rocks along high side of track) upslope of track junction, with drainage flows down track. Older style small interpretation panel on high side of track.

Remove large central protruding rock and build rock step onto outcrop beneath, armour tread below step (as safe approach to track junction immediately below).

**(Medium – for passability/safety issues [on approach to track junction])**

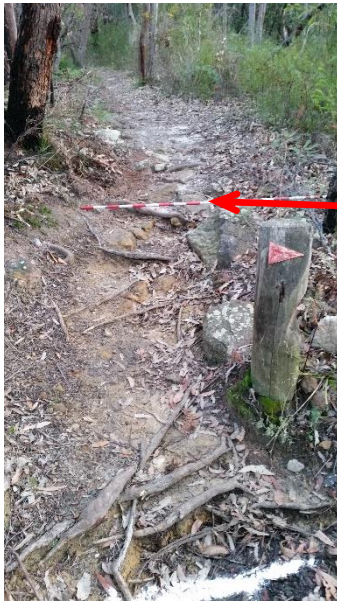
#### **Site ID: Junction Segments 8 and 9 (and junction with track to S)**

**Location:** 337943 6260763 90° junction between Segment 8 (on ridge) and Segment 9 (downslope to W/NW). Junction with un-marked but well-used track to S (to APZ behind, N of, Warringah Street). Junction is in dip at top of “chute” in rock ledges downslope with considerable drainage inflow from both tracks above. Log post with 2 small metal directional arrows, but no signposting.

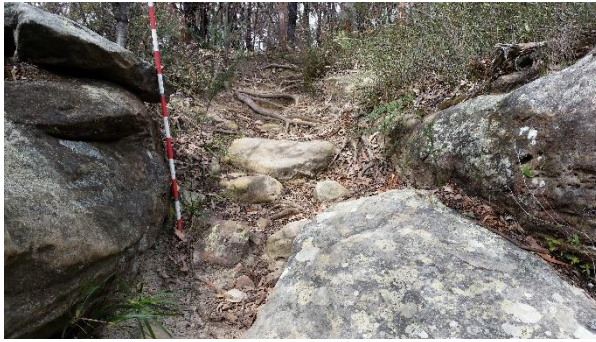
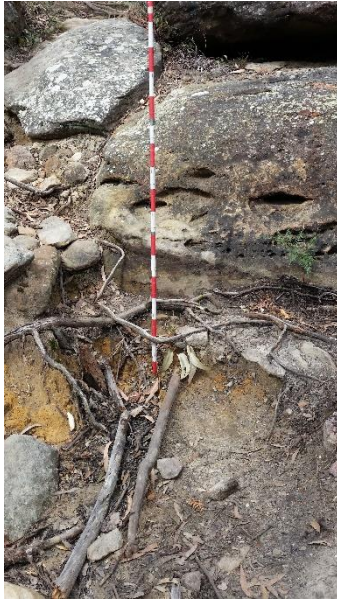
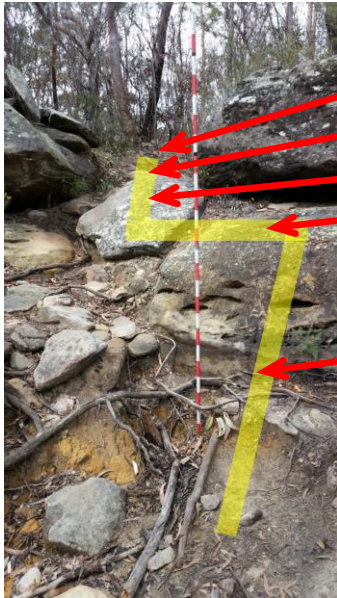
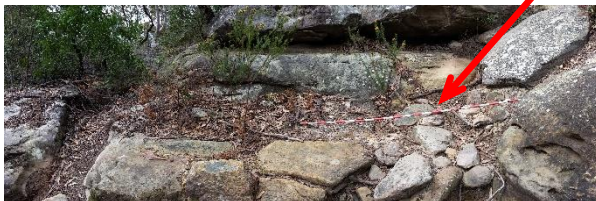
**Site ID: NT – 9(A)**

**Location:** 337943 6260763 top (top of Segment, junction with Segment 8 and un-marked track to S)  
337937 6260766 bottom

Large embedded rocks above (downslope from junction), to “chute” between rock ledges with sloped boulders and narrow gap alongside (ankle hazard), embedded rocks and roots below with 700mm drop/scarp to compacted sand/clay bench with embedded rocks and outcrops at bottom of site. Lower rock ledge runs to S, below main rock face, at bottom of “chute” with 1,300mm drop to sand/rock bench at bottom of site. Old tall metal post on lower bench, no sign attached. 13m long, 20° gradient overall (27° gradient over “chute” and lower ledge/scarp) total level change of 3.2m (2.2m level change over “chute” and lower ledge/scarp). Substantial drainage capture and flows down, eroded 200-500mm below NSL (deeper at bottom of site).

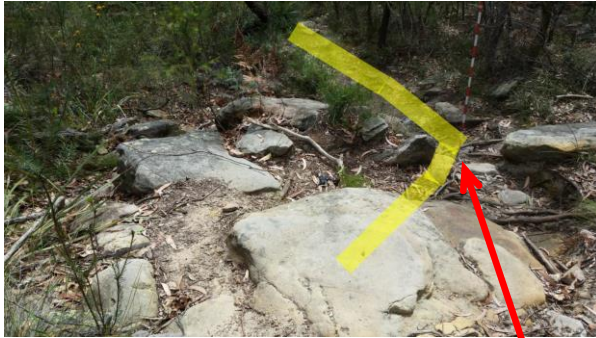
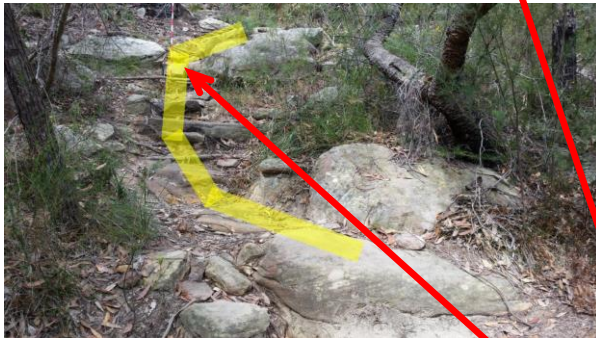
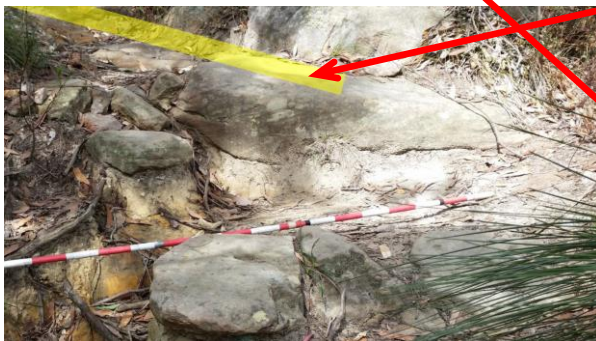
**Site ID: NT – 9(C)**

*Location:* 337930 6260770 top

337924 6260774 bottom

15m rocky slope at 23° gradient overall (steeper at top 23° gradient, 17° gradient on lower half), 3.9m total level change, series of rock ledges and outcrops on lower two-thirds, upper third half curves up onto large flat/rounded rock ledge, multiple “natural” steps formed by embedded and protruding boulders/rocks and outcrops (to 400mm high), 500-1,000 mm wide, considerable drainage down track with scour to 300-400mm below NSL, flows braid around upper large flat/rounded rock ledge, some loose stone (slip hazard).

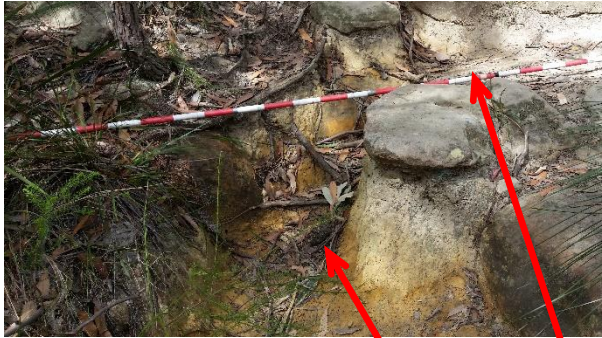
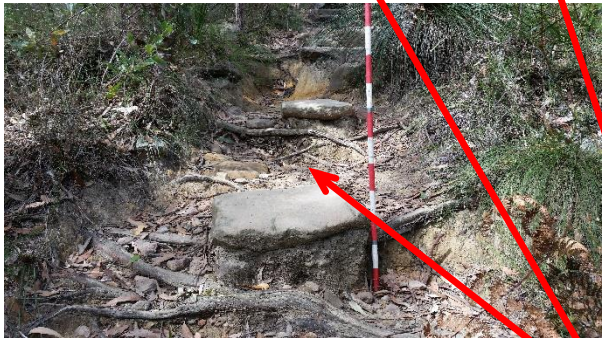
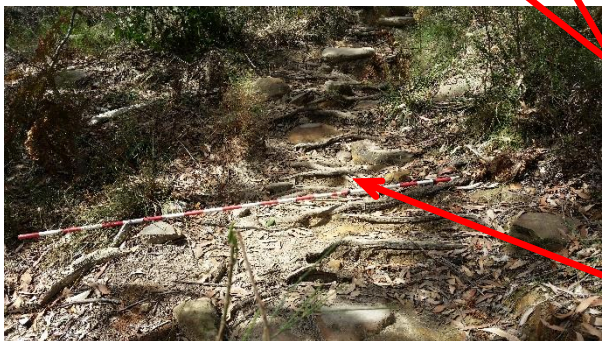
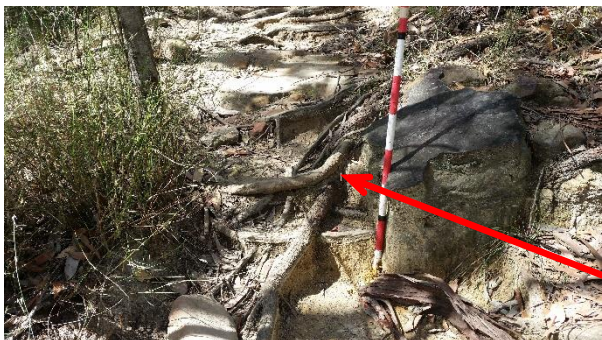
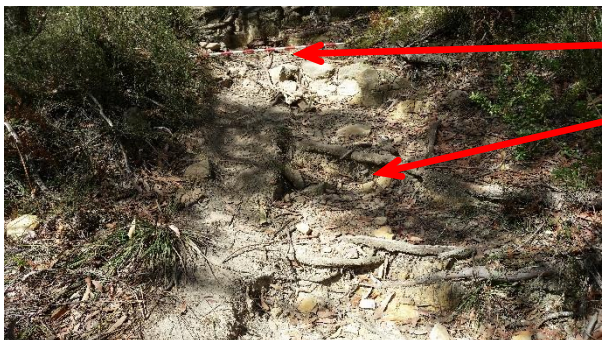
*Location:* 337924 6260774 top

337911 6260780 bottom

17m rocky slope at 16° gradient overall, boulders and rock outcrop on upper part including “pedestal” rocks to 300-400mm (one at 500mm) above eroded track surface below, 1.5m overall rise over 5m at upper end (but also entrenched to 500mm below NSL), embedded rocks on middle/lower part (1.1m overall rise over 5.5m), frequent protruding/retaining roots throughout, 600-1,500mm wide, compacted sand and loose sand/rocks/gravel (slip hazard), considerable drainage down track with scour to 300-400mm below NSL.

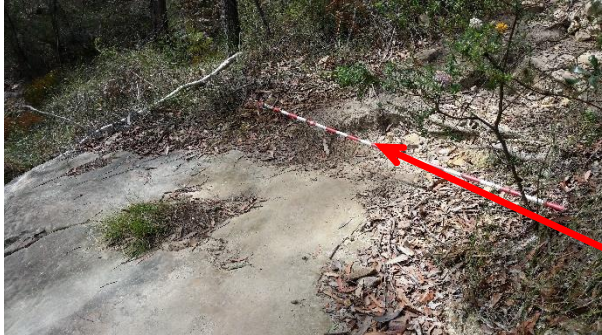
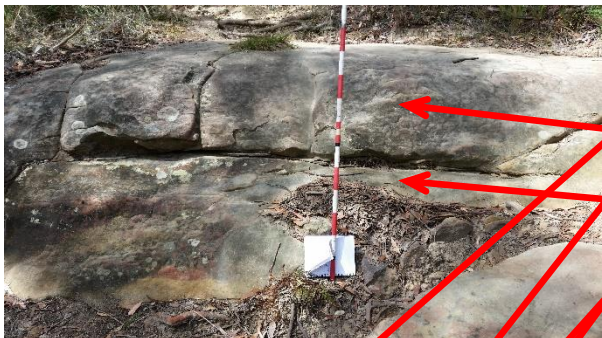
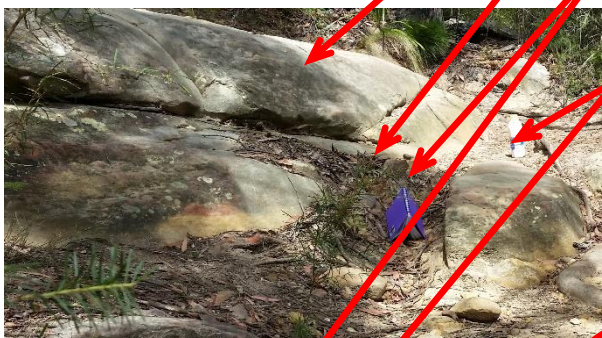
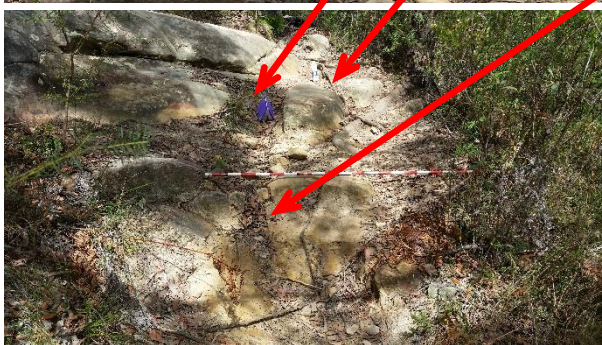
**Site ID: NT – 9(F)**

**Location:** 337906 6260783 top  
337895 6260799 bottom (and  
bottom of Segment)

24m slope at 15° gradient overall, 26 scored timber step-and-runs and steps (10 with drainage/scour around end [mostly on upper half of slope], 1 with a log extension), 1 log waterbar above bottom step, 800-1,200mm wide, track from NSL to 250-300mm below NSL in places, runs/treads of compacted sand and loose stone/gravel, loose/deposited sand at bottom of slope, drainage over all steps but little scour. Log post with small metal directional arrow at bottom of slope (90° turn at bottom, into Segment 10).

Level uneven treads and compact or remove loose stone/gravel – as/where needed.

Extend/realign 4 existing timber steps as waterbars/steps.

**(low)**

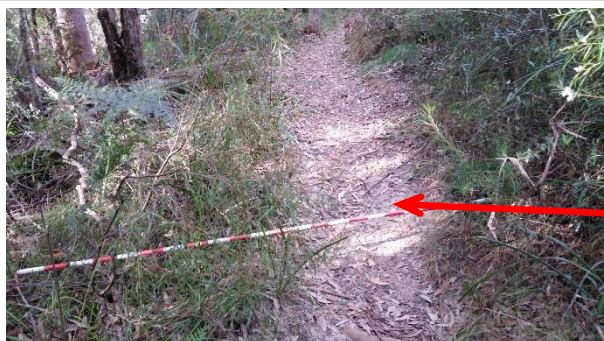
**Site ID:** NT – 10(A)

**Location:** 337878 56260790 Compacted sand track, 700mm wide, dished to 50mm, on 4° gradient.

**Works:**  
Waterbar.  
(low)

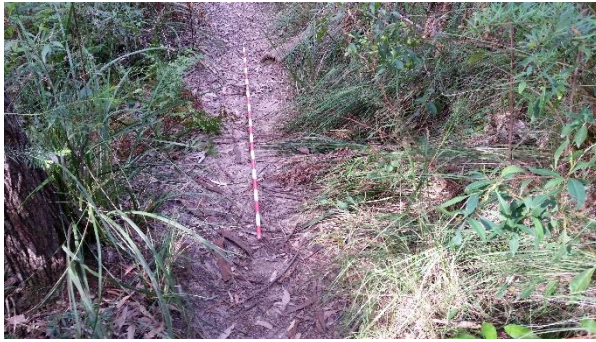
**Site ID: NT – 10(B)**

**Location:** 337873 6260786 Ephemeral drainage line in dip (1.5m wide flow path), seepage/ponding area with pool on downslope side off track. and

Monitor for track widening (wet area avoidance) and need for stepstones  
**(monitor)**

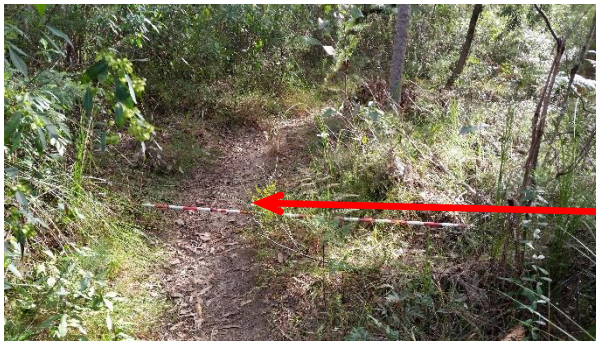
**Site ID: NT – 10(C)**

**Location:** 37868 6260779 Compacted sand track, 700mm wide, dished to 50mm, on 6° gradient.

Waterbar/step.  
**(low)**

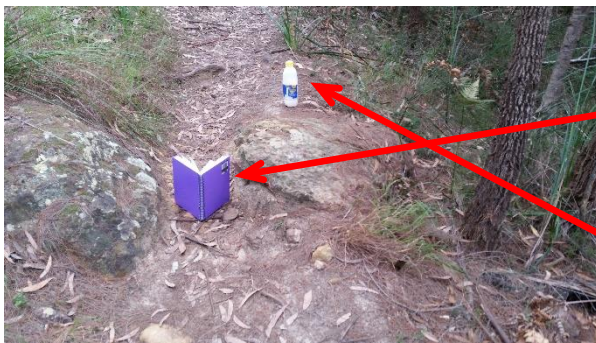
**Site ID: NT – 10(D)**

**Location:** 337836 6260783 Embedded small rounded boulders with gap between, 300mm wide and 300mm deep.

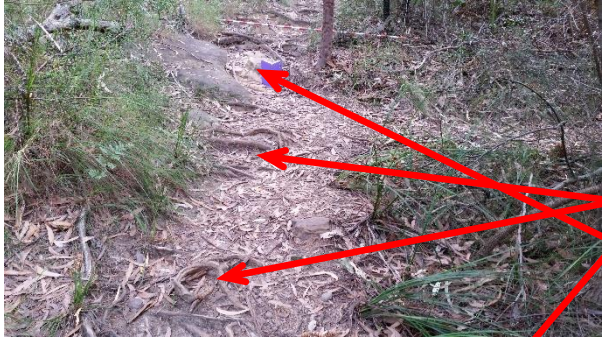
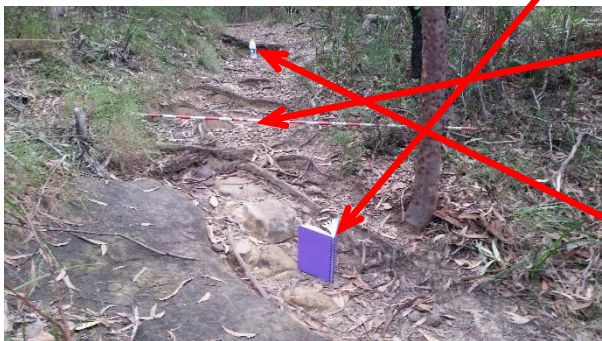
**Site ID: NT – 10(F)**

*Location:* 337755 6260738 Slope to larger drainage line crossing, 5m at 6° gradient and 1.2 change in level overall, compacted a sand/clay at top of slope benched-in to 200mm on high side and retaining/step roots with 300mm face, flat embedded rock and protruding roots on slope below, moist sand/loam on edge of drainage line (with rock pavement bed). Old style small interpretation panel beside drainage line.

- 3 steps at top, boxed/retained on low side, with filled/compacted treads. Top step angled to also act as waterbar (but leaving sufficient tread width below for a safe step).
- 2 steps, built onto in-situ rock, boxed/retained on low side, with extended tread (retained on low side, and filled and compacted over roots upslope) above upper step.
- Pull-in track width on approach to drainage line crossing and barrier/block (rock rubble).

**(Medium)**

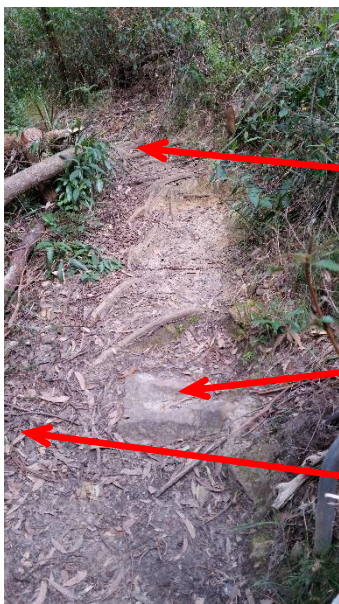
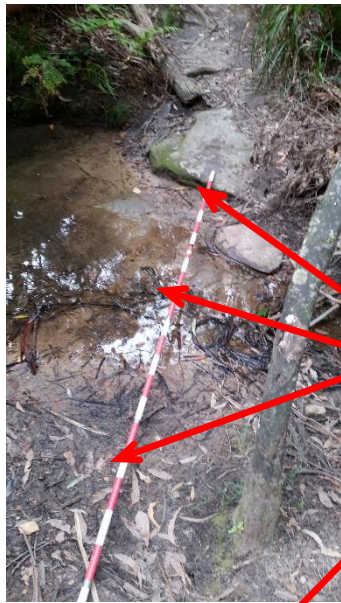
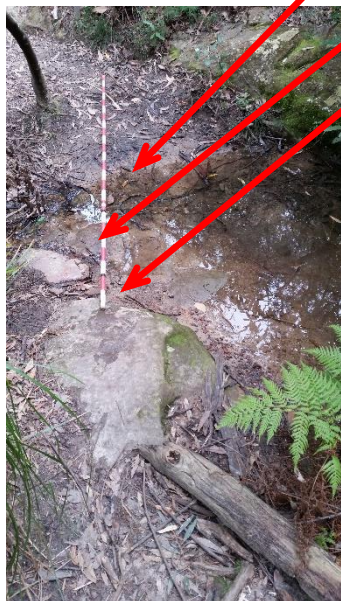
**Site ID: NT – 10(G)**

**Location:** 337750 6260738 Larger drainage line crossing, wet/flowing with rock pavement bed/crossing, 1.8m wide, moist sand/loam on SE bank, flat rock outcrop on NW bank.

Set rock onto pavement/outcrop on NW edge, to “square-off” step in/out of drainage line.

**(low – and monitor for bank erosion and undercutting of track treatments after high flows)**

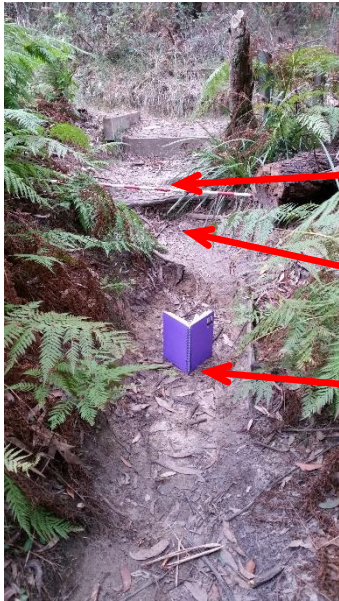
**Site ID: NT – 10(H)**

**Location:** 337747 6260742 Guttered compacted sand track to 250mm below NSL, 600mm wide, retaining roots at top of slope, drainage flows down track from junction with North Balgowlah Link Track above.

Remove existing root at top of slope and replace with waterbar, extend waterbar upslope (beyond track edge) to catch/divert drainage from end of lowest step on North Balgowlah Link Track above.

2 step-and-runs on guttered track, with filled and compacted tread, box/retain low side if needed.

**(Medium – for sustainability issues [to limit sediment inflows to drainage line below])**

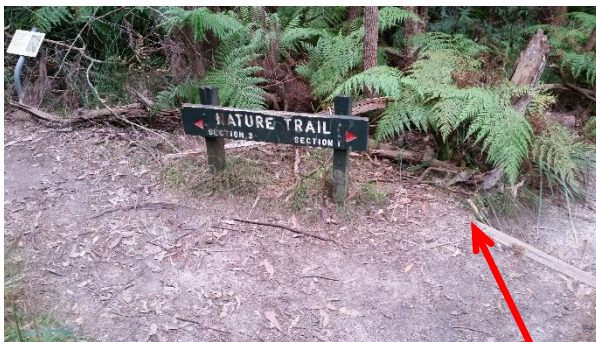
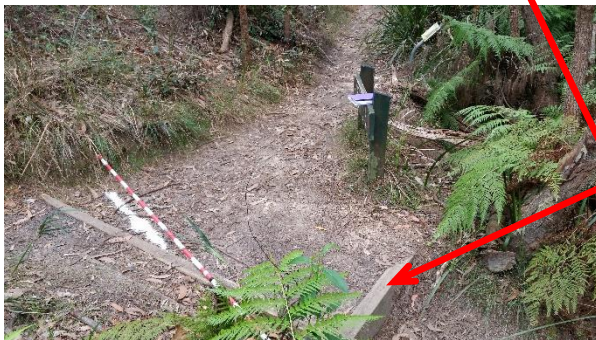
**Site ID: NT – 10(I)**

**Location:** 337745 6260746 Junction with North Balgowlah Link Track from upslope to SW, 90° turn in Nature Trail to NE, 2 routed timber track identification and directional signs (“NATURE TRAIL” sign fair condition only, “NORTH BALGOWLAH” sign good condition). Timber step/waterbar at top of slope to Nature Trail to SE (Site NT – 10(H)), full of sediment with drainage flows over and down track. Old style small interpretation panel (fair condition only).

Clean out step/waterbar, and extend outlet to discharge well off track (and prevent backflow onto track below)

**(low)**

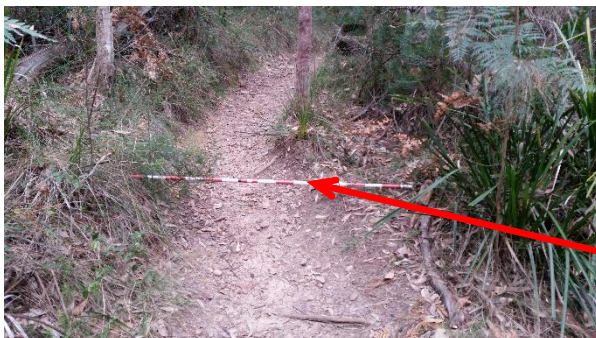
**Site ID: NT – 10(J)**

**Location:** 337748 6260767 Compacted sand and gravel track on 3.5° gradient and drainage flows, 700mm wide, dished to 75mm.

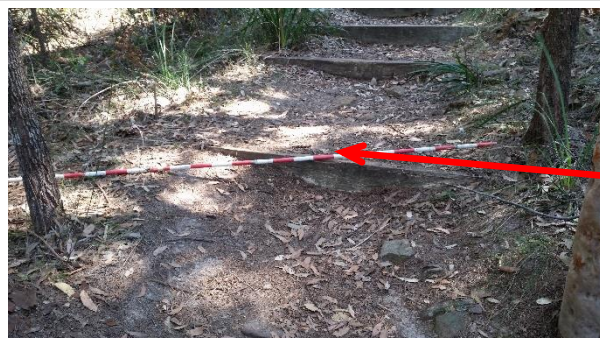
### Site ID: NT – 11(A)

*Location:* 337761 6260795 Wide sleeper step with drainage flows over.

Realign as waterbar/step (for extra drainage protection at top of slope) and cleanout.

**(Medium – for sustainability issues [to catch/divert flows at top of extended slope below])**

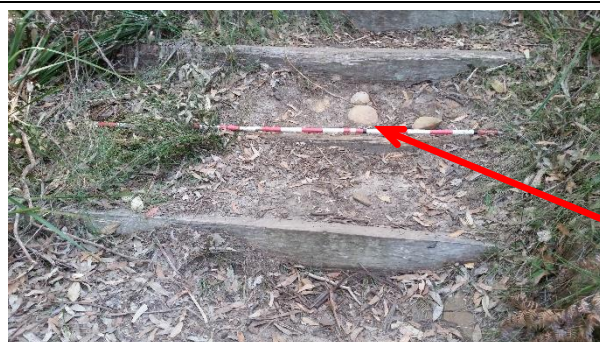
### Site ID: NT – 11(B)

*Location:* 337764 6260803 Rotten/buried sleeper step, with embedded rounded rocks above on sloping tread.

Replace sleeper step, and fill/compact tread above (over rocks) to step above.

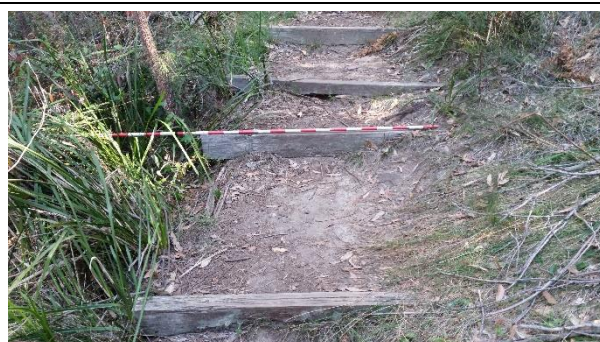
### Site ID: NT – 11(C)

*Location:* 337767 6260809 Rotted/missing sleeper step with protruding reinforcing rod remaining (trip hazard), rounded embedded boulder below on high side.

Remove old reinforcing rod.

**(Medium – safety issues [trip hazard])**

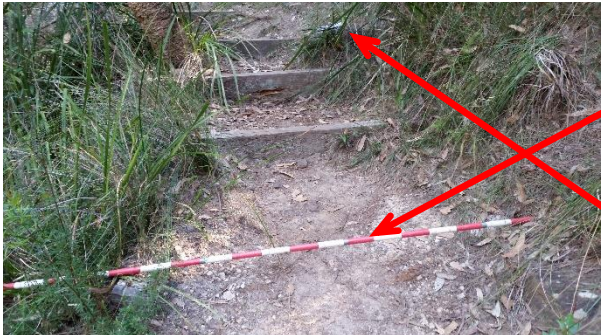
### Site ID: NT – 11(D)

*Location:* 337769 6260818 2 rotting sleeper steps (rotting from underside), and rotten retaining timber edge to tread.

Monitor for failure of sleeper steps and collapse/erosion of edge of track, replace as/when needed.

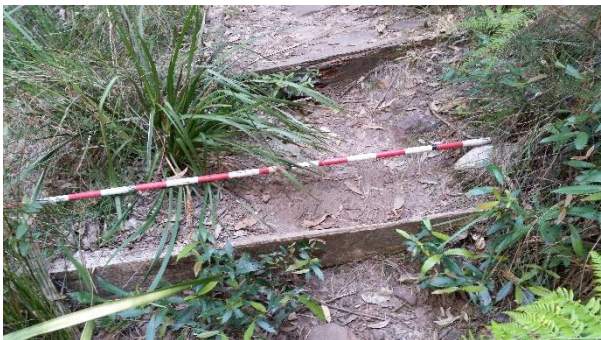
**Site ID: NT – 11(F)**

*Location:* 337772 6260822 Rotting sleeper step above, worn sleeper step below.

Monitor for failure of sleeper steps, replace as/when needed.

**(monitor)**

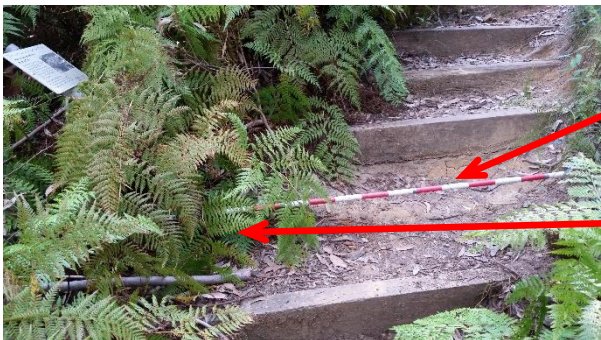
**Site ID: NT – 11(G)**

*Location:* 337778 6260825 Missing angled step (in longer run of sleeper steps on steep slope, 19° gradient), 250mm drop off step above/upslope, compacted sand/clay tread, old style interpretation panel beside track (good condition).

Box/retain low side of tread below new step, and level tread (as stopping/reading area for interpretive panel).

**(low)**

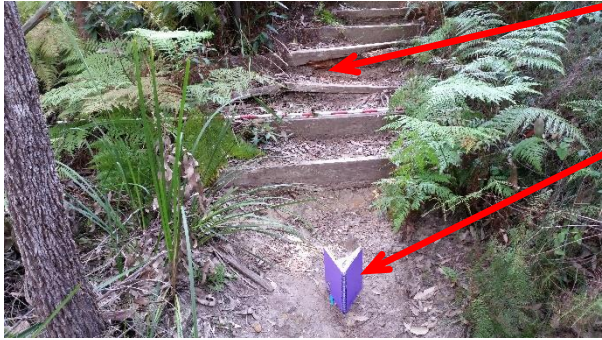
**Site ID: NT – 11(H)**

*Location:* 337781 6260829 2 rotten and failed wide sleeper steps/waterbars – upper step loose and sticking up, lower step broken and loose (hazard) – in longer run of sleeper steps on steep slope, 19° gradient. 350mm step off lowest wide step/waterbar onto eroded track with embedded rock. Drainage flows down.

Replace 2 rotten/failed/broken steps/waterbars, and fill/compact treads above (box/retain along low edge if needed).

Build step onto in-situ rocks 1m below/downslope of existing bottom step, fill/compact tread above back to bottom step (box/retain along low edge if needed).

**(HIGH – for safety issues [to remove trip hazard on steep run of steps])**

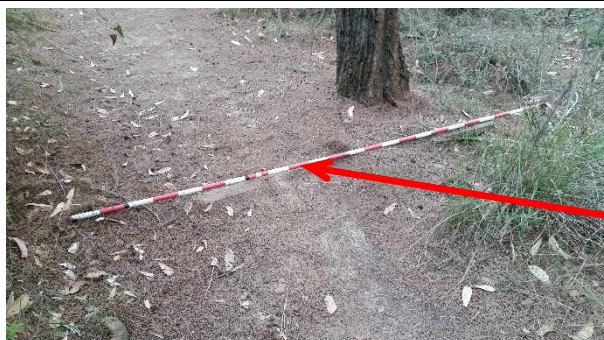
#### Site ID: NT- 12(B)

*Location:* 337799 6260871 Buried and non-functional step/waterbar, rotting at exposed end off low side of track.

Replace step/waterbar.

**(low)**

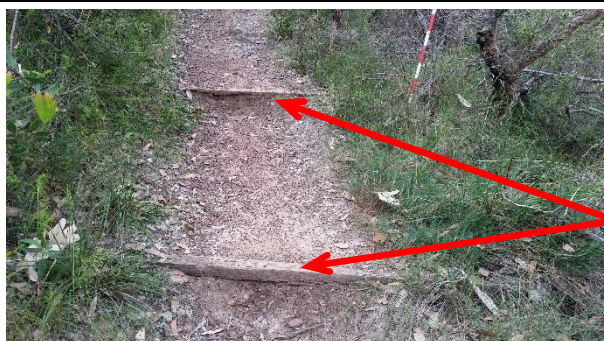
#### Site ID: NT- 12(C)

*Location:* 337809 6260911 Dished track on compacted sand with laterite gravel, 2 steps/waterbars rotting from underside.

Replace 2 steps/waterbars.

**(low)**

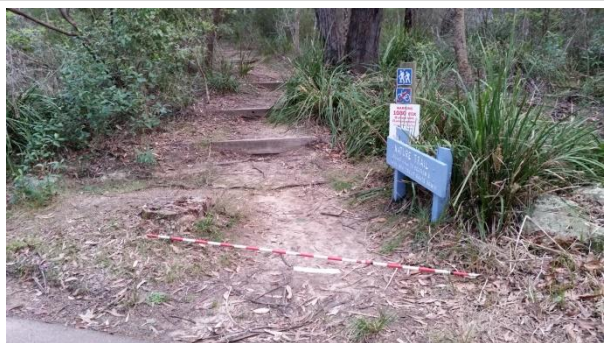
### Site ID: PLT - 1(A)

**Location:** 338343 6260505 Trackhead at park access road (Sir Roden Cutler VC Memorial Drive) opposite playground with interpretation shelter and toilets, new routed timber sign (track identification and orientation, "NATURE TRAIL") in good condition, log post with 2 pictograms ("walkers" and "no bikes") in good/fair condition, adjacent routed timber sign ("WILDFLOWER PROTECTED AREA") in good condition, roadside drain crosses start track.

Monitor for muddiness and need to rock armour or install a stone lined invert at drain crossing.

**(monitor)**

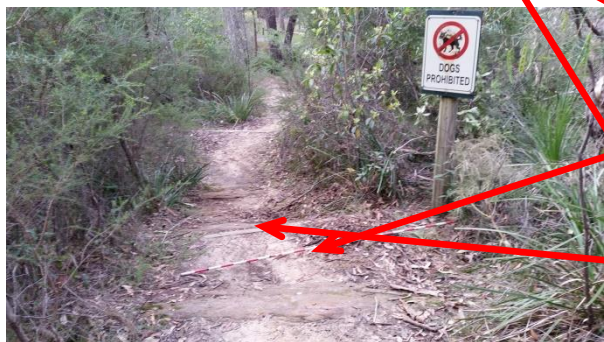
### Site ID: PLT - 1(B)

**Location:** 338351 6260478 Sleeper step with drainage flows over and scouring above angled rock outcrop, then sleeper step/waterbar with angled rock outcrop and embedded rock below. Log post with larger "Dogs Prohibited" text and pictogram, facing upslope, 30m S of trackhead.

Clean out waterbar.

**(low)**

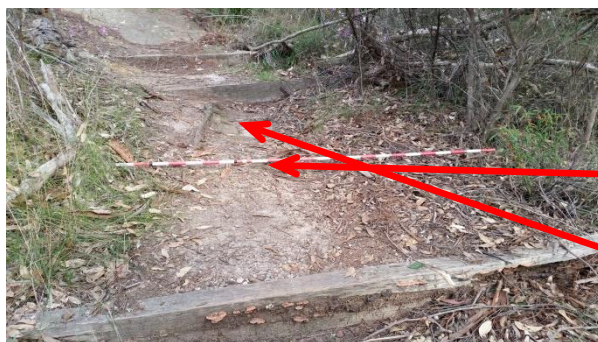
**Site ID: PLT - 1(C)**

*Location:* 338355 6260471 2 sleeper steps (lower step shaped to fit rock outcrop below), then uneven rock outcrop with sloped/angled rockface below, drainage flows down, protruding root on compacted sand flat then angled outcrop/ledge (250mm step-off) below, waterbar downslope. Low Eucalypt branch at top/W of site

- Level upper part of rock outcrop, with level tread or small step.
- Cut 3 steps into sloped/angled rockface ledge (at least 700mm wide).
- Remove protruding root and rock armour/flagging landing.
- Cut step in lower outcrop (at least 700mm wide), and rock armour/flag landing below.
- Clean-out waterbar below.
- Hazard mark low branch (or drop).

**(Medium – for passability issues, as is close to picnic area)**

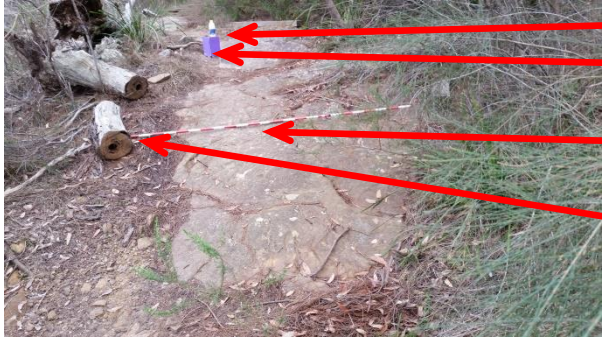
**Location:** 338358 6260463 3m sloped rock outcrop and 1m rock outcrop above with gap/channel down E edge, small cross-sloping gap of compacted sand in between outcrops, some avoidance and track widening to NE (short logs placed to block access), sleepers on NW side (not fixed), drainage flows down, overall drop of 1.1m over 5.5m.

Install waterbar above.

Infill gap beside upper outcrop and level (rock armour/flagging if required).

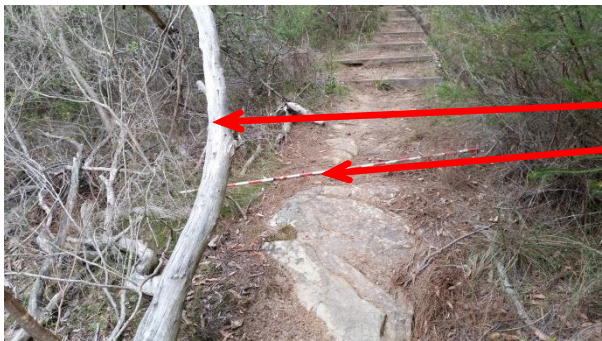
**Location:** 338368 6260459 Small rock outcrop above and larger flat but sloping outcrop, with angled Casuarina branch intruding onto track above, drainage flows over/down.

Remove overhanging Casuarina branch.

Install stone-lined invert above larger outcrop, flagging to extend rock outcrops to match with invert as needed (required to divert flows off track before larger rock slope below (Site PLT - 1(E)).

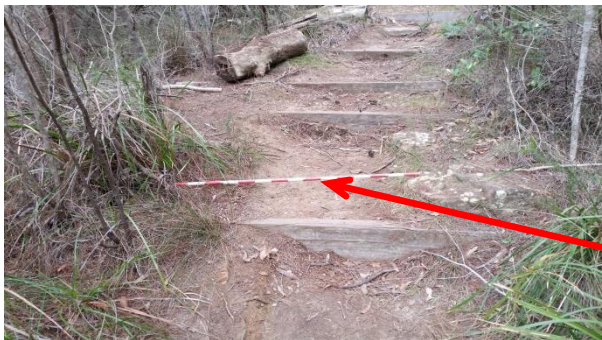
**Location:** 338377 6260454 1,100mm wide compacted sand tread between sleeper step-and-runs, slightly dished, rock outcrop adjacent to W on edge of track.

Install additional waterbar, built onto in-situ outcrop.

**(low)**

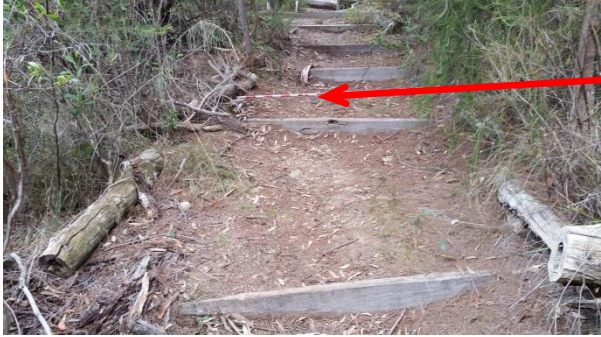
**Site ID: PLT - 1(H)**

*Location:* 338382 6260448 2m wide compacted sand tread between sleeper step-and-runs just downslope of junction with Nature Trail. Overhanging Scribbly Gum branch.

Install wide stone-lined invert, replace sleeper step below with new sleeper waterbar

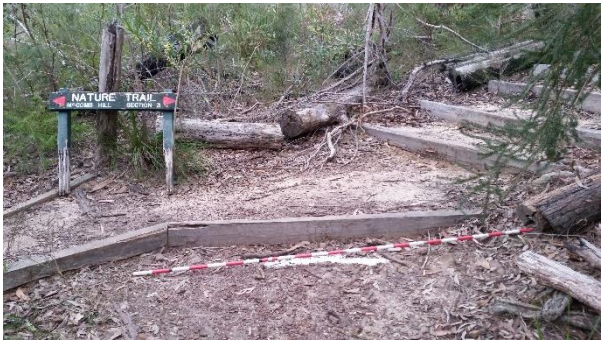
**Site ID: Junction with Nature Trail (NT-3 to E, and NT-4 upslope to W)**

*Location:* 338390 6260443 Small routed timber sign for “NATURE TRAIL”, with “MCCOMB HILL” and “Section 3” both with directional arrows. Dislodged (leaning against tree stump) and in poor condition.

Upgrade signage at junction as per Manly Dam Sign Location Plan.

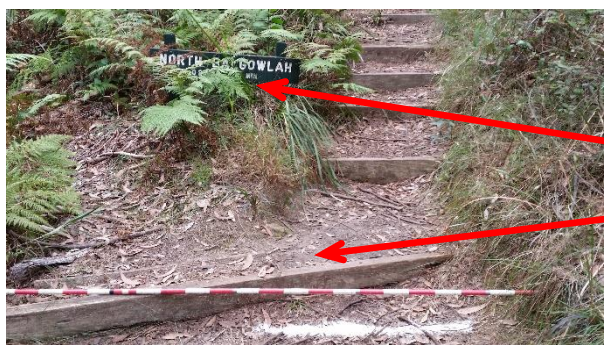
### **Site ID: Junction with Nature Trail (NT-10)**

*Location:* 337745 6260746 Junction of North Balgowlah Link Track (upslope) and Nature Trail (Segment 10). Routed timber sign ("NORTH BALGOWLAH"), good condition (but one post rotting from top). Elongated timber step/waterbar at bottom of top of North Balgowlah Link Track, full of sediment with drainage flows over and down/E on Nature Trail.

Upgrade signage as per Manly Dam Sign Location Plan.

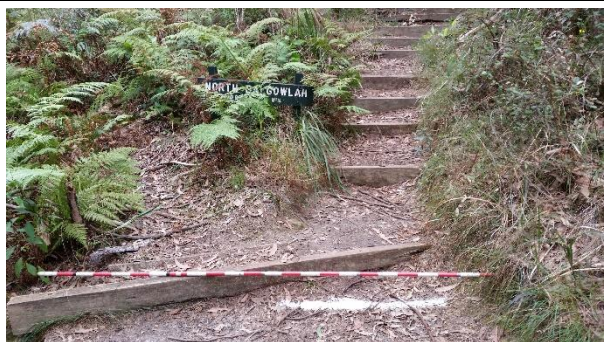
### **Site ID: NBLT – 1(A)**

*Location:* 337741 6260744 (midpoint) Run of 14 timber steps/step-and-runs (6 boxed at upper end) in good/fair condition, over 15m length at 14°, 700-1,500mm wide, 2 steps extended as waterbar, 2 rotting treatments (worst at upper end of site), most treatments are full of sediment and failed with drainage flows down/over but little scour or washed out ends.

Clean out waterbars.

Replace rotting treatments.

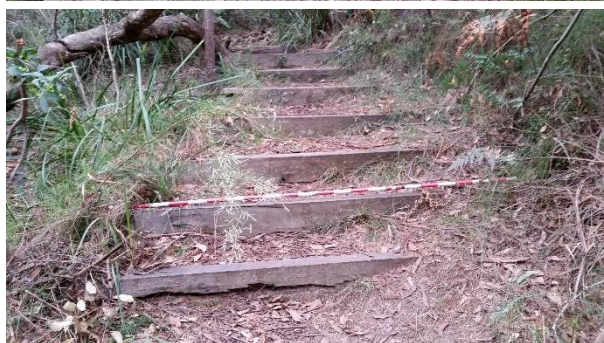
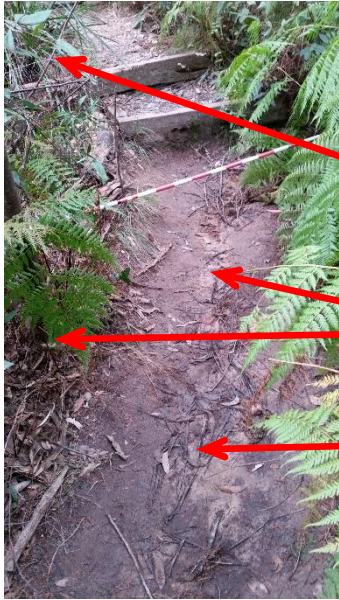
**Site ID: NBLT – 1(B)**

*Location:* 337721 6260732 Drainage line captured by track (bank and log 300mm opposite where tributary meets track deflects flows down track) with ephemeral flows along track for 5-6m to NE, moist compacted sand and seepage. Boxed step with 350mm drop off above junction with drainage line, with double step/waterbar above. Trample tracks upslope from lower/N end of site.

- Open low-side windrow beside step/windrow upslope.
  - Open mound for 2 - 3m opposite tributary. Build stone lined channel/invert to carry tributary across track.
  - 5+m of low FRP boardwalk over crossing, butting into existing boxed step.
- Monitor for repeated blocking/diversion of drainage line.

**(Medium – for passability)**

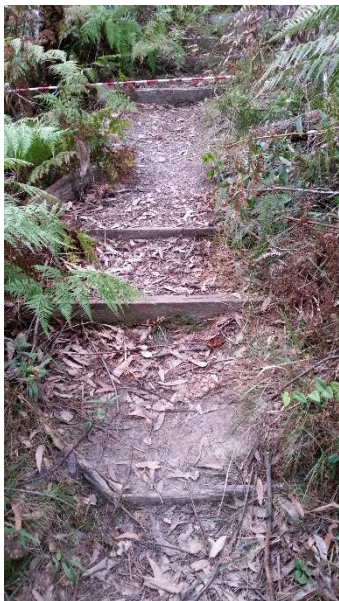
**Site ID: NBLT – 1(C)**

*Location:* 337723 6260730 (bottom = top of Site NBLT-1(B))  
337725 6260722 (midpoint)  
337716 6260707 (top)

Run of 35 timber sleeper steps/step-and-runs and waterbars, comprising - 20 steps/step-and-runs (several edged or with rotten edges), 4 with wash/scour around end, 10 steps extended/acting as waterbars, and 1 rotten step. 32m long, 18° overall (variously 13°, 11° and 18°), compacted sand between treatments, 700-1,600mm wide. Most treatments are full of sediment with flows over, but limited scour. Rotted/missing steps. Rotted out or missing treatments at 3 points. Generally fair/good condition

- Replace 4 missing or rotten steps/waterbars.
- Block (with embedded rock) 4 end wash arounds.
- Replace 3 rotten edging/boxing.
- Clean out waterbars.
- Monitor for further rotting and treatment failure.

**(low)**

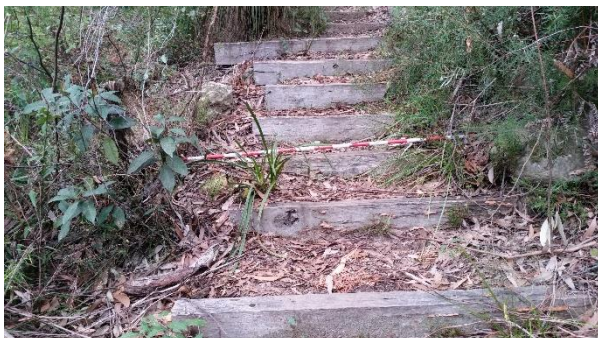
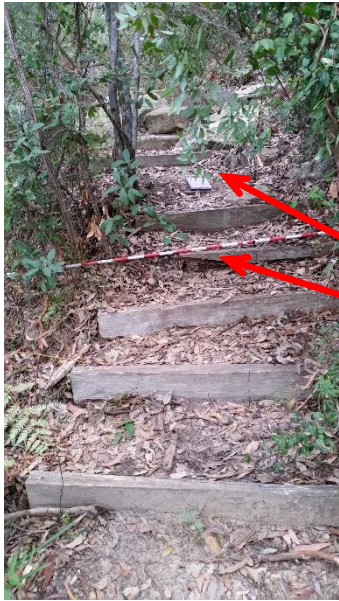
**Site ID: NBLT – 1(D)**

*Location:* 337717 6260703 6m section of compacted sand and embedded rock, 900-1,200mm wide, 23°. Run of 7 sleeper steps – 1 rotten/missing, 1 with rotten end and flows/wash around end, all full of sediment and failed with flow over but no serious scour. Old edging/boxing, but rotten. Overhanging/intruding vegetation.

Replace 2 failed/rotten steps as extended steps/waterbars (to discharge well off track). Clear / trim overhanging vegetation. Monitor for further rotting and treatment failure.

**(low)**

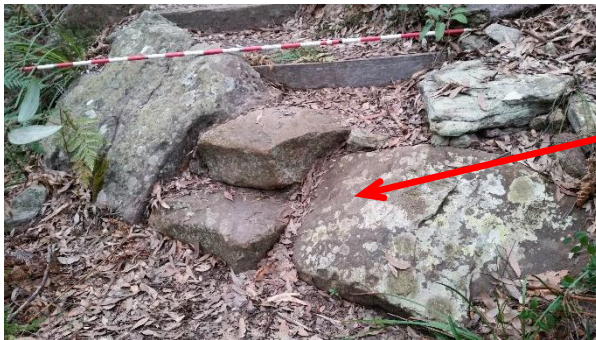
**Site ID: NBLT – 1(E)**

*Location:* 337716 6260700 Sloped boulders/outcrop with 2 placed stone steps in between. Timber step above, part rotten on upper edge.

Monitor timber step for replacement.

**(low)**

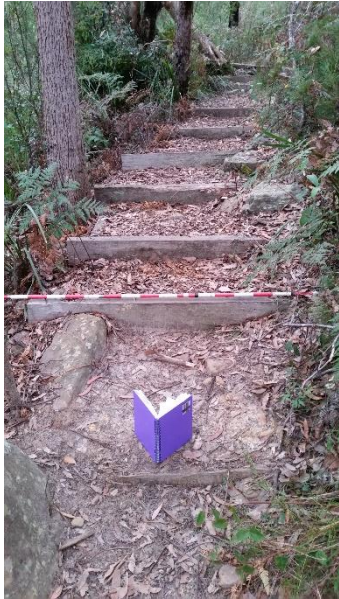
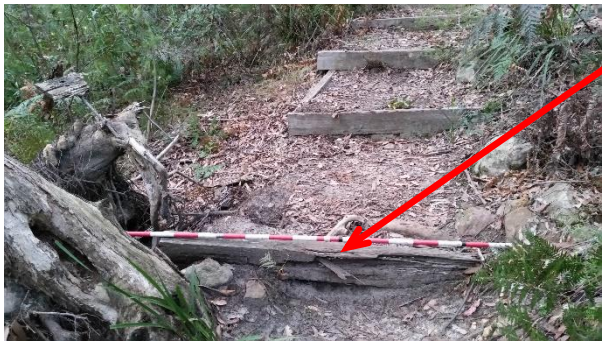
**Site ID: NBLT – 1(F)**

*Location: 337717 6260699 (bottom = top of Site NBLT-1(E))*

Run of 23 timber steps, step-and-runs and waterbars, most boxed/edged, most full of sediment and failed with flows over but only occasional limited scour, comprising - 13 steps/step-and-runs, 4 rotting steps (1 uprooted by fallen tree, trip hazard), and 6 steps/waterbars. 29m section, 900–1500mm wide, 9° lower section then 15° upper section. Also 1 missing/rotted treatment and 1 old log waterbar (now buried and non-functional). Treatments generally good length, no wash arounds.

Replace uprooted rotten step, and box/edge above along low side.

Replace missing / rotten steps.

Monitor for further rotting and treatment failure.

**(Medium - safety issue [trip hazard] at uprooted step - otherwise low)**

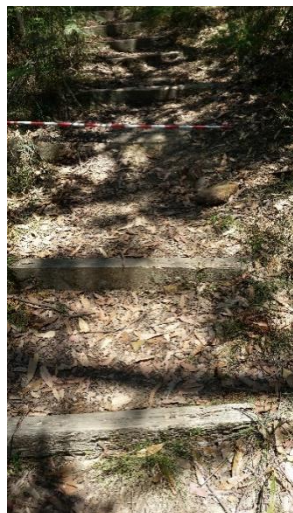
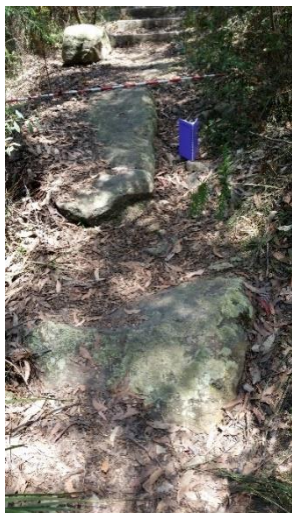
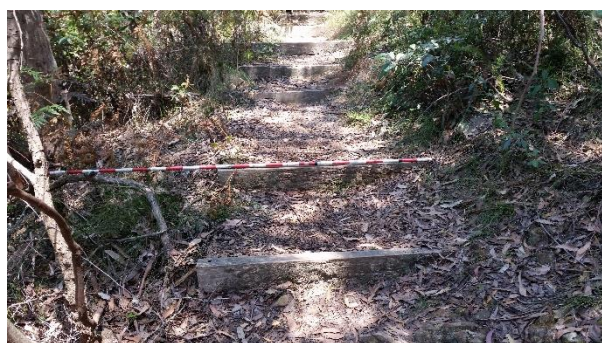
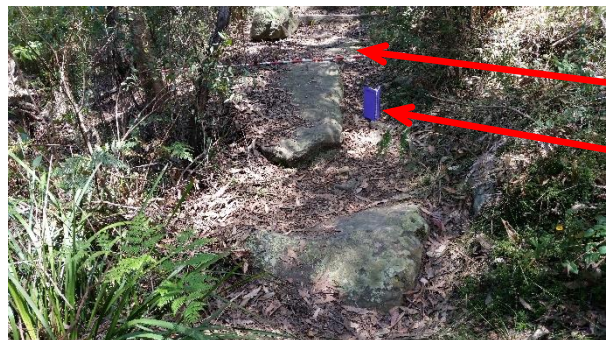
**Site ID: NBLT – 1(G)**

*Location:* 337709 6260667 (bottom)  
337699 6260654 (midpoint)  
337688 6260641 (top)

Run of 19 timber steps, step-and-runs and waterbars, 900-1,400 mm wide, comprising - 12 steps (2 with wash around end), 3 rotten/rotting steps, and 4 steps acting as waterbars (most treatments boxed/edged along low side, but edging usually buried) - benched into slope 50-75mm along high side. All full of sediment and failed with flows over, but limited scour. Treads of compacted sand, with occasional roots plus embedded rock and gravel. 1 missing (rotted) step/waterbar. Large embedded rock with natural step up (200mm high sloped) about half way, with sloping rock slab above, and shallow gap/gutter along upslope side with drainage down (but no scour). Flat embedded pavement above.

Replace rotten or missing waterbars and steps.

Monitor for further rotting and treatment failure, including boxed edges.

**(low)**

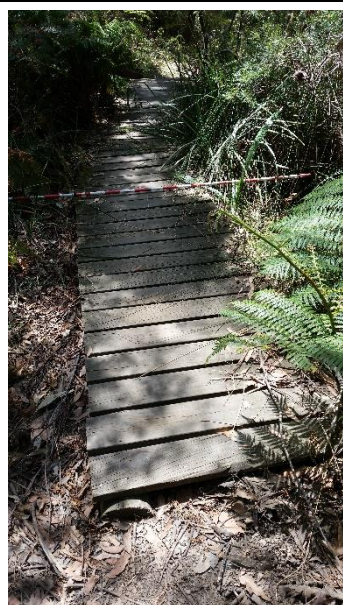
**Site ID: NBLT – 1(H)**

*Location:* 337688 6260639 Low level (floating ?) timber boardwalk, 7.5m long and 900mm wide slight kink in centre, over ephemeral drainage line with sedges and ferns. Good condition. Old disused and overgrown track angles to upslope at N end, but not used. Slightly tilted/angles deck at S end, possibly due to wash (and some deposition) from slope above (Site NBLT 1 (I)).

Monitor for excess sediment cover at S end.

**(monitor)**

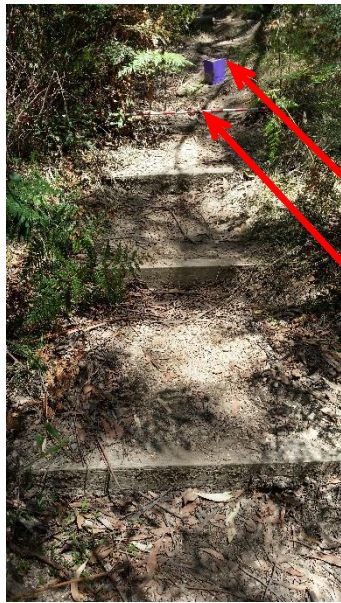
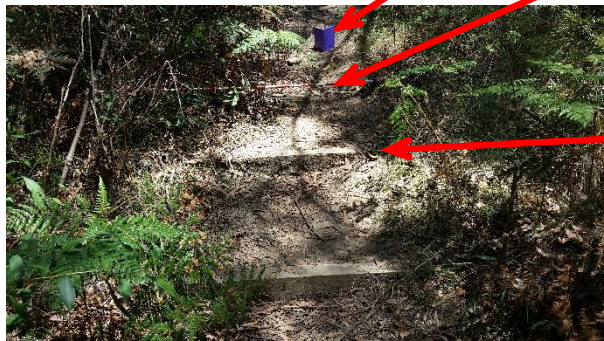
**Site ID: NBLT – 1(I)**

*Location:* 337683 6260628 3 timber steps/waterbars at bottom end and 3 timber steps at top end, over 9m site with 10° slope, all full of sediment and failed with drainage over but no scour, gravel/sand deposition on lower treads. Top step being detoured, only half of tread in use, with shallow gutter and roots above. Middle step has wash around end (high side).

Reinstate/replace existing top step as step/waterbar, extend/anchor well into upslope bank and extend outlet well off track on low side, fill and level/compact above (upslope to new step/waterbar).

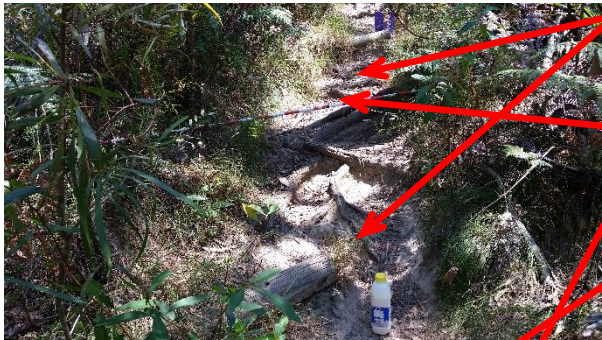
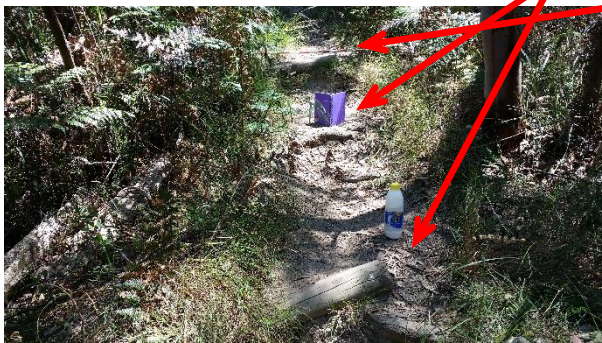
**Site ID: NBLT – 1(M)**

**Location:** 337663 6260604 10m section of compacted sand with embedded laterite gravel with multiple protruding roots on slope creating an uneven surface, 600-1,000mm wide, 10° slope overall (steepest over roots in lower half), drainage down entire site and dished to 100-150mm below NSL. 3 log waterbars/steps but all detoured with worn path and drainage down on high side.

Build 4 boxed step-and-runs on lower (protruding roots) section of site, fill and compact over roots

Angled and extended middle step (of 4 boxed steps) as waterbar.

Build new waterbar upslope of step-and-runs.

Replace in-situ retaining root with new step/waterbar.

Reinstate/replace uppermost log step/waterbar and extend/anchor well into upslope bank.

Extended outlets on all waterbars to discharge well off track, but extend to different lengths to avoid concentrating outflows downslope beside/offset from track.

Remove protruding roots.

**(Medium – for sustainability, to divert flows early on upper slope)**
