# MANLY DAM WALKING TRACKS AUDIT

for  
**Northern Beaches Council**  
May, 2017

CONTROLLED DOCUMENT  
**“Manly Dam Walking Tracks Audit”**

**FINAL ISSUE**

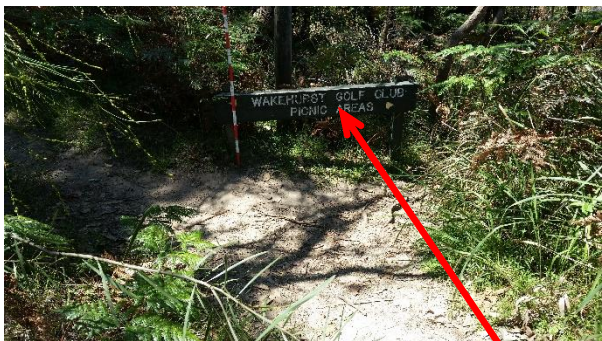
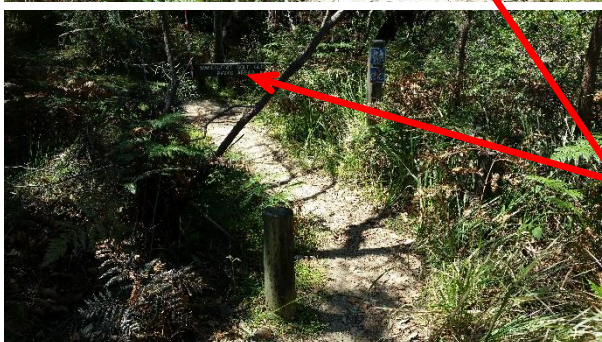
**Site ID: NBLT – 1(O)**

*Location:* 337647 6260600 Track junction, older-style routed timber directional sign (“WAKEHURST GOLF CLUB” and “PICNIC AREAS”), fair condition only, old tall log post behind (but nothing on it). Newer log post 3m to S towards road with “Walkers” and “No Bikes” pictograms. 2.5m S/SW to another 2 low log posts (1 each side of track, but nothing on either). North Balgowlah Link Track turns 90° S at junction towards Manning Street (from E/downslope), but very well defined/used track heads cross-slope to N/NW (not assessed). Track slightly upslope/S from junction, 600-700mm wide, has loose sediment/fill deposited from Manning Street trackhead 14m away.

Remove redundant posts.

**(low)**

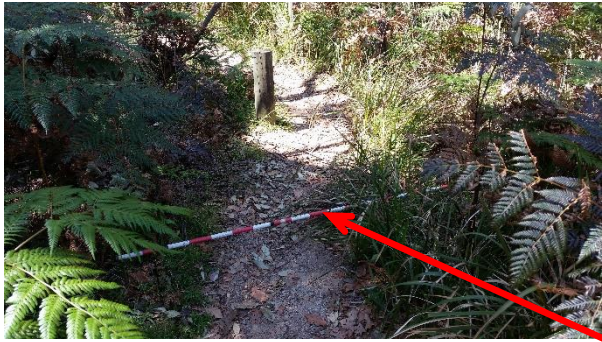
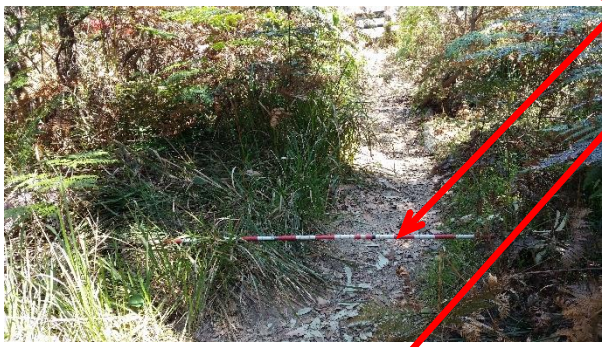
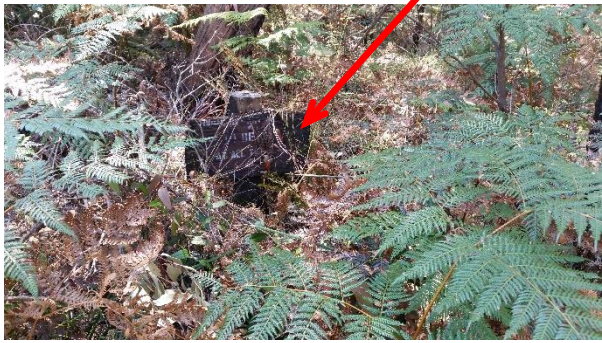
**Site ID: NBLT – 1(P)**

**Location:** 337642 6260595 Compacted and loose sand and imported/loose fill, 600mm wide, 4° slope with drainage down track from Manning Street trackhead 6-7m away, no scour and track only slightly dished. Old burnt sign off to NW side of track, partly screened by vegetation

Remove redundant burnt sign.

**(Medium – for passability/safety and sustainability issues)**

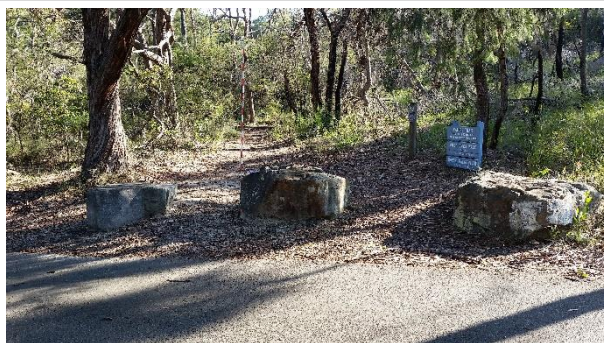
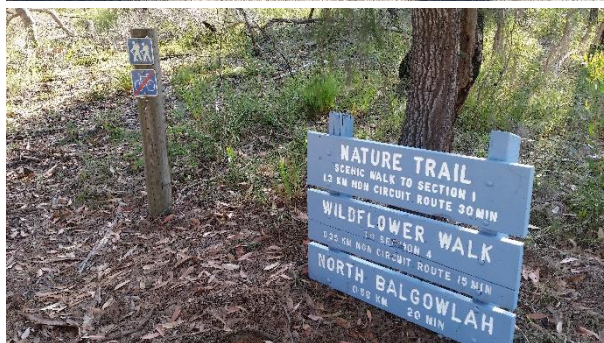
### Site ID: WW – 1(A)

**Location:** 337847 6260988 Eastern trackhead at park access road (Sir Roden Cutler VC Memorial Drive), 3 large boulders as vehicle barriers along edge of road at track entry, 6m wide entrance funnelling down to 1,500mm after 6m, compacted sand and loose sediment/stones (but stable track surface), some drainage down track into roadside drain, 3-panel routed timber sign (track identification and orientation for NATURE TRAIL and WILDFLOWER WALK, and to NORTH BALGOWLAH) in good condition, and log post with 2 pictograms (“walkers” and “no bikes”).

Routine maintenance only.

**(low)**

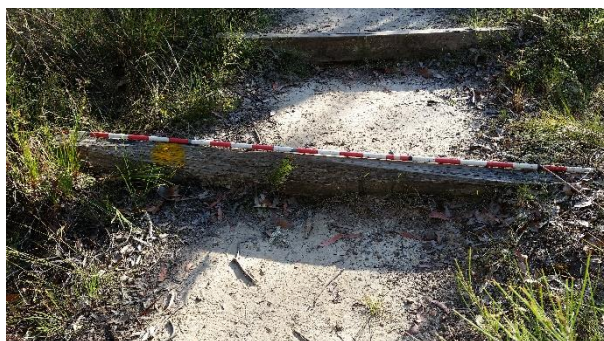
### Site ID: WW – 1(B)

**Location:** 337834 6260969 Wide sleeper step, worn on face with protruding anchor rod (steel reinforcing bar) on edge of track, painted yellow.

Monitor for increased safety hazard at protruding anchor rod.

Monitor for rot/wear and need to replace sleeper step.

**(monitor)**

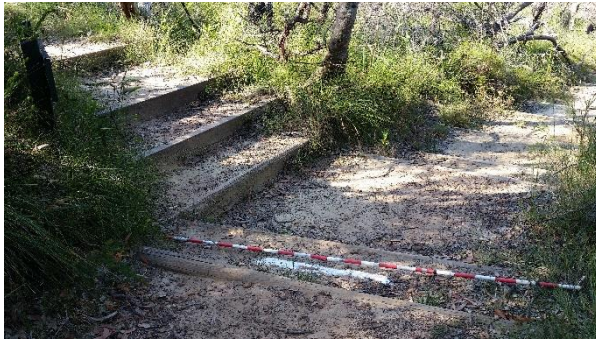
**Site ID: Junction with Nature Trail (at end of Segment NT – 12)**

*Location:* 337819 6260958 Junction with Nature Trail, wide boxed landing/junction of compacted sand with retaining sleeper steps to both tracks. Routed timber track identification and directional sign (“NATURE TRAIL AND NTH BALGOWLAH” and “WILDFLOWER WALK”) in fair condition.

Upgrade signage at junction, as per Manly Dam Sign Location Plan.

**(low)**

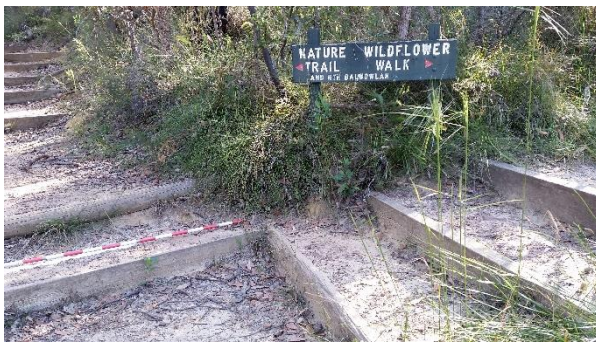
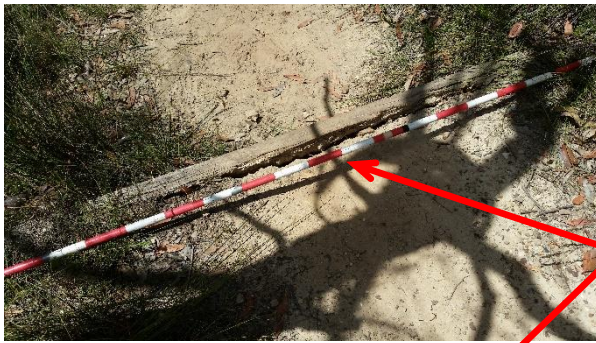
**Site ID: WW – 1(C)**

*Location:* 337818 6260960 Rotted and loose sleeper step (hazard), dead tree (200mm DBH) on low side of track (leaning over track).

Replace sleeper step and angle (with extension, if required) to also act as waterbar, compact track surface upslope.

Fall dead tree leaning over track (potential hazard).

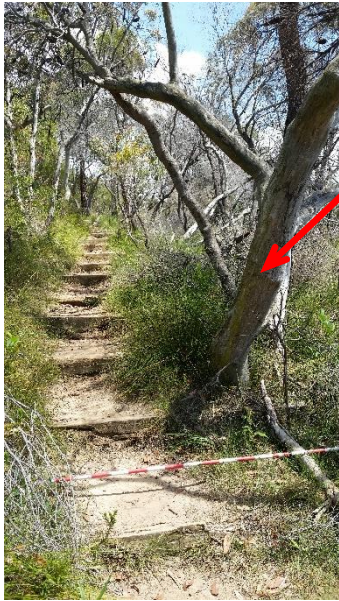
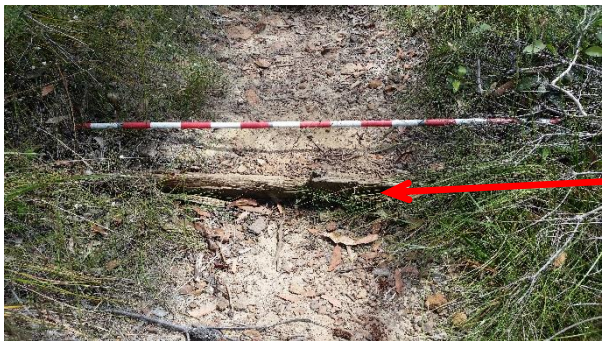
**Site ID: WW – 1(D)**

*Location:* 337814 6260962 2 rotten sleeper steps, upper one is also loose. 2 dead trees, greater than 200mm DBH, on low side of track – upslope tree has limb and trunk over track (potential hazard).

Replace sleeper steps, compact track surface upslope.

**(HIGH – tree safety issue)**

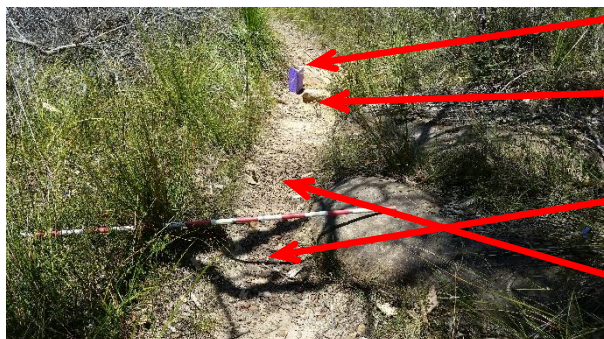
**Location:** 337762 6261011 Above – sandstone outcrop as angled natural step, with embedded rocks below on high side, flows down. Below – gutter 75-100mm deep 500mm wide for 2.5m with sandstone boulder/outcrop on high side at lower end (track narrows to 400mm).

Build waterbar 1m above upper outcrop to catch/divert flows.

Infill upper outcrop to squared off as stone step, build new stone step below (save Xanthorrhoea if possible)

Fill/compact gutter above for at least 2m back to new steps (obtain fill from run on / deposition area below). Block/barrier (rock rubble) beside steps to prevent avoidance/widening.

**(low)**

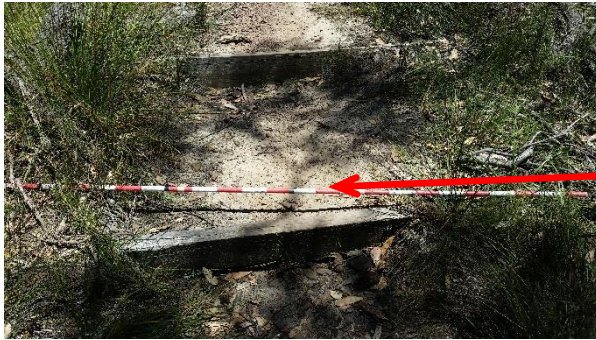
**Site ID: WW – 2(B)**

*Location:* 337755 6261020 Sleeper step, with drainage flows over.

Extend high and low sides and realign to better function as waterbar.

**(low)**

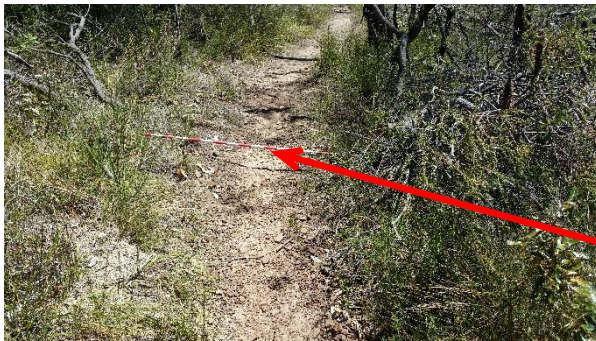
**Site ID: WW – 2(C)**

*Location:* 337750 6261020 Compacted sand and exposed roots on laterite slope, gently dished, 700mm wide, 3° with drainage flows down,.

Build waterbar and fill/compact above to level of roots.

**(low)**

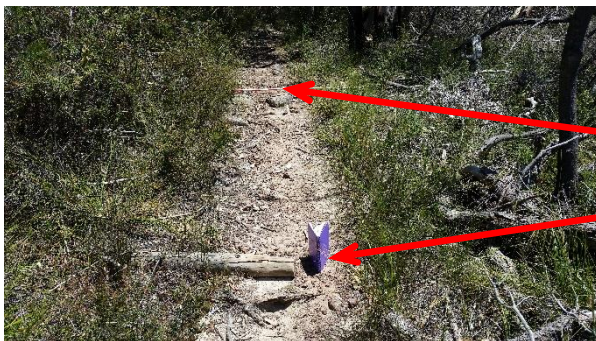
**Site ID: WW – 2(D)**

*Location:* 337726 6261043 Old log waterbar part way across track, track dished to 50mm with embedded lateritic rocks and gravels, 6° with drainage flows down.

Extend/relocate in situ log waterbar over track, or replace with new waterbar.

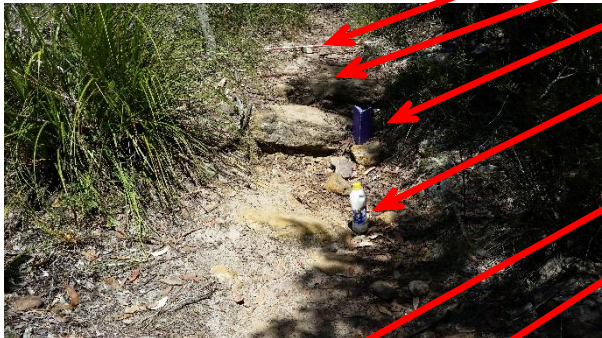
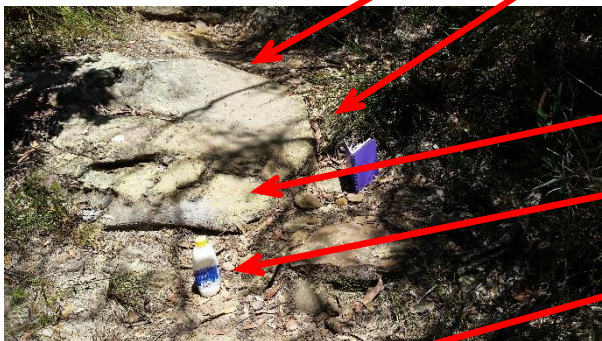
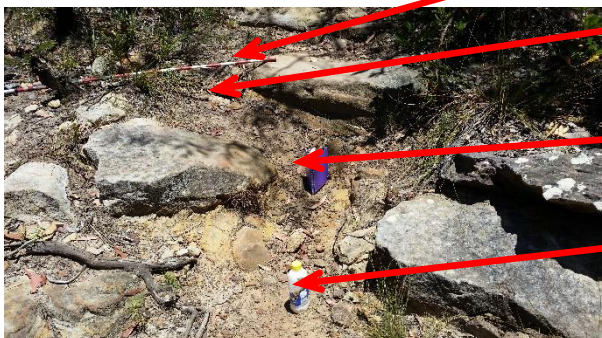
14m long slope at 11-13° of outcrops and embedded/protruding rocks set in dished/guttered compacted sand and loose rocks/stones with loose laterite gravel, large sloping boulder across most of track midway with drainage gutter along W edge, drainage flows down entire section with scour over/round rocks and eroded steps of 350-400mm off rocks (often onto sloped track sections), track width from 600mm (between rocks) to 1,200mm, sleeper waterbar at base with drainage flows over.

Build boxed step onto in situ rock below lower sleeper step, fill/compact above.

**(Medium – for passability and sustainability/impact issues)**

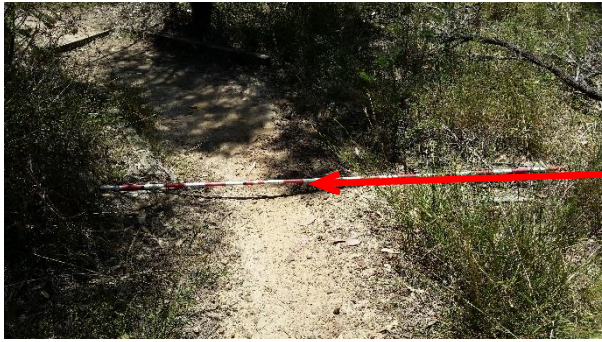
**Site ID: WW – 2(F)**

*Location:* 337720 6261071 Remains of old (rotten/burnt) timber waterbar.

Replace with new waterbar.

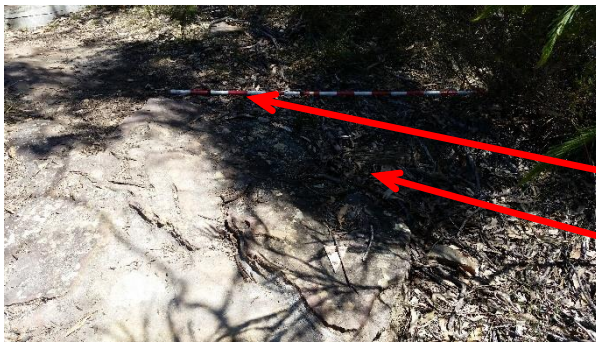
*Location:* 337696 6261082 Old log waterbar off W side of rock pavement – full and failed.

- Build new stone waterbar off upper/W lip of pavement.
- Pull-in and block/barrier (rock rubble) flow path to W side of pavement.

**(low)**

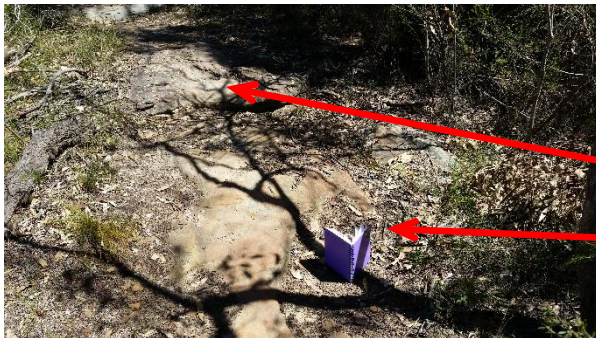
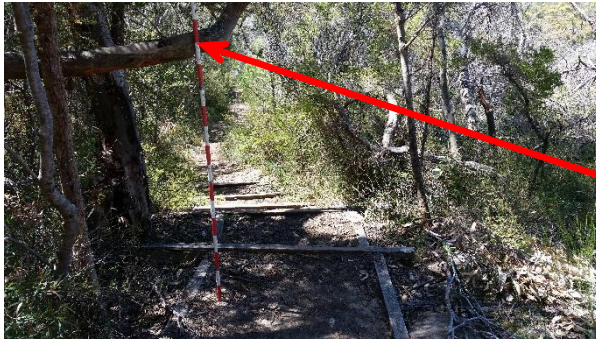
#### Site ID: WW – 3(B)

*Location:* 337694 6261084 Upper rock pavement with roots on step-off below. Lower rock pavement with curved gap/dip in W side of outcrop.

- Remove roots, fill/compact track surface (rock armour if needed).
- Rock armour gap beside lower pavement to square-off. Define W edge of track (rock rubble/barrier).

**(low)**

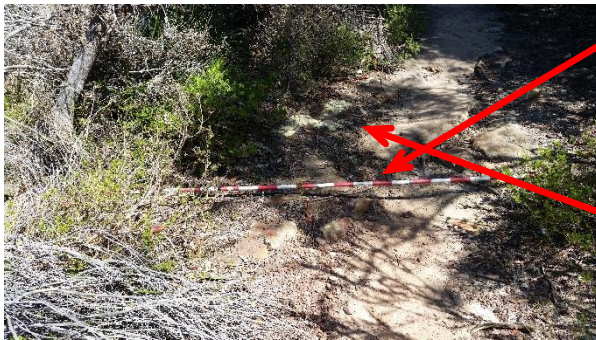
**Site ID: WW – 3(D)**

*Location:* 337695 6261100 Rotted/missing timber step, protruding stumps above (trip hazard).

Replace sleep step, angled as waterbar.

Remove small stumps.

**(low)**

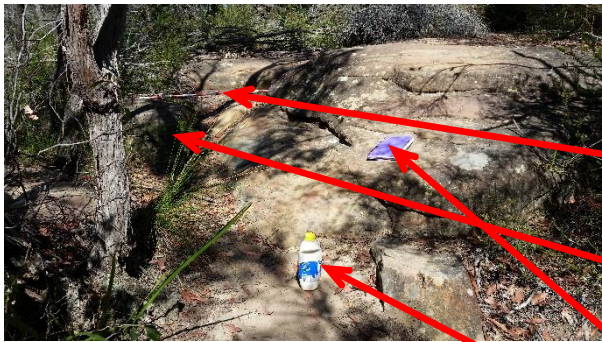
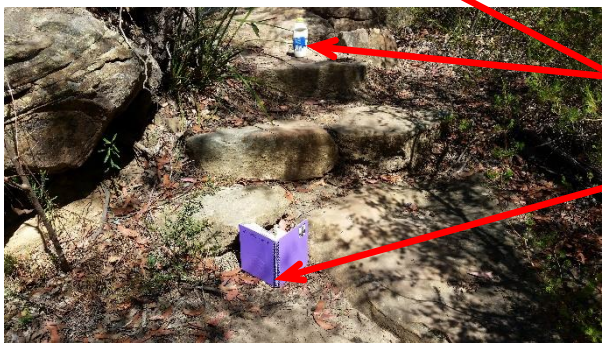
**Site ID: WW – 3(F)**

**Location:** 337689 6261130 Large sloped rock ledge with dual routes. “High” SW route over stepped rock ledge, 2 ledges 250-300mm high and squared/angular placed rock at base of ledge. “Low” NE route off NE side of outcrop along flatter drainage line (fed by flows off rock ledge and from gutter along ledge’s upper/SE edge between embedded rock outcrops). Routes rejoin at NE base of ledge, then placed rock step (700mm wide and 250 step-off) and double rock step below (1,100mm wide and 2 300 step-off), then flat rock outcrop (100-200mm step-off) to boxed sleeper step with compacted sand tread built onto lower side of flat outcrop. 18° over 9m (on direct route over ledge).

Build rock wall across top of lowside/NE gutter above rock ledge to divert flow off track and downslope to NE.

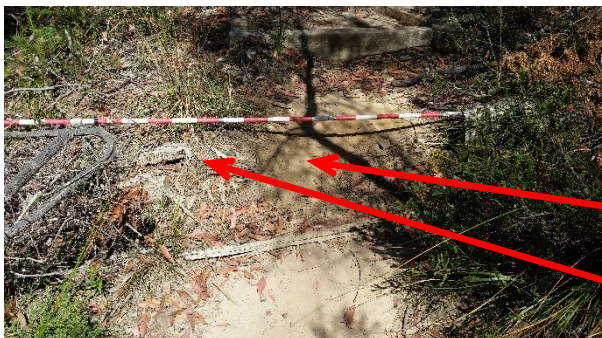
Missing/rotted step/waterbar, protruding anchor rod (steel reinforcing bar) on N side (trip hazard), large log upslope and downslope either side.

Remove steel reinforcing bar.

**(Medium – safety issue)**

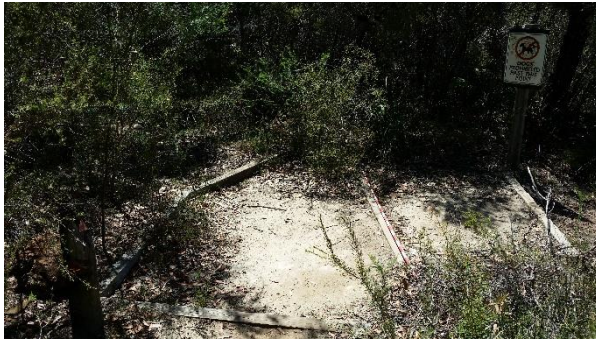
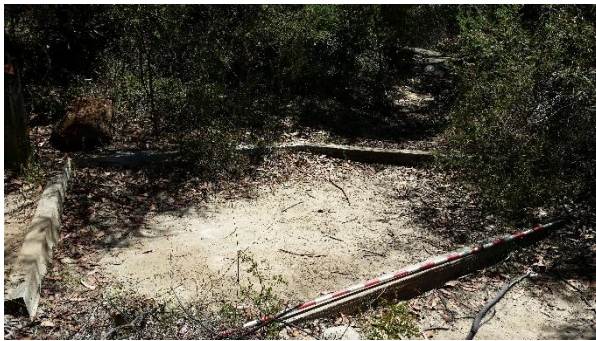
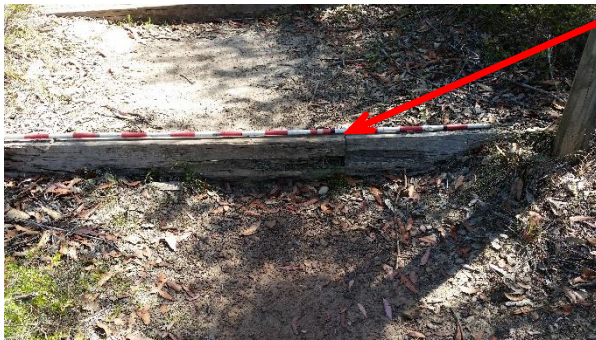
**Site ID: WW – 3(H)**

**Location:** 337681 6261139 Junction with informal, but well-used, track W/NW to golf course – as compacted and landing, at 90° bend in track to NE, with edging/retaining sleepers along high side and sleeper step across track downslope. Old log waterbar remaining inside 90° bend (remains of former alignment). Old low post with 2 directional arrows – fair condition.

Downslope/NE to long sleeper waterbar (with extension) rotten at W end and loose (when trodden on) just NE/downslope of track junction, and log post with larger “Dogs Prohibited” text and pictogram adjacent (facing upslope to track junction) – fair condition.

Replace waterbar downslope of junction, and clean out.

**(low)**

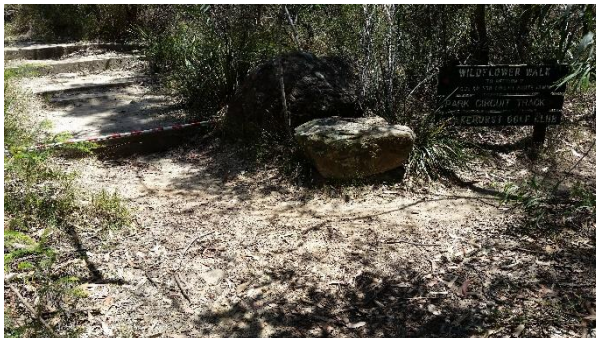
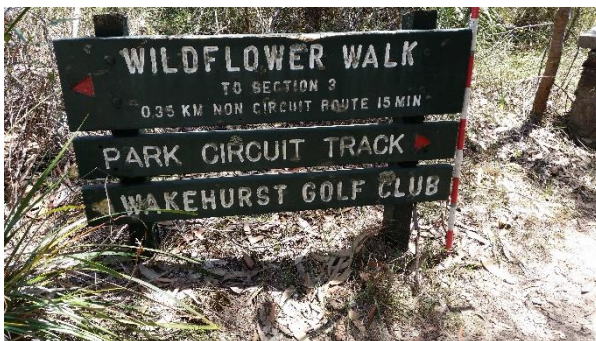
**Site ID: Junction with Park Circuit Track (West)**

**Location:** 337693 6261159 Junction with Park Circuit Track (West), older style 3 panel routed timber tack identification and directional sign (“WILDFLOWER WALK”, “PARK CIRCUIT TRACK” and “WAKEHURST GOLF CLUB”) - in fair/poor condition. Large boulder, as informal seat. 15m S of bridge, and 23m S of trackhead (but signage not easily visible from trackhead).

Upgrade signage at junction, as per Manly Dam Sign Location Plan.

**(low)**

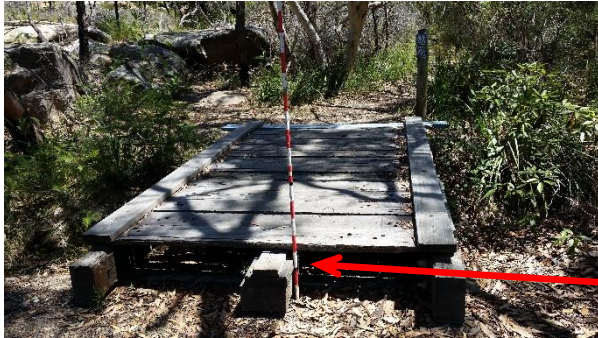
**Site ID: WW – 3(I)**

*Location:* 337705 6261164 Timber plank (sleeper) bridge 1,800mm wide with 200mm wide toe-boards along edges, on large square beams, across drain along road edge (1m drop off each side of bridge). Sleeper step off S end (200mm high), plank missing on N end with exposed beams (trip hazard) and 400mm step off. Log post with 2 pictograms (“walkers” and “no bikes”) at NW end of bridge.

Replace missing plank, and add step off, N end of bridge.

**(low)**

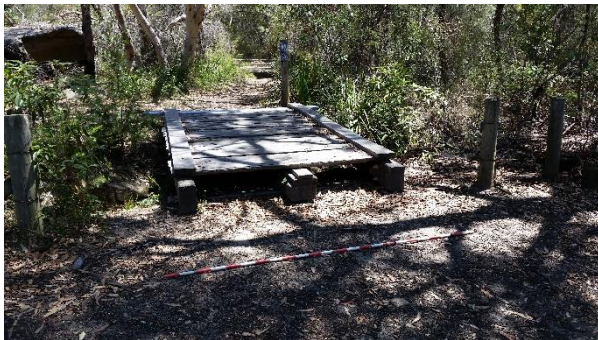
**Site ID: WW – 3(J)**

*Location:* 337707 6261166 Western trackhead at carpark and park access road (Sir Roden Cutler VC Memorial Drive) – no signage. Posts for slip-rail gate located either side of bridge (but no rail). No track identification or orientation information.

**(Medium)**

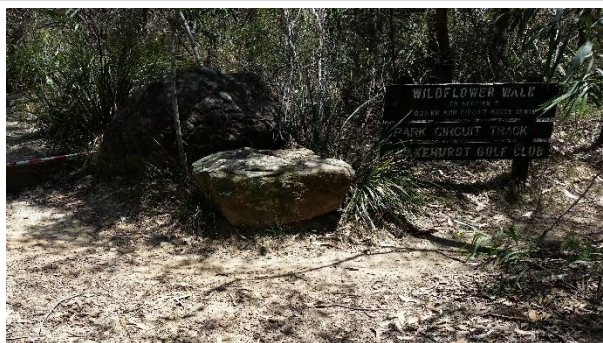
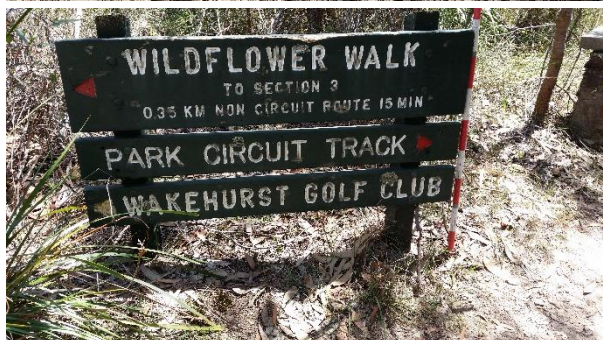
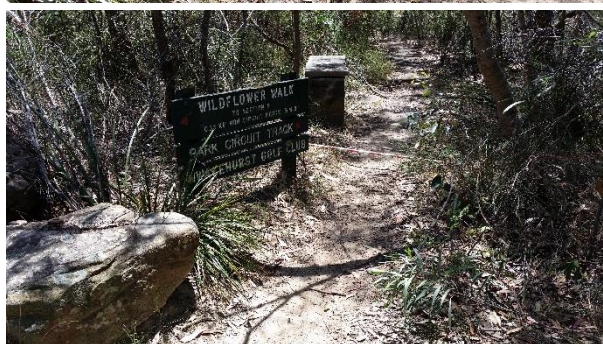
### Site ID: Junction with Wildflower Walk (E end of PCT(W))

**Location:** 337693 6261159 Junction with Wildflower Walk, older style 3 panel routed timber tack identification and directional sign ("WILDFLOWER WALK", "PARK CIRCUIT TRACK" and "WAKEHURST GOLF CLUB") - in fair/poor condition. Large boulder, as informal seat, at junction. Start of track 600-800mm wide, compacted sand and embedded gravel, small sandstone squared bench, with concrete top (split/cracked) at 5m down track, fair condition only.

Monitor condition of bench, repair as/when required.

**(low, and monitor)**

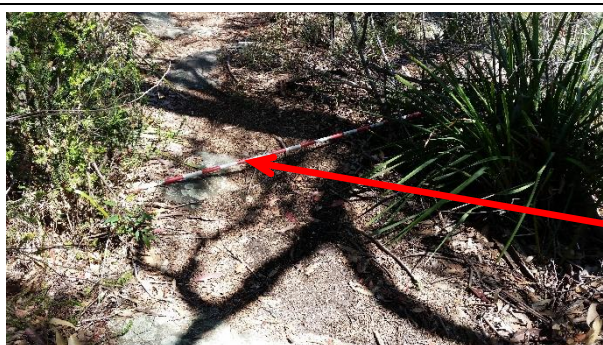
### Site ID: PCT(W) – 1(A)

**Location:** 337680 6261175 Rounded outcrop with compacted sand, dip upslope, ponding and natural discharge area.

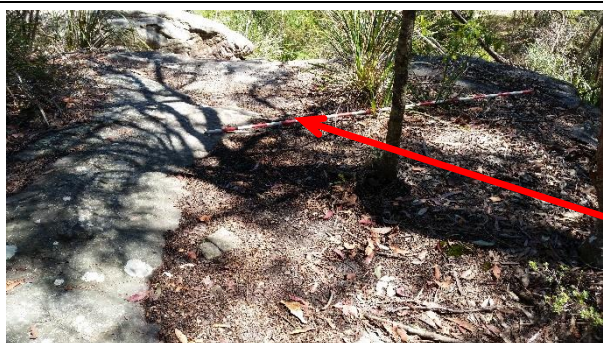
### Site ID: PCT(W) – 1(B)

**Location:** 337675 6261181 Rounded top of rock ledge, compacted sand and gravel with ponding area adjacent on low side.

Build stone waterbar onto in-situ outcrop, discharge N over sloped rock ledge

**(Medium – to prevent flow down rock steps below, Site PCT(W) – 3(C)).**

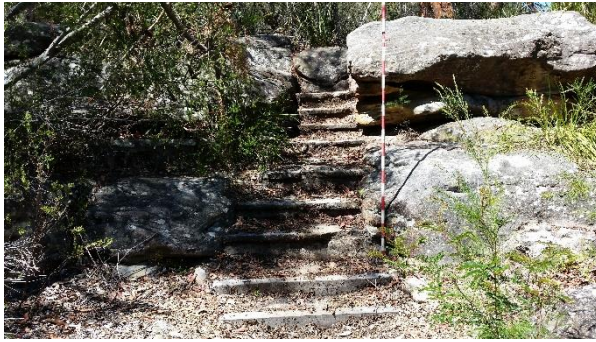
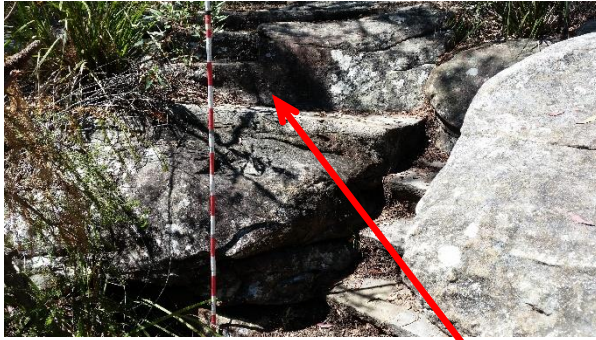
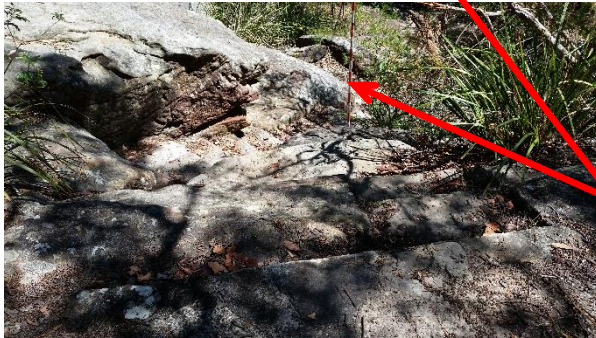
**Site ID: PCT(W) – 1(C)**

**Location:** 337675 6261185 Split rock ledge – ledge above, large boulders (squared) below. “S” bend of well-constructed rock steps cut into and built onto face of ledge and over/between boulders, 24° and 3m height difference overall. Wide stone flagged landing at top of ledge, then 2 steps (700mm wide) cut into upper slope of ledge, curving 90° to a concrete landing/ramp below, then curving 90° to a 300mm high step off to 4 stone flagged steps cut/set into lower part of ledge (900mm wide, 150-200mm risers), then short flagged landing at top of boulders and finally 3 stone flagged steps between boulders (800-1,000mm wide, 150-200mm risers) and 2 sleeper steps off bottom (2 more sleeper steps 2.5m downslope, with drainage flows over but no scour) 1.2m drop off side of upper landing, over steeply sloped/rounded edge of ledge onto steps and rock below. Drainage flows down entire site but well-built/stable and no scour.

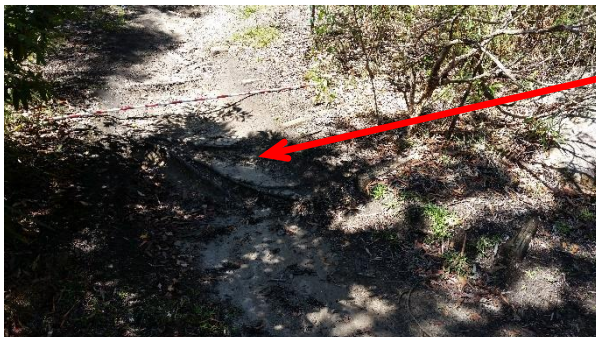
**Site ID: PCT(W) – 1(E)**

**Location:** 337657 6261191 Large flat outcrop/boulder with eroded gutter adjacent 500mm wide 300mm deep with exposed roots and flows down. Compacted sand track surface v below/downslope with 2 large protruding Angophora roots and sloped rock outcrops below.

Rock flagging/infills and /or cut level landings onto lower outcrop.

**(Medium – for passability and sustainability issues, and high traffic area adjacent to picnic sites)**

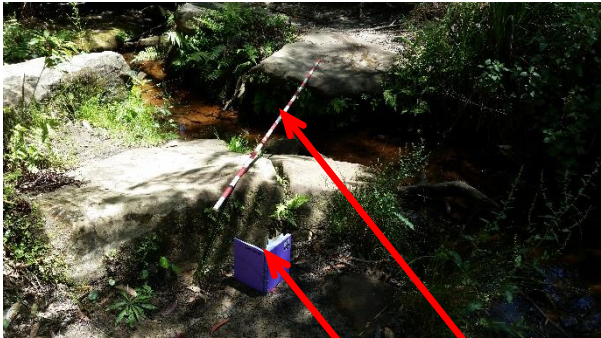
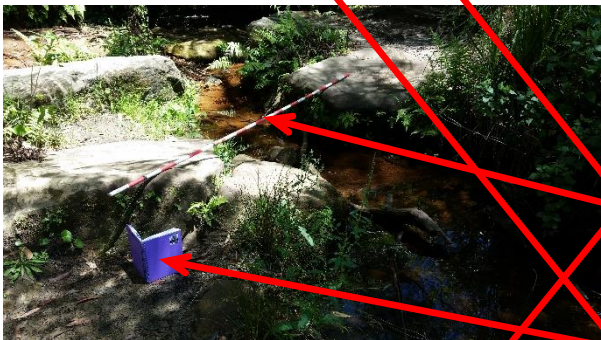
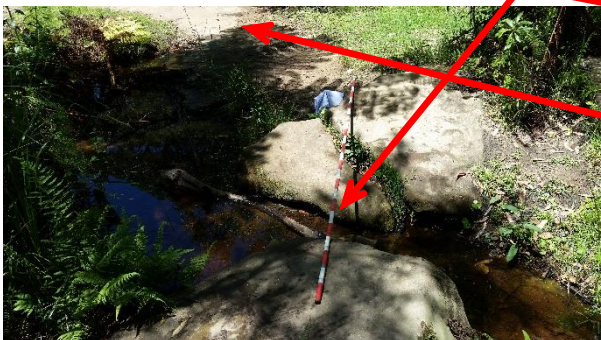
**Site ID: PCT(W) – 1(I)**

**Location:** 337638 6261214 Large area of exposed roots, up to 100-200 mm high and gaps beneath, trip hazard, in compacted sand track 1,000-1,200mm wide.

Waterbar, at least 1 pace above boxed step, to divert flows to protect FRP bridge and step downslope.

**(Medium – for safety/passability issues on approach to bridge, high traffic area)**

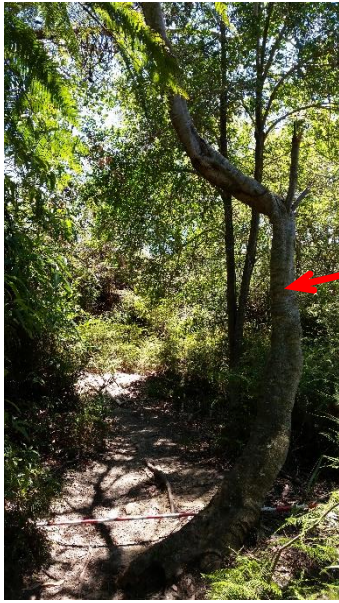
*Site ID:* **PCT(W) – 1(J)**

*Location:* 337639 6261220 Large dead Banksia beside track, trunk bends over track, and trip hazard at base.

Fall dead Banksia, remove roots and level track.

**(HIGH – safety issue, high traffic area)**

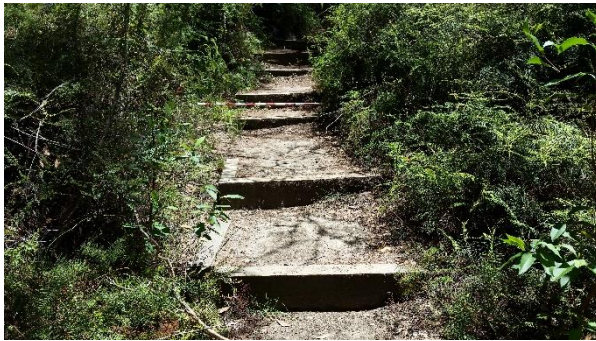
*Site ID:* **PCT(W) – 1(K)**

*Location:* 337636 6261229 (midpoint)  
Run of 7 sleeper steps, 3 boxed, 1,100mm wide and 100–200mm risers, through fern banks, good condition. Drainage flows over/down but minor scour only, compacted sand treads. Sleeper waterbar at top, full of sediment and failed. Log post with large “Dogs Prohibited” sign at top of steps, facing N – good condition.

Clean out and reinstate/relocate waterbar.

**(low)**

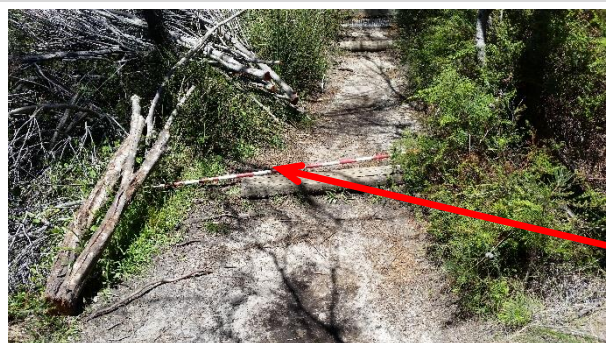
**Site ID: PCT(W) – 2(A)**

**Location:** 337644 6261287 Old log waterbar, short with drainage flows around NE end, compacted sand track 1,100mm wide, 3° slope.

Replace or extend waterbar.  
**(low)**

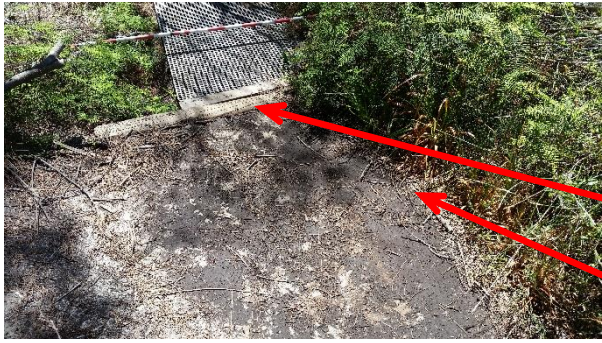
**Site ID: PCT(W) – 2(B)**

**Location:** 337644 6261294 Embedded log at S end of low FRP boardwalk, with ponding/run-on areas above/upslope and track widening (avoiding puddle/mud).

Clean-out waterbar and open outlet at E end.

Open windrow along low side of track.  
**(low)**

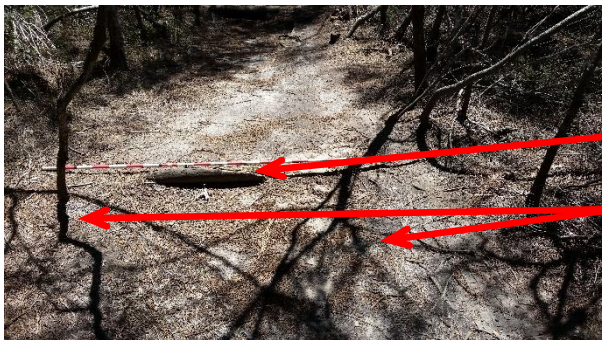
**Site ID: PCT(W) – 2(C)**

**Location:** 337648 6261314 Rotted log waterbar/step, very wide track 1,500-2,000mm of compacted sand track, 3° slope.

Pull in track and define/barrier edges on both sides (can use fallen/cut branches – abundant in surrounding area).

**(low)**

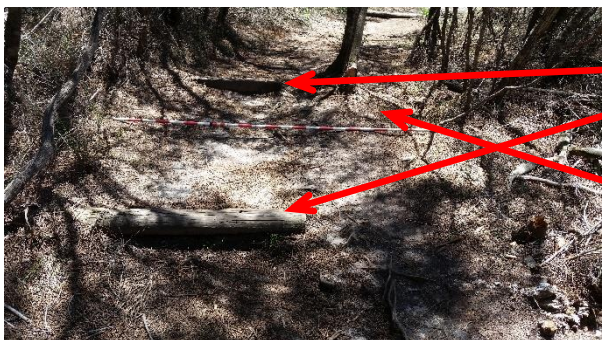
**Site ID: PCT(W) – 2(D)**

**Location:** 337644 6261318 Log step, short (half-track width) and being avoided with track widening. Scored steeper step upslope, drainage flows around end near small tree with exposed roots. Compacted sand 1,800-2,000mm wide, 3° slope. Track widening and braiding around small tree on inside of curve.

Extend/replace lower step and realign as waterbar.

Block/barrier braided track, and pull in track and define/barrier edges on both sides, mainly lower/E side (can use fallen/cut branches – abundant in surrounding area).

**(low)**

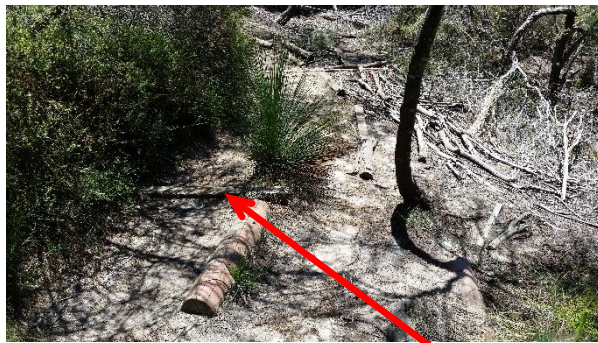
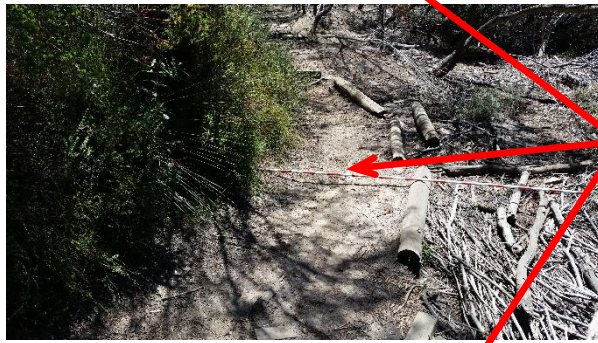
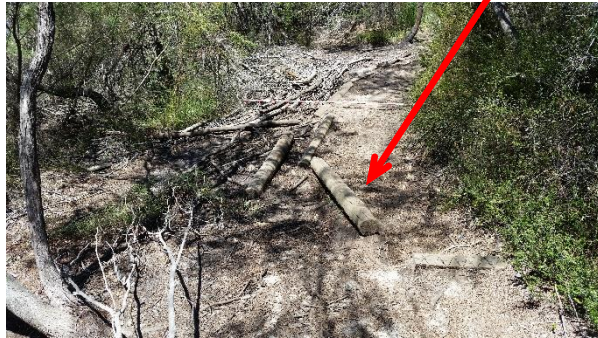
**Site ID: PCT(W) – 2(E)**

**Location:** 337645 6261335 Track curving down slight slope/dip with considerable ponding (drainage flows in each side, N and S), ponding partly retained by loosely placed logs along low edge. Scored sleeper steps at both ends and post laid at SE end along low side. Lots of laid branches beside low side (to contain track prevent detour, or provide a drier walking surface), 900–1,200mm wide with track widening on both approaches. Unsightly.

Timber or FRP low boardwalk, 10m long, with waterbar (or wide gutter) under each end. Barrier track alongside boardwalk (can use fallen/cut branches – abundant in surrounding area) to prevent avoidance.

**(Medium – for passability and impact issues, to stop track widening and vegetation disturbance)**

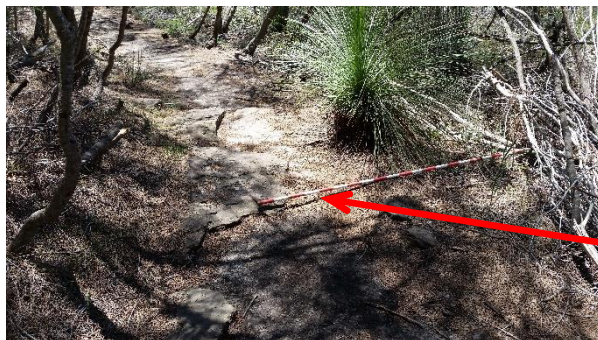
**Site ID: PCT(W) – 2(F)**

**Location:** 337634 6261369 Low rock outcrop on higher/W half of track on 3° slope with drainage flows down track, trample track to nearby dam edge.

Build rock waterbar onto in-situ outcrop (save Xanthorrhoea).

**(low)**

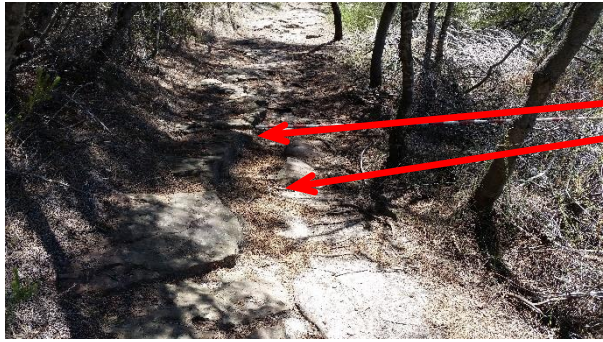
<p><b>Site ID: PCT(W) – 2(G)</b></p> <p><b>Location:</b> 337621 6261408 Rock pavement and flat outcrops on higher/W half of track on 3° slope, small trench between rocks, drainage flows down track.</p> <p><b>Works:</b></p> <ul style="list-style-type: none"> <li>Build rock waterbar onto in-situ outcrop.</li> <li>Rock infill and flagging along lower/E side of outcrops/pavement, match levels to existing, low step at end if needed.</li> <li>Monitor for avoidance and track widening, and need for edge barrier.</li> </ul> <p><b>(low, and monitor)</b></p>

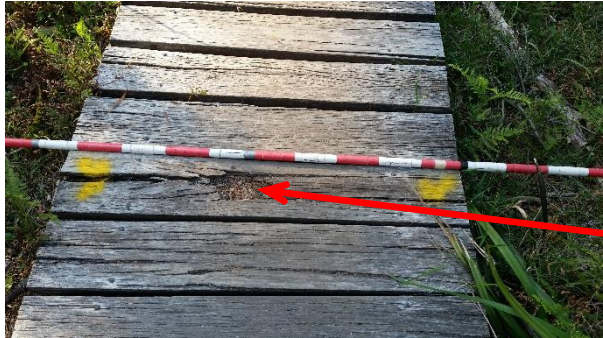
<p><b>Site ID: PCT(W) – 2(H)</b></p> <p><b>Location:</b> 337537 6261501 One plank marked yellow on low timber boardwalk, split/rotting and lifting/split – trip hazard. Small dead tree on low side of boardwalk nearby.</p> <p><b>Works:</b></p> <ul style="list-style-type: none"> <li>Replace plank.</li> <li>Fall small dead tree.</li> </ul> <p><b>(Medium – safety issues)</b></p>

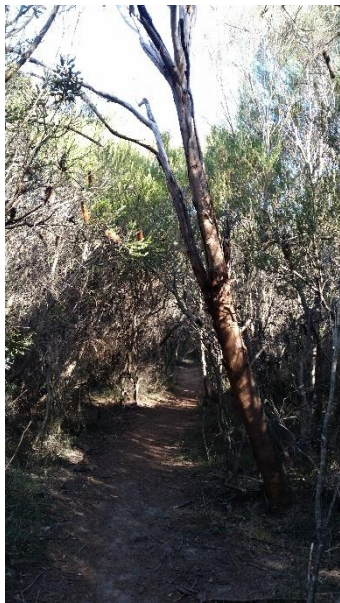
<p><b>Site ID: PCT(W) – 2(I)</b></p> <p><b>Location:</b> 337461 6261588 Dead Eucalypt, 300mm dbh, on high/W side and leaning over track.</p> <p><b>Works:</b></p> <ul style="list-style-type: none"> <li>Fall tree.</li> </ul> <p><b>(HIGH – safety issue)</b></p>

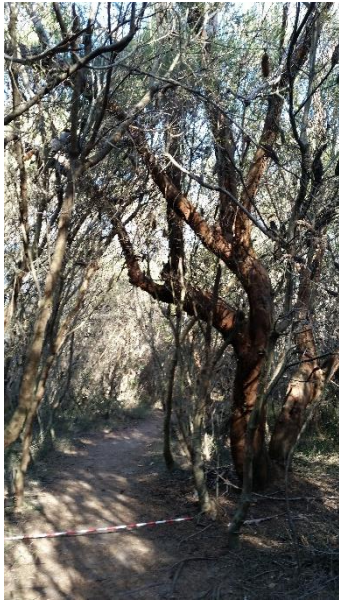
*Site ID:* **PCT(W) – 2(J)**

*Location:* 337450 6261594 Dead Eucalypt, 300mm dbh, on high/W side with 3 large branches over track.

Fall tree.

**(HIGH – safety issue)**

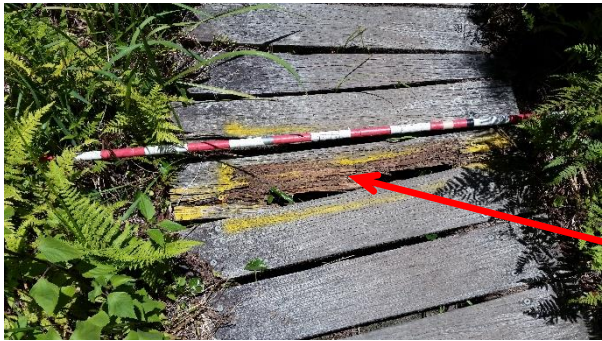
*Site ID:* **PCT(W) – 2(K)**

*Location:* 337353 6261600 Rotted plank on low timber boardwalk (angled/cut plank on curve), outlined yellow but faded - trip hazard. Near old dam/wall.

Replace plank.

**(HIGH – safety issue)**

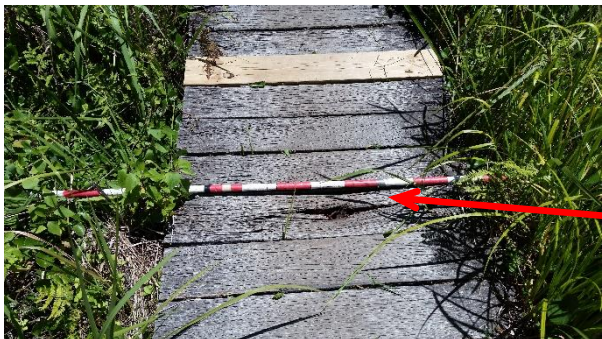
*Site ID:* **PCT(W) – 2(L)**

*Location:* 337342 6261599 Rotten plank, broken and collapsed, on low timber boardwalk. Not hazard marked.

Replace plank.

**(HIGH – safety issue)**

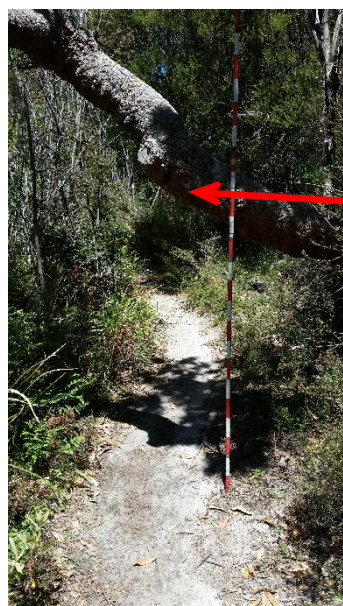
*Site ID:* **PCT(W) – 2(M)**

*Location:* 337331 6261608 Large leaning overhanging Banksia, only 1.5m clearance on high/SW side of track.

Mark as hazard, on both sides of trunk.

Monitor tree health, for tree fall hazard.

**(low)**

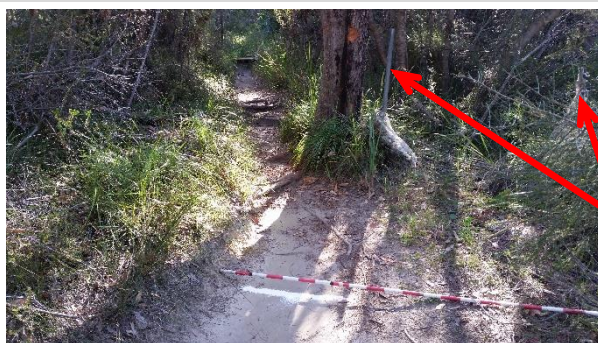
**Site ID: PCT(W) – 3(A)**

**Location:** 337322 6261629 Two old star pickets beside track to N at bend (minor hazard).

Remove star pickets.

**(low)**

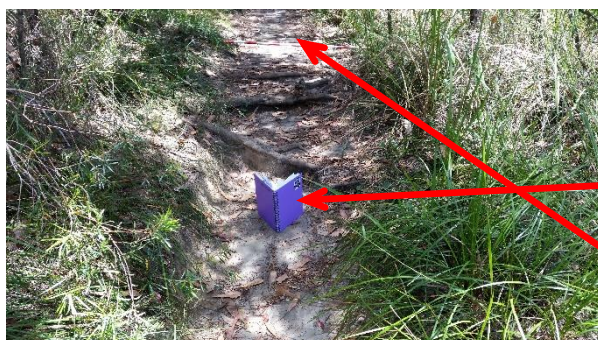
**Site ID: PCT(W) – 3(B)**

**Location:** 337318 6261627 800mm wide compacted sand track with 2 protruding roots acting as steps (75mm and 100mm high), entrenched track 250mm face on high/S side and 150mm slope on lower/N, drainage down and over roots.

Waterbar above boxed step (at least 1 pace upslope).

**(low)**

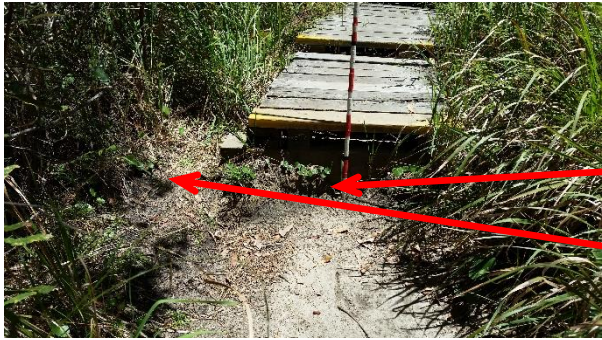
**Site ID: PCT(W) – 3(C)**

**Location:** 337306 6261623 E/SE end of low timber boardwalk with 400mm step off, avoidance track to SW into adjacent sedges.

Build extra step off end of boardwalk.  
Block/barrier avoidance trample track and rehabilitate.

**(Medium – for passability and impact issues)**

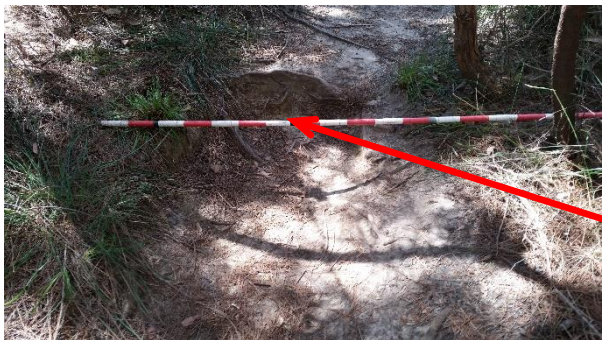
**Site ID: PCT(W) – 3(D)**

**Location:** 337293 6261632 800mm wide compacted sand track with 2.5° slope with protruding root acting as step 150mm high. Slightly entrenched track 150mm face on high/S side and 100mm slope on lower/N side, drainage down and over roots.

Install sleeper step below root, and fill/compact upslope behind (remove root if still protruding).

**(low)**

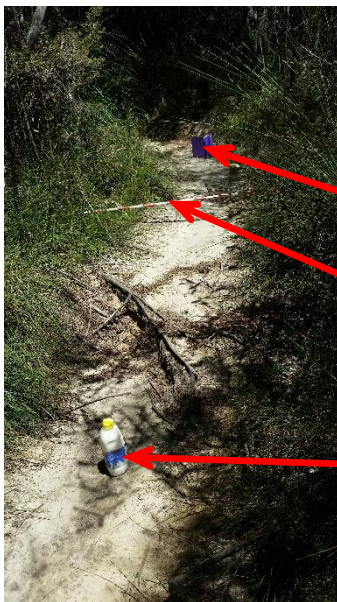
**Site ID: PCT(W) – 3(E)**

**Location:** 337290 6261639 Curving track of compacted sand 900-1,100mm wide on 3° slope, steeply dishd to 200mm below NSL at top below protruding 150mm high root/step, angled root/step 200mm high downslope at bottom, entrenched track 200mm face on high side and 100mm slope on lower side.

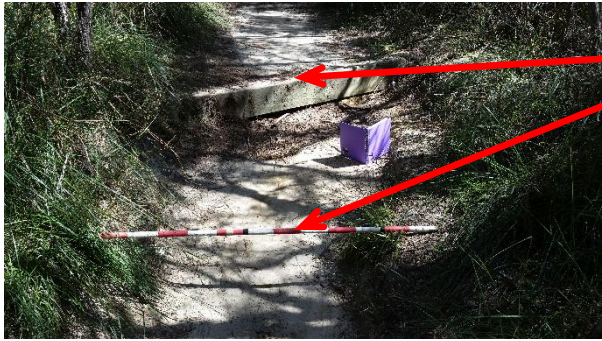
**Site ID: PCT(W) – 3(F)**

**Location:** 337295 6261644 Scored sleeper waterbar, full of sediment and failed with scour over and around higher end, 350mm step off and entrenched track to 300mm below NSL. Track 1700mm wide of compacted sand downslope, narrows to 800mm after 2m, entrenched to 150mm below NSL.

**Works:**

Raise and clean out in-situ waterbar.

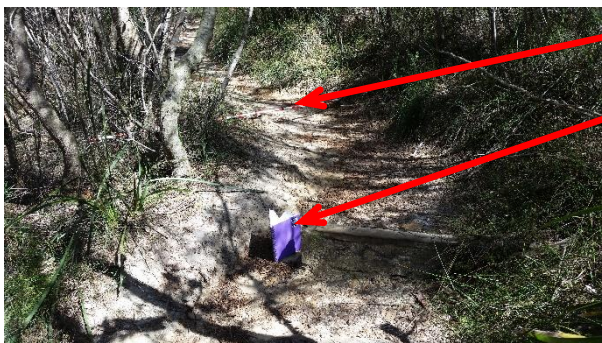
**Site ID: PCT(W) – 3(G)**

**Location:** 337289 6261661 Curve on 2.5° slope (with a long gently sloped track above providing a large catchment), track of compacted sand and gravels and some embedded rock, 800-1200mm wide, dished to 250mm below NSL (on high side). Scored sleeper step, 300mm step off, only two thirds across track with deep gutter and drainage flows down/around end with gutter to 300mm deep.

**Works:**

Waterbar above, before curve on slope with extended discharge.

Replace sleeper with new waterbar/step extending across entire track (including gutter), fill and compact above/upslope (obtain fill from deposition area downslope).

Pull-in track width, define/barrier edge (with branches).

**(low)**

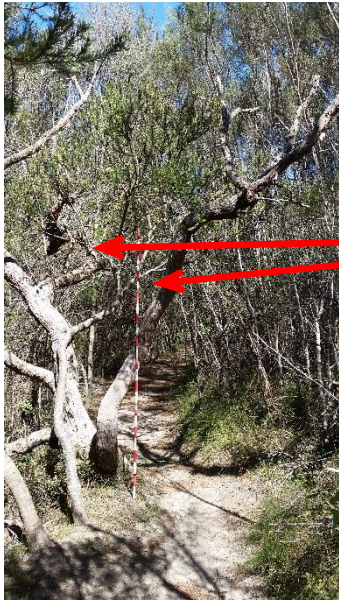
*Site ID:* **PCT(W) – 3(H)**

*Location:* 337259 6261689 Dead tree with branch 150mm diameter hanging over track. Second dead tree (with 2 trunks) 5m to SW off track.

**(HIGH – safety hazard)**

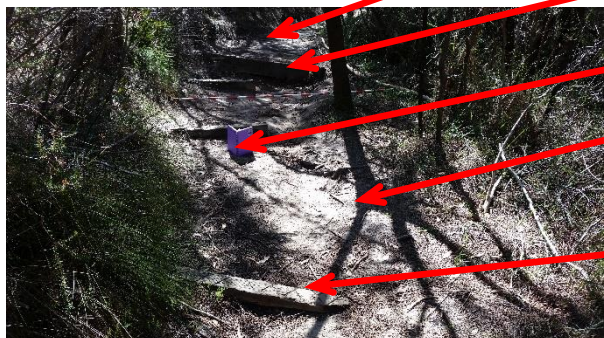
**Site ID: PCT(W) – 4(B)**

**Location:** 337235 6261700 Compacted sand, 900mm wide, dished to 75mm, 2.5° slope with drainage flows down and roots exposed upslope.

Install waterbar below roots with extended outlet to discharge well off track, fill/compact track surface over roots (remove roots if still protruding).

**(low)**

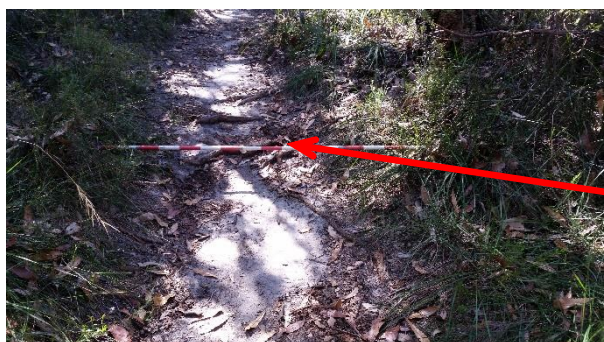
**Site ID: PCT(W) – 4(C)**

**Location:** 337211 6261698 Compacted sand, 800-1,000mm wide, dished to 200mm, 5° slope with drainage flows down, exposed roots.

Install waterbar below roots, fill/compact track surface upslope/above over roots (box/terran on low side if required).

**(low)**

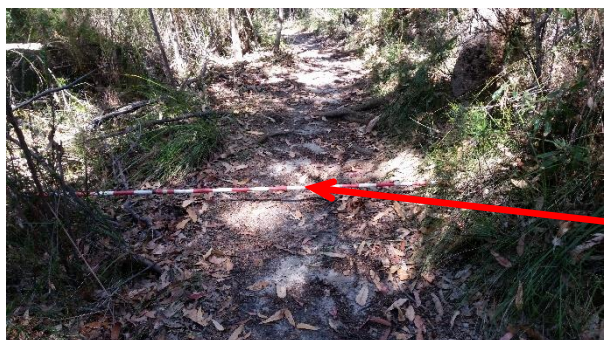
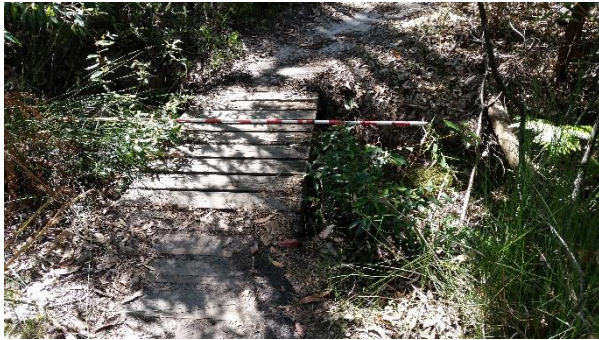
**Site ID: PCT(W) – 4(D)**

**Location:** 337198 6261694 Short timber boardwalk/bridge over ephemeral tributary, 2.6m long and 900mm wide, 800mm drop to creekbed, sand and leaf litter covering 600mm at W end (but not rotting as yet).

Monitor for rot at SW end.

**(monitor)**

(waterbars proposed upslope on each side, Sites PCT(W)-4(C) and PCT(W)-4(E), will help minimise sediment deposition over each end of bridge)

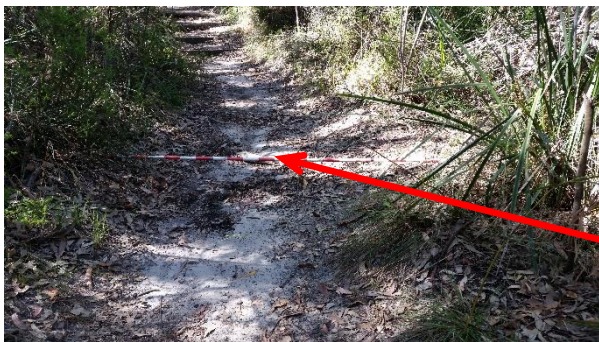
**Site ID: PCT(W) – 4(E)**

**Location:** 337197 6261701 Compacted sand, 1000mm wide, gently dished to 75mm below NSL, 1.5° slope with considerable drainage flows down from steps/slope 6m upslope to N/NW (Site PCT(W)-4(F)).

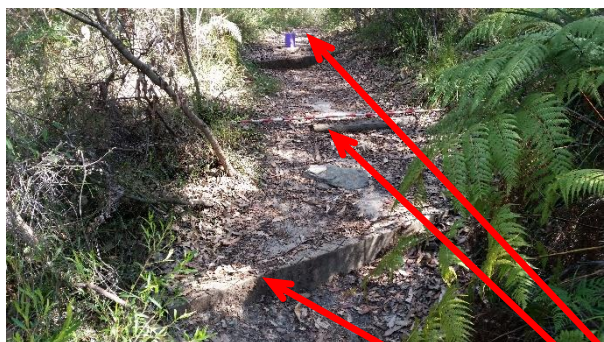
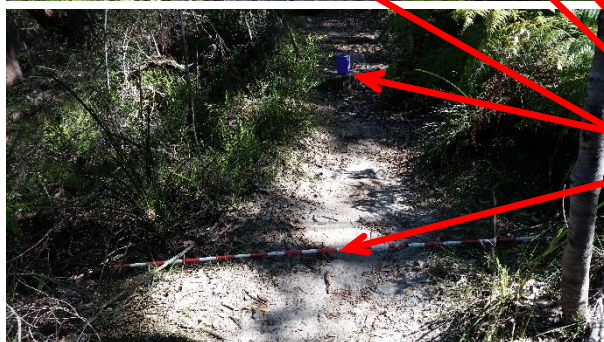
**Site ID: PCT(W) – 4(G)**

**Location:** 337190 6261747 Compacted sand track, 1,200-1,500mm, with some embedded rock (a few protruding), 7° slope with drainage flows down track to compacted sand flat at bottom with drainage off track to NE. 2 scored sleeper waterbars, both full of sediment and failed with drainage flows over but no scour. 2 short log steps (1 above upper waterbar and 1 between waterbars) with drainage flows around ends of both.

- Clean-out both waterbars.
- Extend upper log step.
- Replace middle log step with sleeper waterbar/step.
- Extend lower waterbar.
- Install extra waterbar 4m below lower waterbar (above run-on area) and pull-in track width, define edge and block/barrier.
- Remove / level protruding rocks and roots.

**(low)**

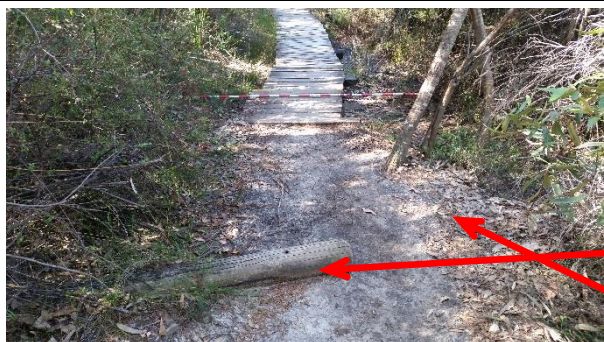
**Site ID: PCT(W) – 4(H)**

**Location:** 337189 6261768 Old log waterbar 2m off S end of low timber boardwalk, only extends half way across track and being detoured – ineffective.

- Remove redundant waterbar.
- Open windrow low side.

**(low)**
