# MANLY DAM WALKING TRACKS AUDIT

for  
**Northern Beaches Council**  
May, 2017

CONTROLLED DOCUMENT  
**“Manly Dam Walking Tracks Audit”**

**FINAL ISSUE**

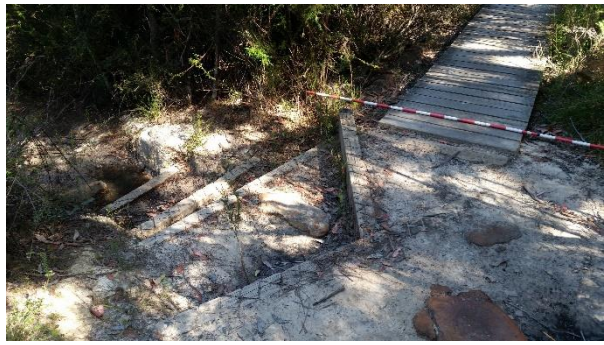
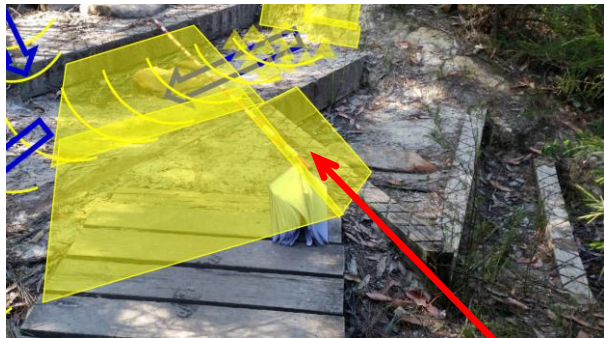
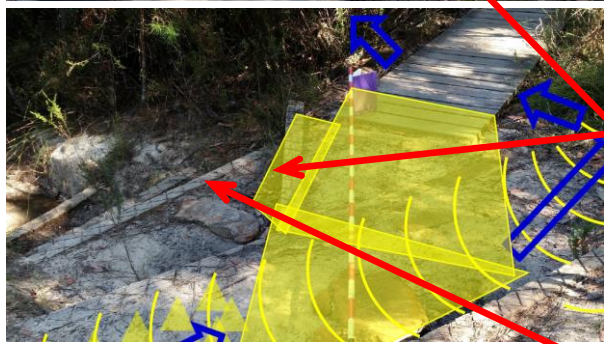
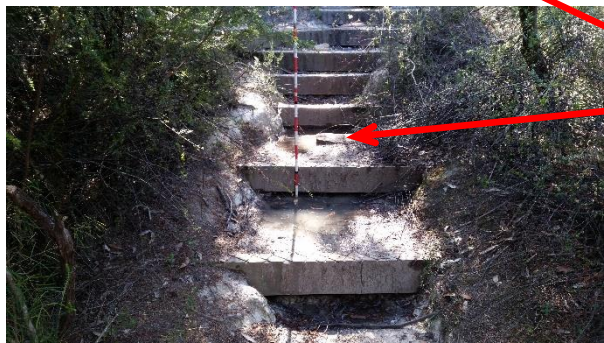
**Site ID: PCT(W) – 4(I) (on side-track)**

**Location:** 337194 6261781 Short track downslope/E to flat area on upper end of dam, from junction at N end of boardwalk and angled embedded/retaining sleepers (main PCT(W) continues upslope to NW at junction). 5 scored sleeper steps and step-and-runs over 6m length on a 10° slope, entrenched to 300mm below NSL in bank of white clay/sand, treads of compacted/deposited sand and some embedded rock 900-1,200mm wide, very considerable flows down from upslope track/steps and slope above with ponding on treads and scour to 350mm high over steps. Heavily used as access to dam margin and flat alluvial fan.

Replace tread off end of boardwalk (above/behind embedded/retaining sleepers) with a wide stone-lined gutter as "catch-drain", extend gutter to S along high/W side of first 1-1.5m of boardwalk, to discharge flows downslope under boardwalk.

Realign/extend first boxed step to better align with centreline of extended boardwalk.

Rock armour lower/E end of side gutter, and trim outlet in lowest sleeper step to allow discharge into new "catch-drain".

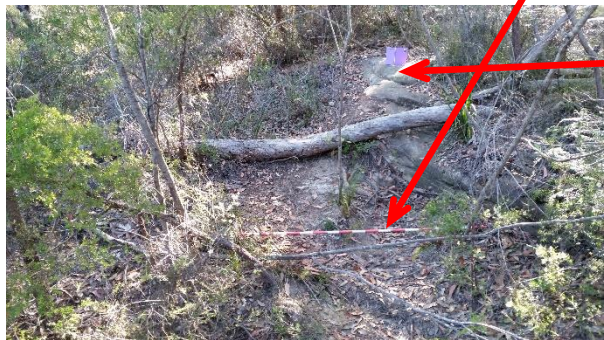
**Site ID: PCT(W) – 4(K)**

**Location:** 337193 6261798 Compacted sand 1,200-1,600mm wide. Short log waterbar above, with flows around both ends. Scored sleeper waterbar below, with log extension low end, full of sediment and failed with flows over and scoured step off 350mm high and deeply dished track 350-500mm below NSL for short distance below waterbar.

Replace log with longer sleeper waterbar.

Install step below, with compacted fill behind/above to reduce step height.

**(low)**

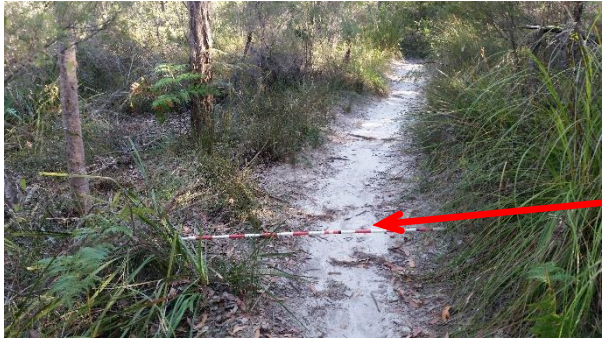
Site ID: **PCT(W) – 4(L)**

Location: 337202 6261847 Compacted and loose sand 700-800mm wide, 2.5° slope with drainage flows down track. Dead trunk/stem (250mm dbh) in tree on high side of track.

**(Medium – safety issue)**

(waterbar alone would only be **low** priority)

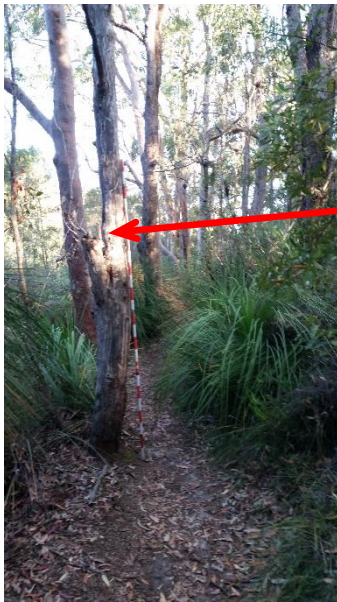
Site ID: **PCT(W) – 4(M)**

Location: 337176 6261889 Dead tree on low side of track, 300mm dbh.

Fall tree.

**(HIGH – safety issue)**

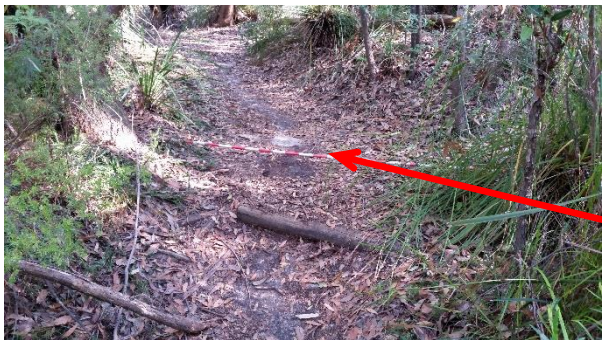
Site ID: **PCT(W) – 4(N)**

Location: 337128 6261975 Compacted sand 1200mm, deeply dished track 200-250mm below NSL. Short log waterbar, full of sediment and failed, with flows round both ends (located at less incised point on track).

Replace with new waterbar just upslope of existing (with extended outlet to discharge well off track if needed).

**(low)**

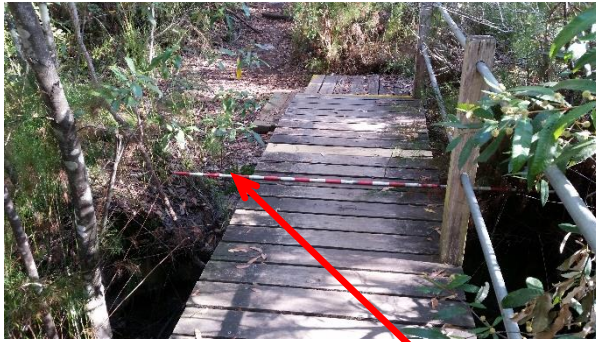
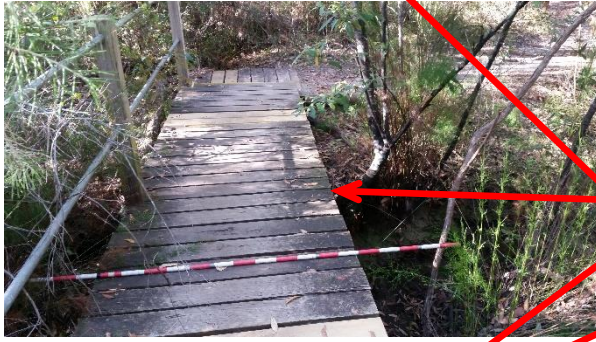
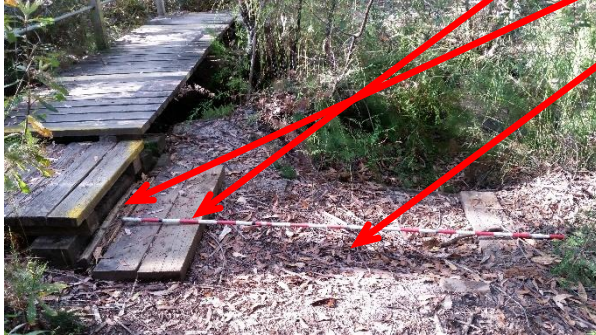
**Site ID: PCT(W) – 4(O)**

**Location:** 337126 6261985 (midpoint)  
Short timber bridge over larger tributary – 5.5m long and 1.2m wide, some new planks, good condition. Double galvanised railing W side, no railing E side and 1,250mm drop to rock creek bed. Timber deck landings off both ends – same width as bridge – for 90° turns on/off bridge. S landing has step (2 planks wide) to E and then older/buried sleepers and logs in rectangle E of this beside tributary bank (trip hazard and invites access to sloping mossy rocks in tributary).

Replace rotten log between existing step and landing (S end).

Replace log with longer sleeper to better retain track edge.

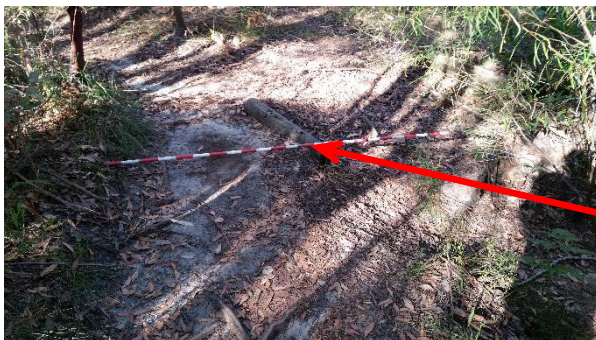
**Site ID: PCT(W) – 4(P)**

**Location:** 337129 6261992 Compacted sand track, flat, 900mm wide. Short (1m) log along/retaining low side of track with sandy bank sloping down to tributary, scour on bank starting to eat into track W of log. Trample tracks to tributary.

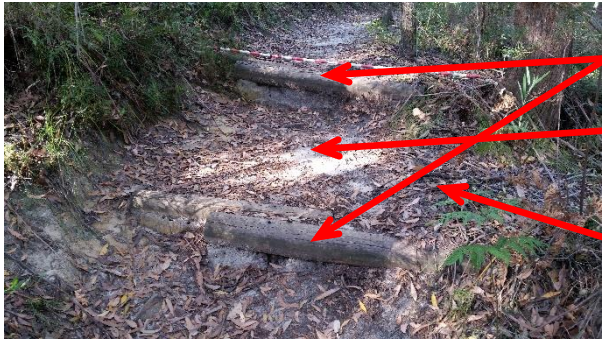
**Site ID: PCT(W) – 4(Q)**

**Location:** 337130 6262000 Compacted sand/clay 1,200-1,400mm wide, 11° slope, benched track with 300mm scrap along high side. 2 double/extended log waterbars, both full of sediment and failed, drainage flows over (and around upper end of lower waterbar), scour below upper waterbar with 300mm step off.

- Replace both logs with new (long) sleeper waterbars.
- Sleeper step below upper waterbar (at least 1 pace below), boxed on low end and filled/compacted tread above.
- Pull-in track width on low side, define and barrier/block edge.

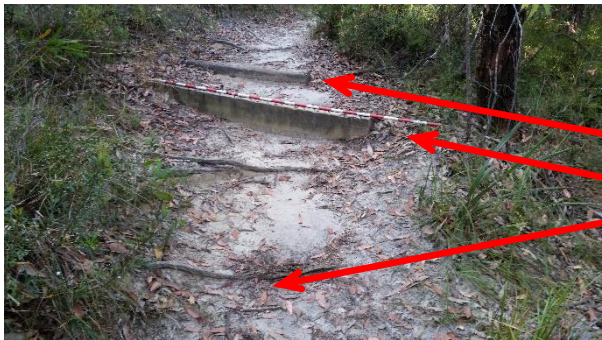
**Site ID: PCT(W) – 4(R)**

**Location:** 337142 6262043 Compacted and loose sand track 1,000-1,200mm wide, benched/sloping to 300mm on high side.. Log waterbar above with drainage flows around lower end, then scored sleeper waterbar below with drainage flows around end and over with scour 250-300mm high and roots below.

- Remove log waterbar.
- Reinstate/extend existing sleeper waterbar.
- Install new sleeper waterbar 1.5-2m below existing and fill/compact above/behind over roots.

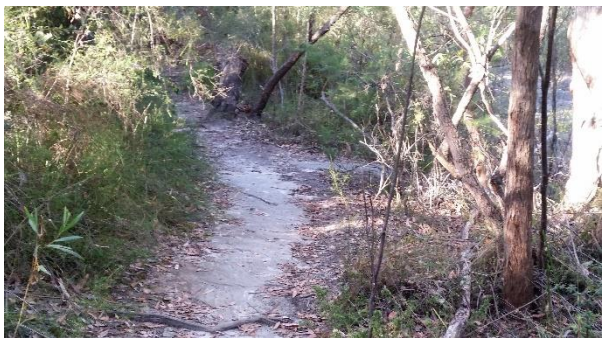
**Site ID: PCT(W) – 4(S)**

**Location:** 337140 6262056 Dead tree low side of track, >300mm dbh. Large well-used trample track to adjacent creekline – sloping rock shelves to cascades/riffles and large pool below. Trample track acts as drainage discharge points from main track, but is over rock outcrop/sloped pavement so no scour issues.

- Fall tree.

**(HIGH – safety issue)**

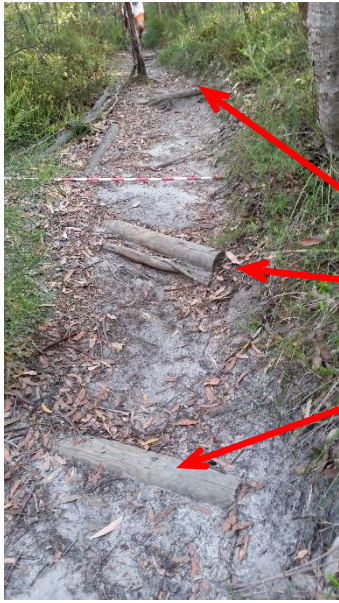
*Site ID:* **PCT(W) – 4(T)**

*Location:* 337147 6262086 Compacted sand and roots, 6m long, 900-1,200mm wide, 3° slope, benched to 250mm on high side. Side/edging log and two short buried log waterbars (both angled wrong way and ineffective).

Remove protruding root (acting as step) at top of site, and replace with sleeper waterbar/step.

**(low)**

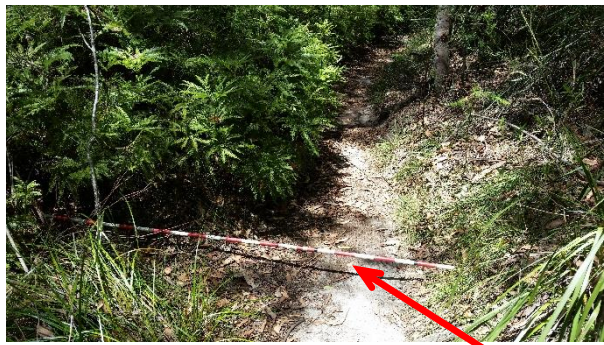
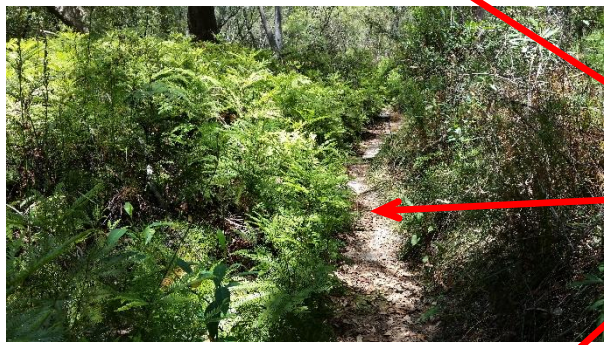
**Site ID: PCT(W) – 5(B)**

**Location:** 337152 6262108 S end  
337163 6262144 N end

Build waterbar at W end (before sand/fern mound low side) with extended outlet gutter to discharge well off track.

Install at least 3 waterbars spaced along whole length, where low side mound height allows (greater more chance to N).

New sleeper step at S end below root to “lock off” this end of track above boardwalk downslope/below (Site PCT(W)-5(A)).

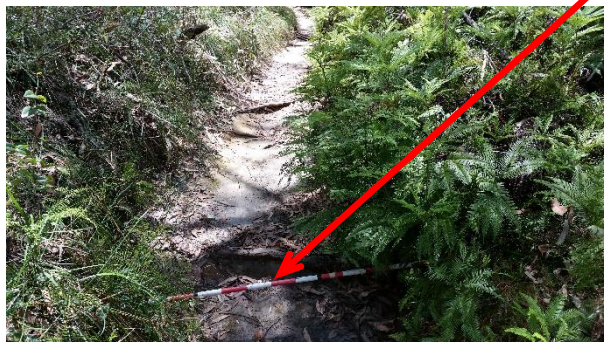
**Site ID: PCT(W) – 5(C)**

**Location:** 337155 6262157 Paired log waterbars with root below, full of sediment and failed, drainage flows over and scoured with 350mm step off, also flows around high end. Compacted sand, 900-1,100mm wide, benched to 300mm high side. 4° slope.

New sleeper step below existing waterbar, box on low side, fill and compacted tread above/behind.

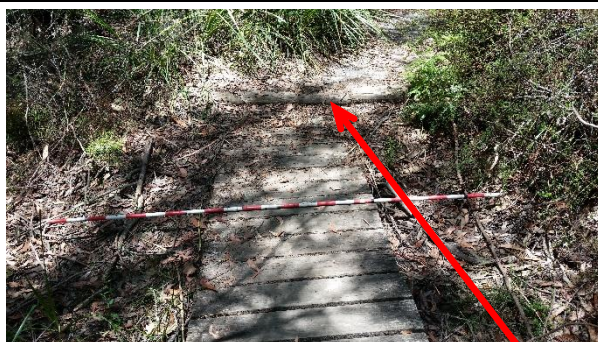
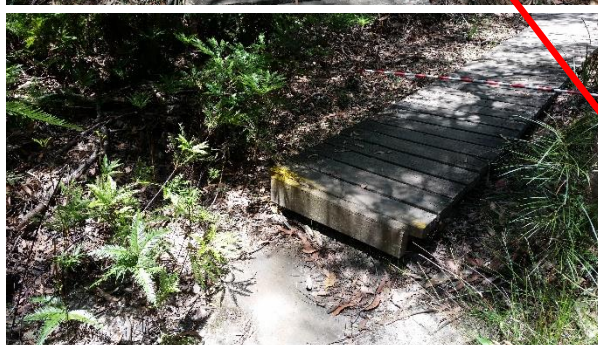
**Site ID: PCT(W) – 5(D)**

**Location:** 337142 6262191 SE end (end of existing boardwalk)  
337131 6262202 NW end

Low timber boardwalk, 16 m long 900mm wide, some new planks – good/fair condition. Extended long waterbar at S end, full of sediment and failed. Step off N end to rounded slightly angled embedded rock. In flood zone with debris against boardwalk, especially at N end.

Monitor after flood/high flows for possible damage/displacement.

Install waterbar 1m upslope of NW end. Monitor after flood/high flows for possible damage/displacement.

**(Medium – for passability [in wet] and sustainability/impact issues [to prevent trail widening and vegetation impacts] – and monitor)**

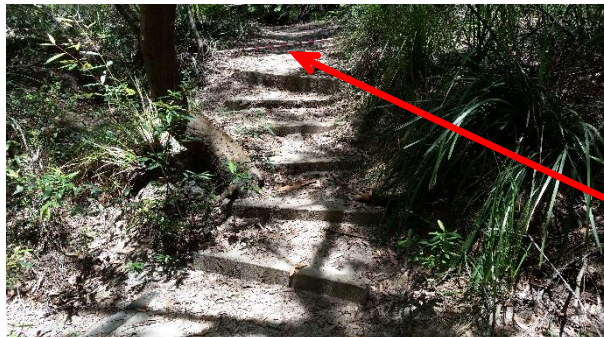
**Site ID: PCT(W) – 5(F)**

**Location:** 337128 6262224 6 scored sleeper steps down loose sand bank to flood terrace downstream of waterfall, loose sand treads, edging/retaining sleeper off base of steps (at 90° to bottom step). Flood/overflow channel adjacent. Access straight ahead from bottom of steps to sandy beach and pool – receives high levels of use.

Install waterbar 1.5m above steps.  
Monitor after flood/high flows for possible damage.

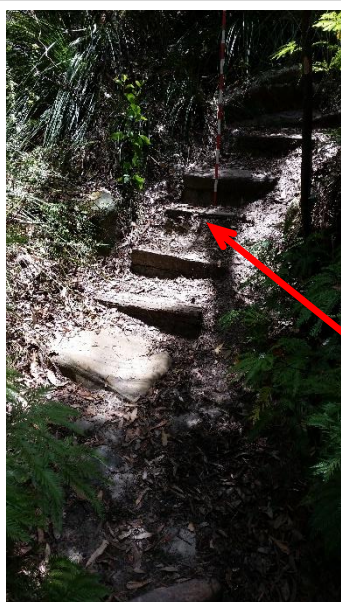
**Site ID: PCT(W) – 6(A)**

**Location:** 337116 6262236 Compacted sand, 700-1,000mm wide, 8m curving track up 20° slope with 2.4m total height change. 5 old (short) sleeper steps, drainage flow and scour down both sides of steps with compacted and loose sand. Trip hazards – exposed protruding pieces of pipe. Flat rock outcrop and embedded rocks on sandy slope at base of steps/slope. Exposed roots with 200mm step up to compacted sand bench at top of steps/slope. Boulders/rock on inside of bend and embedded rocks at top of slope.

Build 11 boxed sleeper steps curving upslope to replace existing (becoming step-and-runs towards low end). Anchor to in-situ boulder/rock where possible. Add “wings” to side of steps to divert flows down and ways from sides and minimise side scour.

Build waterbar at top, butt onto boulder high side (at least 1m above top step).

**(Medium – for passability and sustainability issues)**

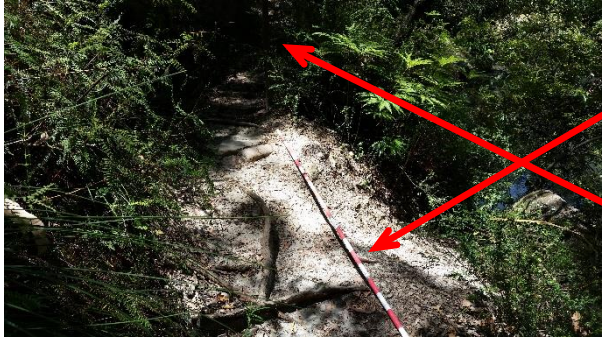
**Site ID: PCT(W) – 6(B)**

**Location:** 337117 6262241 Compacted sand track along bench, 700mm wide and benched in to 250mm high side.

Eroding/washed-out on lower side, cutting into track for 1.2m length, at top of steep loose slope to boulders/pool below – hazard. Roots and embedded rock. Site is off SW end of safety railing, galvanised pipe, at next Site (Site PCT(W)-6(B)).

Retain track edge with rock//block edging and fill/compact track surface (monitor if further need to rock armour track surface).

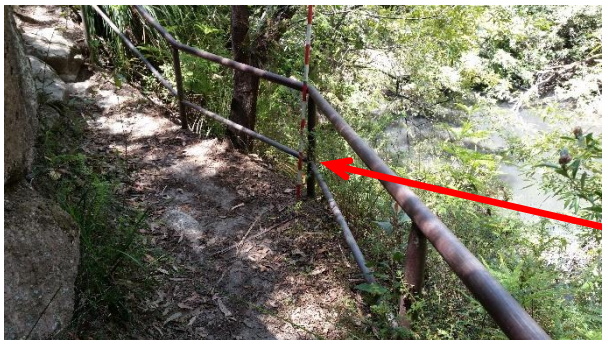
**Location:** 337122 6262245 (midpoint of safety railing)

Track of loose sand 700mm wide along narrow bench, with rock ledge on high side and steep/sheer drop to boulders/pool below on low side. Galvanised pipe, double safety railing, along low side of track - low only 700mm high for 4m at bend (due to sediment/fill from upslope raising track level) elsewhere to 1,000-1,00mm high.

Raise railing (or preferably remove fill and lower track – as will stop rust at base of galvanised posts as well).

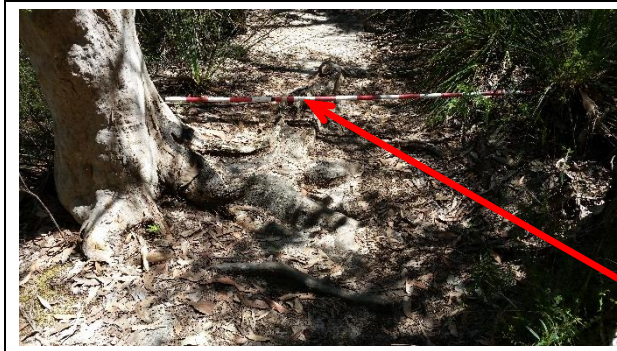
**Site ID: PCT(W) – 6(G)**

**Location:** 337129 6262268 Large protruding root to 100mm high along and across track, partly rotten - trip hazard (and >1.5m high rock ledge through vegetation off NE side of track).

**(Medium)**

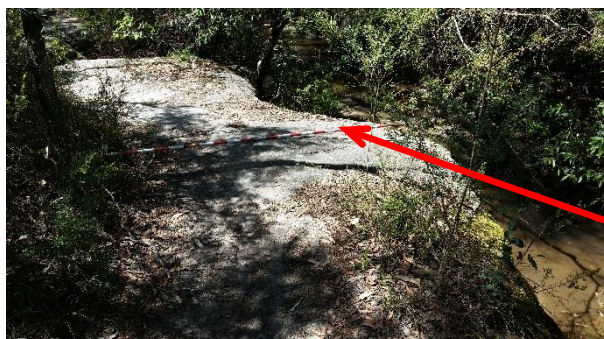
8m long rock shelf with 1.8-2.1m drop off sheer edge to rocky creekbed, track (wear path) only 500mm from edge of drop at closest point (1-1.5m elsewhere) – fall hazard.

Install simple totem style caution/warning signs at each end of rock shelf (or single sign in centre of shelf on creekside).

**(HIGH – safety issue)**

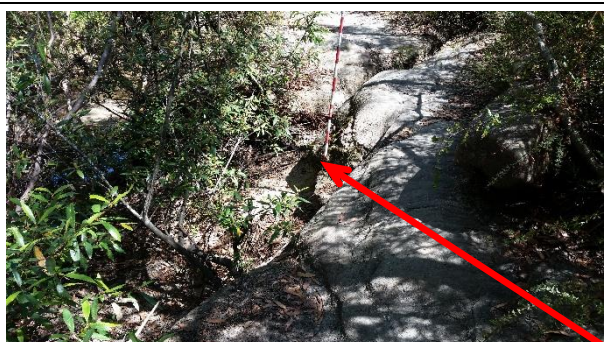
### Site ID: PCT(W) – 7(B)

Location: 337131 6262282 Angled and sloped rock ledges with central crevice/gap, steep edge of ledge 700mm high, rock ledge narrows to N to 600-700mm wide and increasing sloped (with second low ledge above) then compacted sand (flood terrace) beyond to N.

FRP step off N end of boardwalk, with large adjacent rock (bedded in) to protect boardwalk from possible flood flows.

**(Medium – for passability issues)**

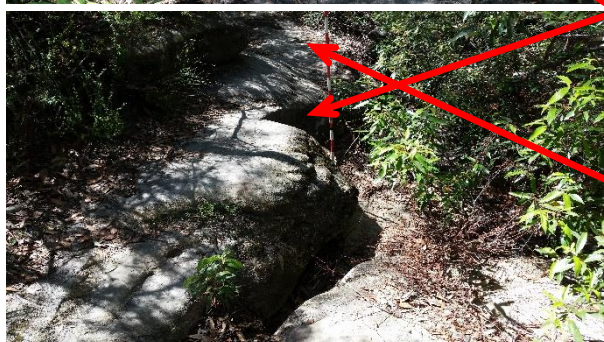
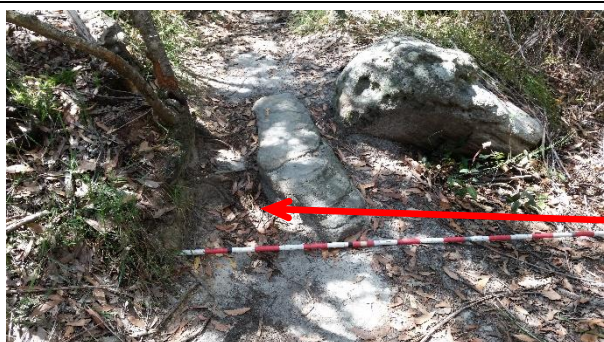
### Site ID: PCT(W) – 7(C)

Location: 337127 6262290 Boulder low side of track, long embedded rock with drainage Trample track to adjacent creek.

Block/barrier avoidance path beside boulder.

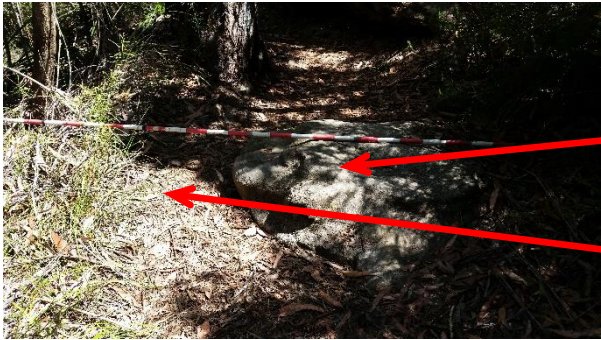
**Site ID: PCT(W) – 7(E)**

*Location:* 337119 6262324 Sloped flat embedded rock with drainage flows down and scour on outside of bend.

Pull-in track width and barrier/block edge to prevent avoidance.

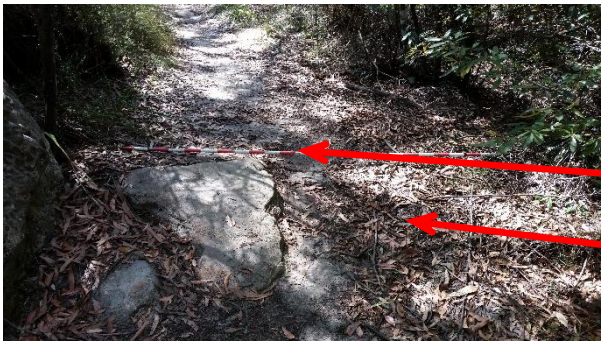
**Site ID: PCT(W) – 7(F)**

*Location:* 337109 6262333 Compacted sand track 1,500mm wide. Old log waterbar full of sediment and failed with drainage flows over and discharge/outlet blocked by windrow. Large protruding root below waterbar. Then angled rounded outcrop 2m downslope, extending across three quarters of track on high-side.

Build rock step onto lower in-situ outcrop, extend and square up. Fill/compact tread above step, with boxing to retain on low side.

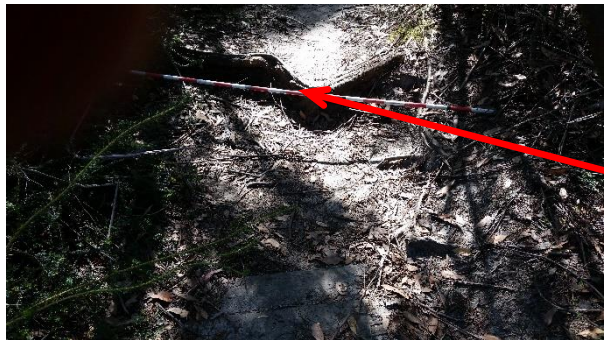
**Site ID: PCT(W) – 7(G)**

*Location:* 337078 6262388 Root acting as step 250mm high, 1.5m off N end of low timber boardwalk, dished track.

Install waterbar and fill/compacted above/behind over roots, cut outlet channel to discharge over adjacent rock pavement in drainage gutter.

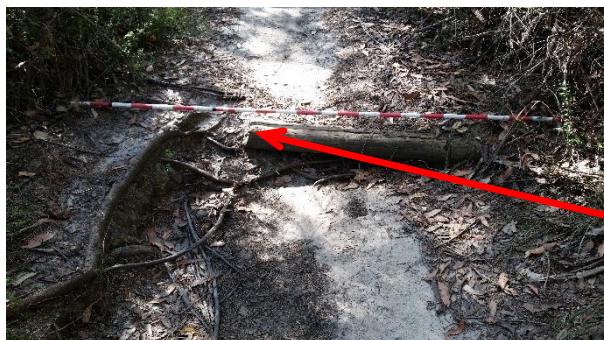
**Site ID: PCT(W) – 7(H)**

*Location:* 337071 6262391 Short log waterbar (extended off low side of track), full of sediment and failed with drainage flows over and flow/scour around high end at protruding roots.

Replace with new waterbar, across entire track.

**(Medium – to divert flows and protect timber boardwalk below to S)**

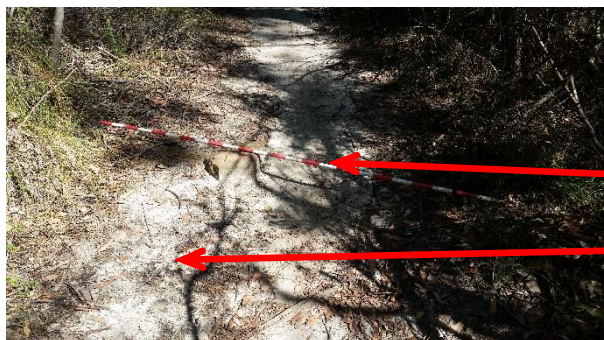
**Site ID: PCT(W) – 7(I)**

*Location:* 337066 6262394 Old log waterbar butted to in-situ rock, off alignment, and avoided due to track widening. *Works:*

Pull-in track width (high side) and barrier/block edge.

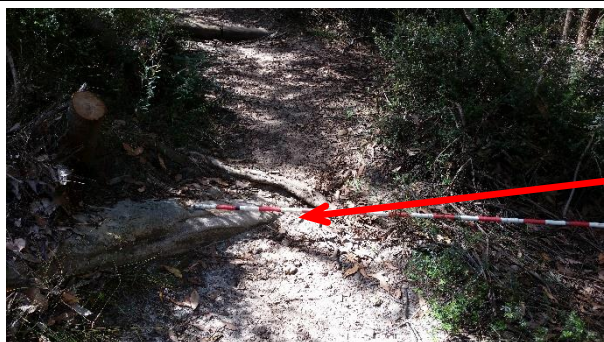
**Site ID: PCT(W) – 7(J)**

*Location:* 337062 6262399 Angled rock outcrop and root (at bottom of slope). *Works:*

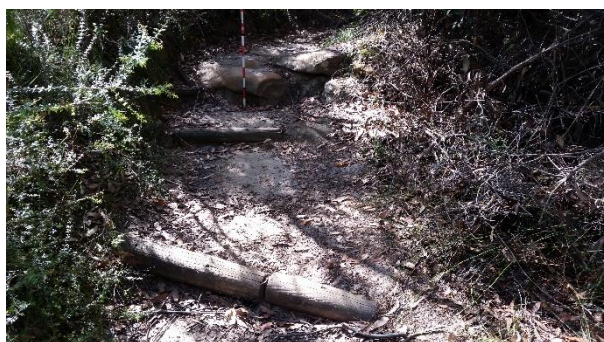
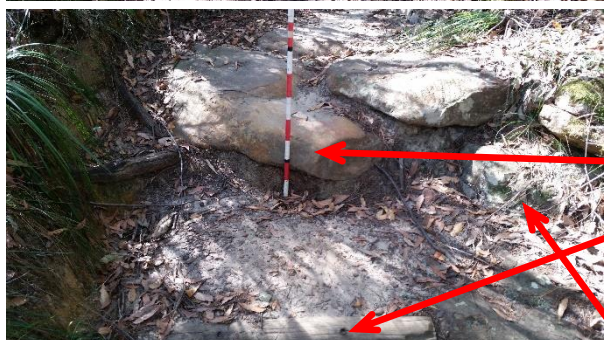
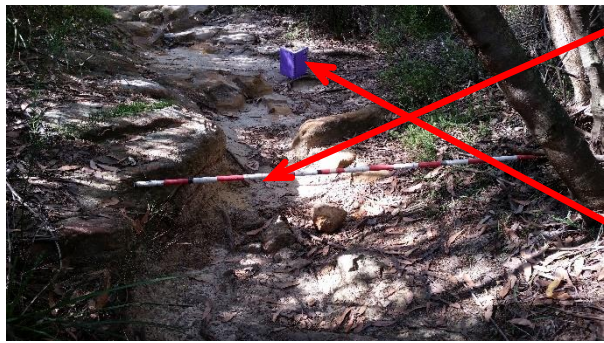
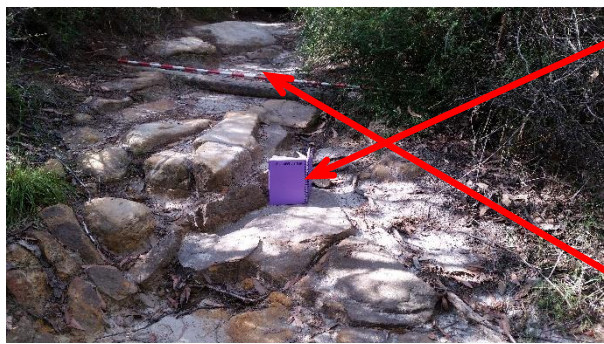
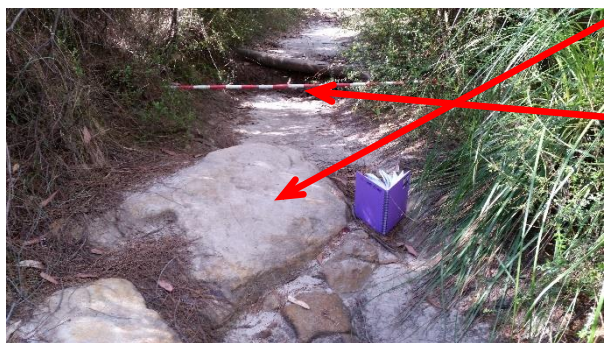
27m section of track with 6-7° slope, mainly embedded/protruding rocks, and loose rocks, in compacted and loose sand plus some clay and laterite gravel, with considerable drainage flows down track and continuing scour. Bottom to top:

- paired/extended log waterbar, full of sediment and failed, then log step butted to rock at low end, track 1200mm wide benched to 500mm on high side;
- rock outcrop, 350mm face as “natural” step, with root/step high side;

- cluster of flat-topped embedded rocks and rock outcrops, mainly on high side of track, 100-300mm faces, gutter and drainage flows down low side,
- log waterbar above embedded rocks, full of sediment and failed flows over/around low end;

- angled embedded boulder and smaller loose rocks below on high side of track, drainage flows on low side with small gutter;
- log waterbar full of sediment and failed, flows over with scour to 300mm below; and

- log waterbar full of sediment and failed, flows over.

Square-up “natural” rock step with well-anchored infill rocks

Build extra rock step below (anchored onto lower rock outcrop) fill and rock armour tread.

Pull-in and barrier/block inside of bend.

Build 2 rock steps off rock ledge/shelf on high side of track, retain/box on low/outer side, then fill above/upslope and compact extended level tread to proposed waterbar above, pull-in track width on low side and barrier/block edge to prevent avoidance.

Build waterbar butting onto in-situ flat topped rock on high side, with extended outlet to discharge well off track (downslope of trample track to creek).

Formalise 2-3 stone steps (lower one may be step-and-run), built onto and incorporating in-situ outcrops and embedded rock), rock armour treads and infill/level between in-situ rocks, pull-in track width on low side and barrier/block edge to prevent avoidance.

Replace log waterbar with stone-lined invert, butted to high side in-situ rock.

Level sloped boulder, rock armour and level gutter along low side to match, square-off off as low rock step.

Replace waterbar, build new boxed step below with filled/compacted tread above/behind.

Replace top waterbar, with extended outlet to discharge well off track.

Clean out all waterbars, where not replaced.

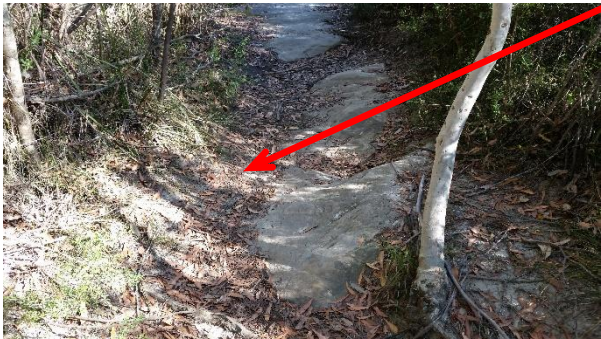
*Location:* 337062 6262457 Deeply dished track, 450mm bellow NSL on high side to 200mm on low side, of wet sand 1,200-1,400mm wide, flat and angled rock outcrops with dip/ponding area between ('run-on' area from track upslope).

Infill and rock armour dip (3m long and 400-900mm wide) to match level of in-situ rocks and provide stable footing - as will continue to be a run-on area with drainage inflows, and potential for inundation in high creek flows.

Monitor for avoidance/widening (especially high side) and requirement to define/barrier track edge.

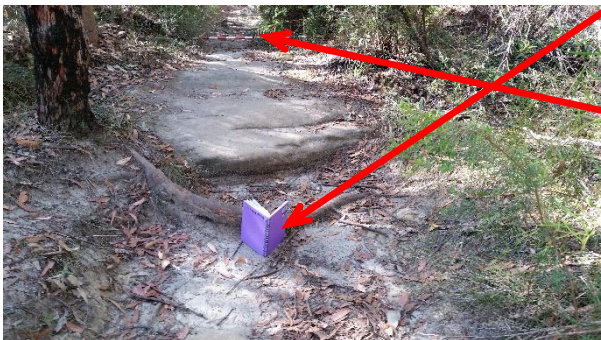
*Location:* 337058 6262465 Large flat boulder/pavement with 200mm step off ledge at lower end, onto protruding roots below.

Build boxed step off low side of boulder/pavement and fill/compact above/behind over root.

Open windrow and cut outlet gutter (on low/creek side) to discharge drainage flows off track (will address small discharges, but larger flows - high creek flows or flooding - likely to come back onto track below boulder/pavement).

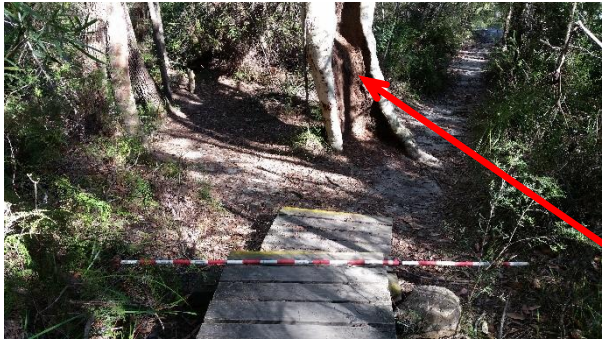
**Site ID: PCT(W) – 9(C)**

*Location:* 337055 6262474 Cleared area, or wide track braiding, around old Scribbly Gum with rotting trunks at S end of low timber boardwalk (with low step/landing off boardwalk end), beside large deep pool in creek immediately to E (attractive).

Monitor condition of Scribbly Gum for safety risk near feature of interest.

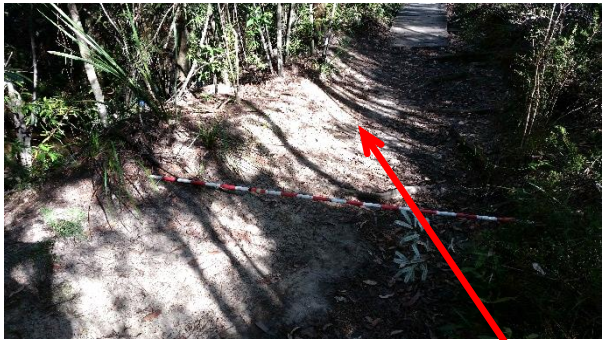
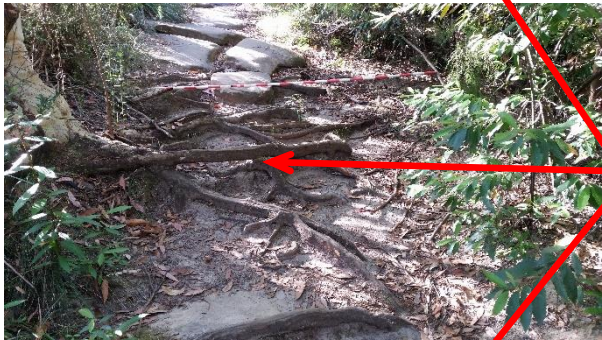
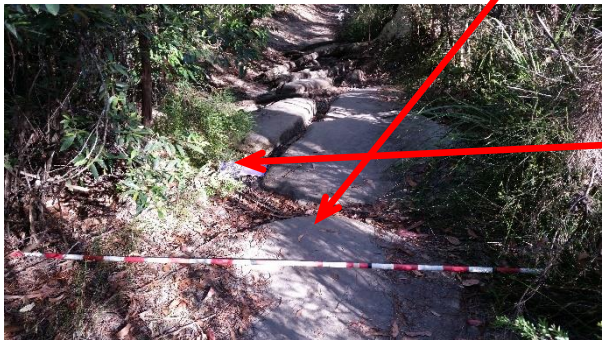
**Site ID: PCT(W) – 9(D)**

*Location:* 337037 6262487 SE end (at NW

SE two-thirds (off end of low timber boardwalk) is compacted and loose sand and exposed roots, 1,200mm wide, flat, deeply dished with flood levee (sand) along low side and creek channel only 3-4m away to E off – inundated during high flows or floods. NW third is large area (4m long) of exposed/protruding roots, some over rock, then large angled rock slabs/outcrops with deep gaps/channels and some roots in between, NW third has 5° slope overall.

Block/barrier redundant track width/edges to prevent avoidance, and rehabilitate.

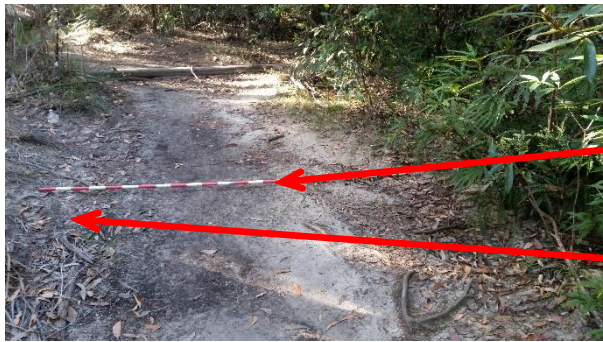
<p><b>Site ID: PCT(W) – 9(E)</b></p> <p><i>Location:</i> 337015 6262505 Compacted and wet sand, 1,500-1,800mm wide, slight crossfall towards low side/E, flood levee (sand) along low side and creek channel (with riffles/cascades) only 5m away. Existing log waterbar at top of slight slope.</p> <p><i>Works:</i></p> <ul style="list-style-type: none"> <li>Install additional waterbar (to support log waterbar upslope), extended length or cut outlet gutter.</li> <li>Define and block/barrier track edge on high side to prevent avoidance/widening.</li> </ul> <p><b>(low)</b></p>

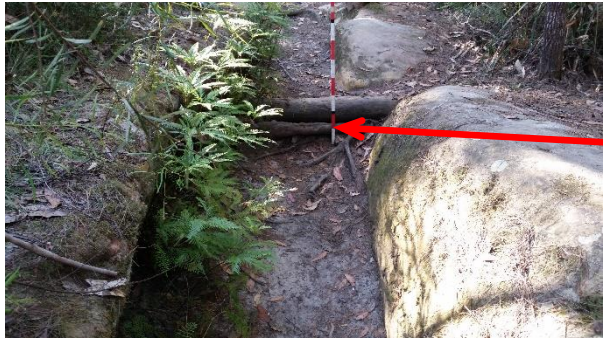
<p><b>Site ID: PCT(W) – 9(F)</b></p> <p><i>Location:</i> 337001 6262509 Log step with roots below, drainage flows over flows over, 800mm wide track below steps in cleft between ledge on high side and boulder on low side.</p> <p><i>Works:</i></p> <ul style="list-style-type: none"> <li>Replace log steps with two stone steps anchored to in-situ ledge and boulder (for additional protection from flooding/inundation and continued drainage flows down/over).</li> </ul> <p><b>(low)</b></p>

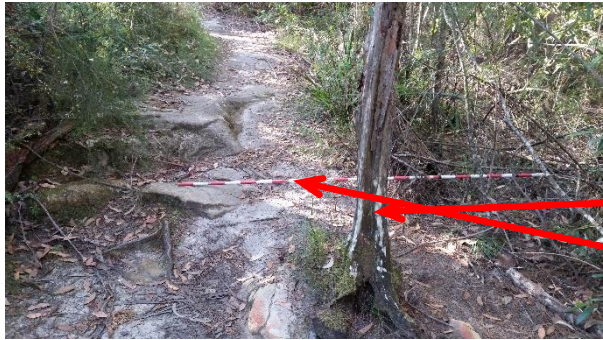
<p><b>Site ID: PCT(W) – 9(G)</b></p> <p><i>Location:</i> 336998 6262511 Rock pavement/outcrop and embedded rock in compacted sand. Small dead tree (rotten), 100mm dbh, below.</p> <p><i>Works:</i></p> <ul style="list-style-type: none"> <li>Fall small tree.</li> <li>Build rock waterbar butted onto in situ material.</li> </ul> <p><b>(Medium – safety issue)</b></p>

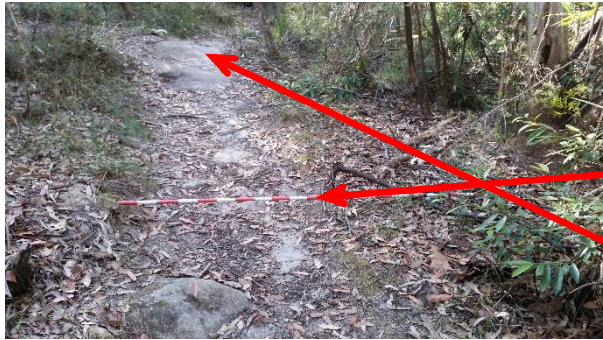
<p><b>Site ID: PCT(W) – 9(H)</b></p> <p><i>Location:</i> 336986 6262510 Compacted sand 900mm wide, with occasional embedded rock, for 11m on 4° slope.</p> <p><i>Works:</i></p> <ul style="list-style-type: none"> <li>Install waterbar midway on slope, butt off in-situ material on high side.</li> <li>Cut level tread in outcrop at top to prevent avoidance/widening.</li> </ul> <p><b>(low)</b></p>

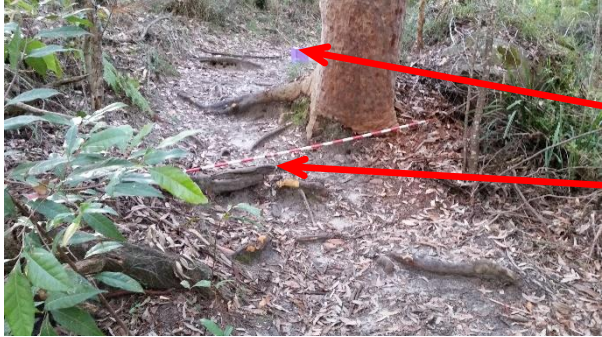
*Site ID:* **PCT(W) – 9(I)**

*Location:* 336942 6262546 Compacted sand 1,000-1,200mm wide on 5° slope, curving up and around large Angophora for 8m, with exposed/protruding roots some up to 300mm step off, drainage flows down track.

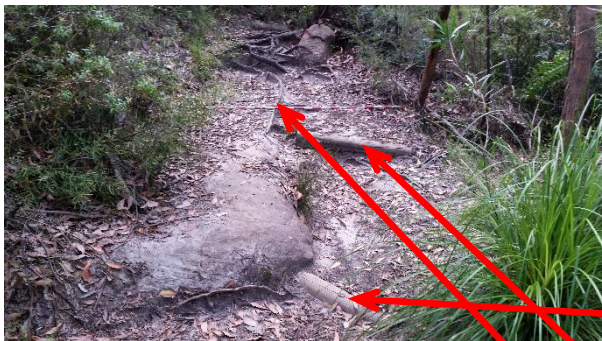
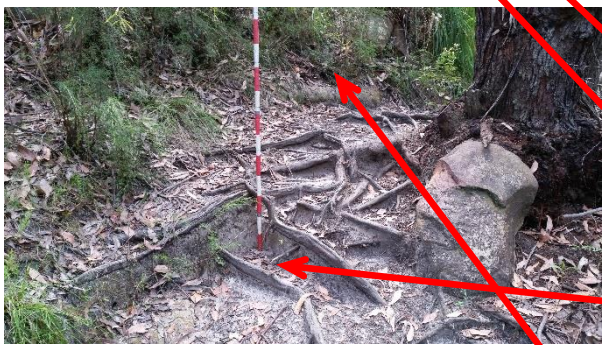
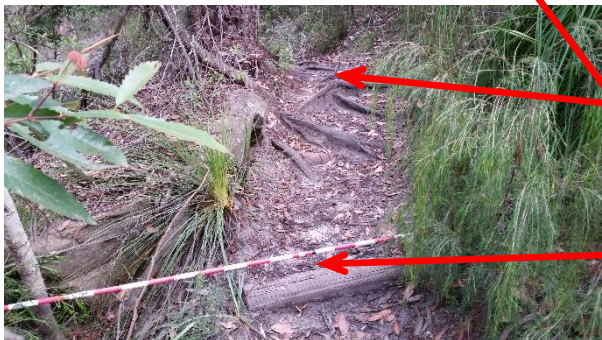
**Site ID: PCT(W) – 10(B)**

**Location:** 336923 6262568 Track retained on low side at SE end by small log above sandy loose slope >1m high. 2 large elongated rounded rock outcrops running longitudinally along track, with lower outcrop/ledge as well as embedded and broken rocks in compacted (wet) sand, track runs both above (higher alignment) and below (lower line) these central outcrops, 4m long at 6° slope. Compacted wet sand track NW of outcrops, 1,500mm wide, small drainage line crosses track for 2.5-3m with ponding and muddy areas on track, then protruding curved root and end of sloped rock ledge to NW.

Wide stone-lined invert at NW end to carry drainage line across track, box/retain on low side if required for stability. Remove protruding root.

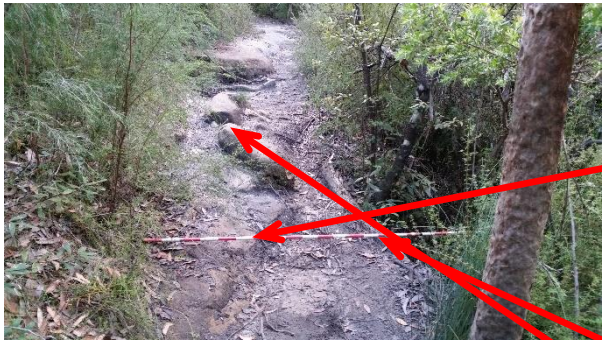
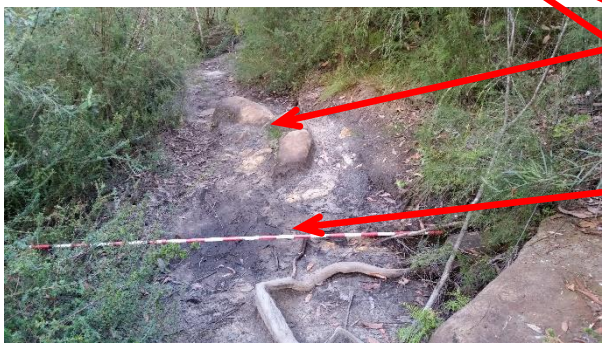
**Site ID: PCT(W) – 10(C)**

**Location:** 336912 6262573 Compacted sand track along low side of long rock ledge/shelf. Sloping and stepped rock ledges at NW end with drainage flows and small gutter down outer/lower side. Well-used trample track to NE, to nearby rock ledge overlooking scenic boulder strewn creekbed.

Cut wide shallow gutter into sloped rock at top of ledge, and extend as short stone-lined gutter (discharging below trample track).

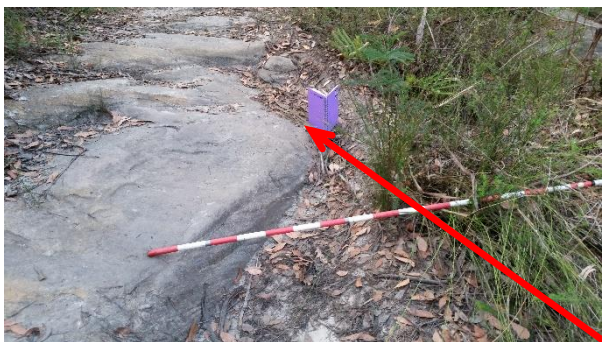
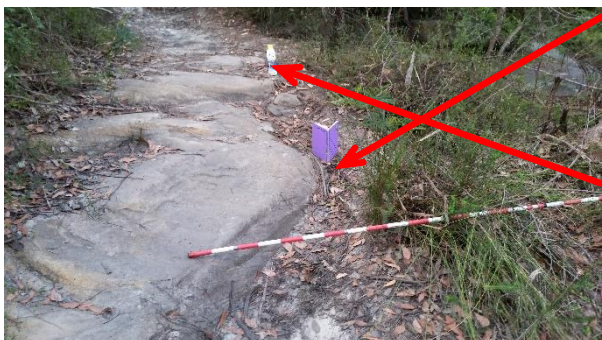
**Site ID: PCT(W) – 10(D)**

**Location:** 336905 6262574 Short log waterbar at top of rock outcrop, full of sediment and failed, flows around low end and over with scour 300mm high to broken rocks below.

Install new, longer, waterbar/step and butt tightly onto rock outcrop (or align upslope/above outcrop).

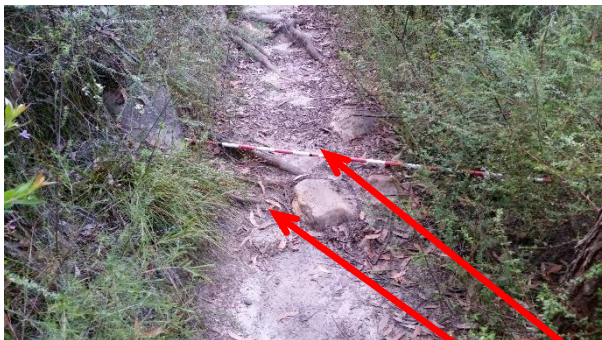
**Site ID: PCT(W) – 10(E)**

**Location:** 336901 6262576 Compacted sand and laterite gravel, 600-700mm wide, 5m long at 8° slope, embedded rocks and roots at bottom of site. Sloping rock outcrop at top of site with protruding roots below to 250mm high, track curves upslope of tree above outcrop. Drainage flows down entire site.

Install waterbar on lower third of slope, above embedded rocks.

Install waterbar at top of site, discharging upslope/NW of tree.

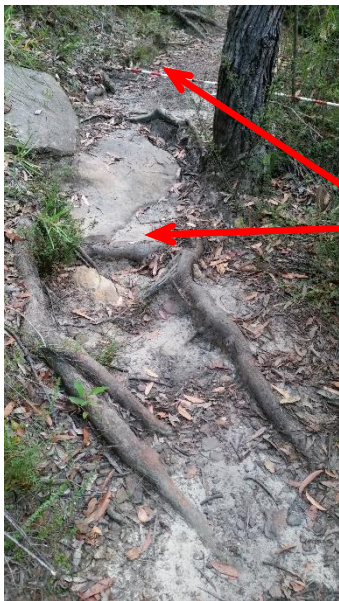
**Site ID: PCT(W) – 10(F)**

**Location:** 336896 6262580 Compacted sand with considerable laterite gravel, 800mm wide, on 4.5° slope.

Install waterbar midway on long sloping track section.

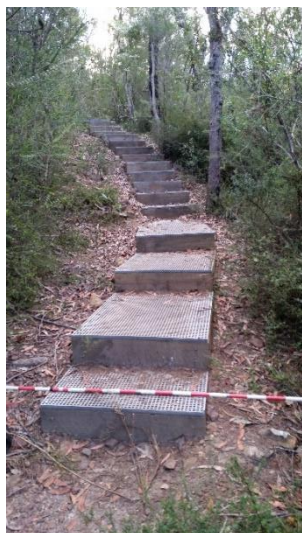
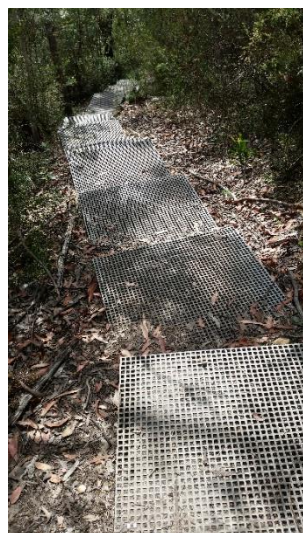
**Site ID: PCT(W) – 10(G)**

**Location:** 336888 6262582 E end

Monitor for trail widening – avoiding angled pavement and/or steps on crest.

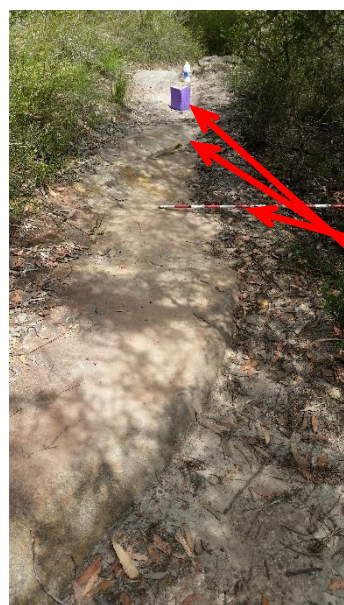
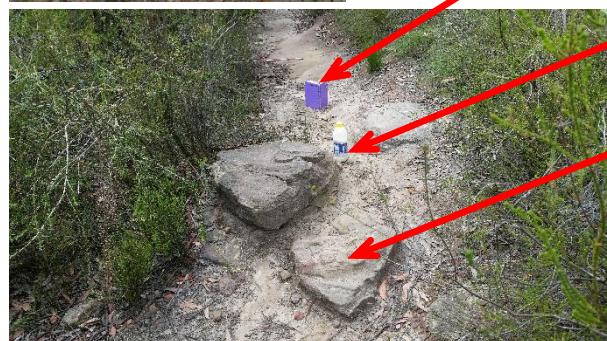
**Site ID: PCT(W) – 10(I)**

**Location:** 336811 6262635 Large rounded outcrop 6m off W end of timber boardwalk (angled/sloping rock ledge straight off boardwalk end then main outcrop is concave at top with only a narrow (500mm wide) and slightly rounded walking route along crest with “lump” at W end. W face of outcrop slopes down to sandy creekbank (and track) hard along channel/pool edge, only 800-900mm above water level (subject to high/flood flows). W face is 3.5m long, overall 14.5° slope and total height difference of 1.5m (to “lump”). Seepage/drainage over upper concave/scalloped section, and steep W face, are both slip hazards. Small broken tree (75mm dbh), creekside at bottom of outcrop points back up W face - broken off handhold (?), now a hazard (“spear”). Section of PVC pipe, with drilled holes, exposed at bottom/W end of outcrop. Attractive views into creek adjacent below, when walking E to W, may distract users from watching their footing over outcrop.

(Close to Perimeter Fire Trail for importing materials.)

**(HIGH – safety issue for stump (“spear”) removal. Medium – for passability and safety issues)**

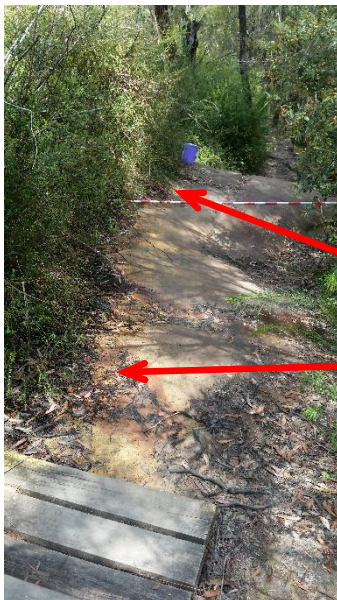
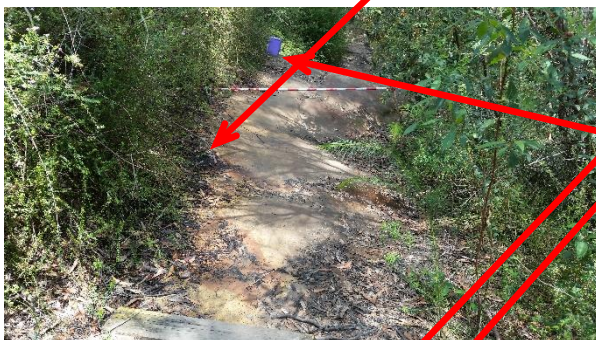
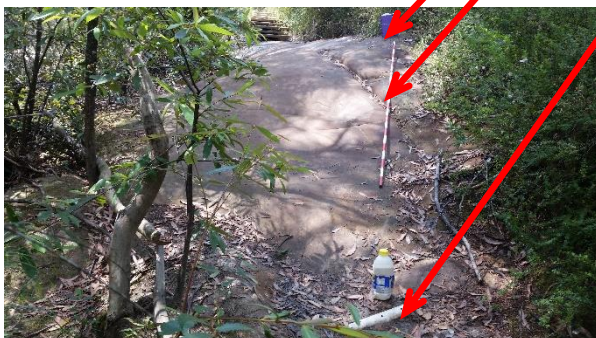
**Site ID: PCT(W) – 10(J)**

**Location:** 336804 6262640 Compacted sand, 900-1,200mm wide flat but benched-in to 150mm on high side, some embedded gravel and a few protruding roots. Extends 8m long bench immediately beside creek channel and only 800-900mm above water level. Subject to inundation in high flows/floods, and also in direct line from main channel over cascade/ledge 5m so would be impacted during floods or high flows – but no sign of significant erosion. However creekbank (and track edge) along W end of site is retained by logs for 3m above large boulder sloping into creek (also an old agricultural drain under at E end of logs). Large stones placed as step at W end, but gap at S end, with root above. Old post with two metal directional arrows at W end of site. (Can see Perimeter Fire Trail and shared mountain bike circuit crossing Curl Curl Creek 30m upstream.)

Replace edge logs with large rock retaining wall in W half of site.

Monitor for damage after high/flood flows. (Close to Perimeter Fire Trail for importing materials.)

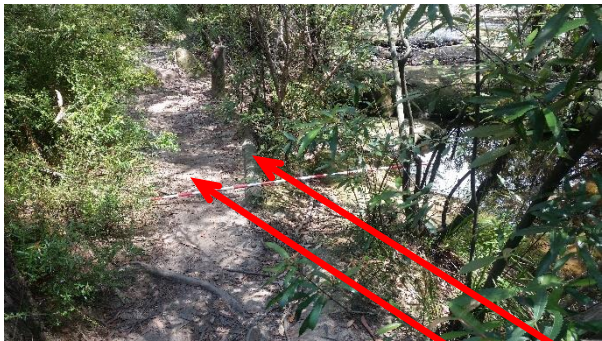
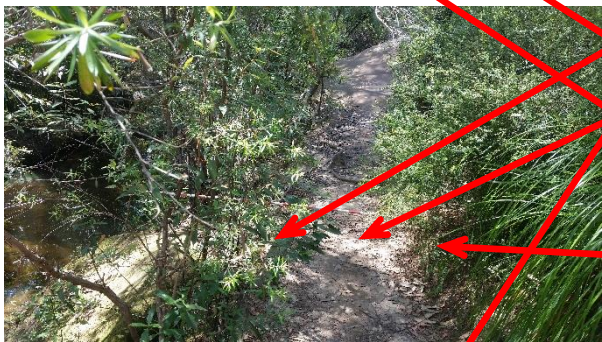
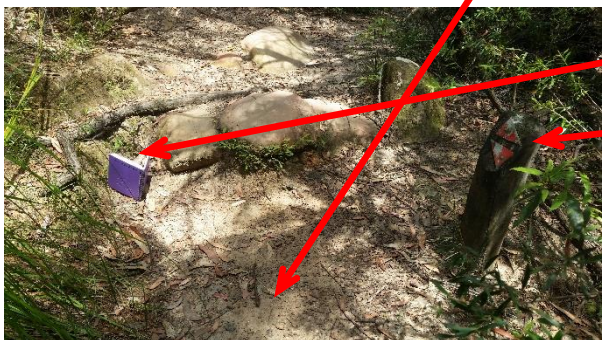
**Site ID: PCT(W) – 10(K) (and side track)**

Embedded rounded rocks and compacted sand and gravel track, gently sloped at bottom of site (above junction with track to NW along creek bank (Site PCT(W)-10(K)). 2 log waterbars, butted to embedded rock at NW end but flows around lower/SE end. Large sloped boulder with drainage flows down/over. Compacted and loose sand and laterite gravel track above boulder, 1,800mm wide, only slightly sloped but loose gravel (and sand) washed from upslope makes surface slippery. Log waterbar above full of sediment and failed with flows over and around low/NW end. Partly rotten tree beside track. Site 9m total length, 17.5° slope overall (but steepest over boulder face, more gently sloped track above and below) and total height difference of 2.0m.

Replace 2 log sleepers with 2 or 3 stone steps with armoured treads, and cut tread/step into lower lip of sloped boulder above.

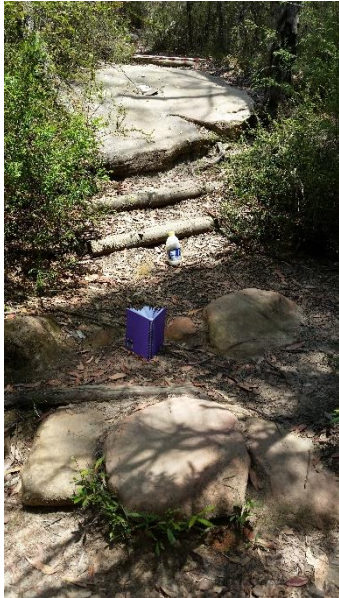
**Site ID: PCT(W) – 10(M)**

**Location:** 36787 6262636 Compacted sand and loose laterite gravel, 1,000-1,200mm wide on 8° slope, 2 points with exposed roots and embedded rocks retaining track surface and acting as small steps with 250mm rise/face, low sloping rock ledge/pavement at top of site, drainage flows down low side of ledge/pavement in shallow gutter and down remainder of site below.

- Build 2 step-and-runs over roots and embedded rocks, boxed/retained on low side with filled and compacted treads.
- Build rock waterbar butting onto top of upper rock pavement, and rock armour/flag shallow gutter below to match level with ledge/pavement.

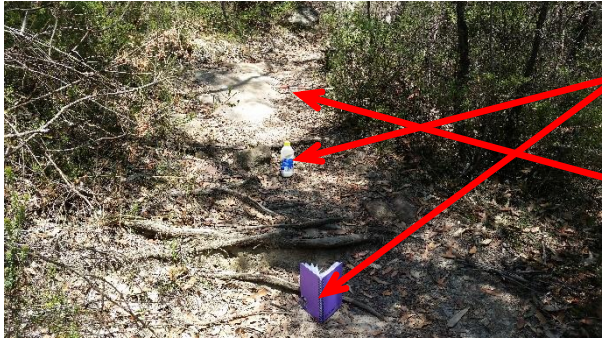
**Site ID: PCT(W) – 10(N)**

**Location:** 336782 6262636 Compacted sand and loose laterite gravel, 3m with 12° slope (steeper on high side of track), sloping rock outcrop with drainage wash down low side, embedded flat rock above.

- Build waterbar butting off flat embedded rock at top of site.
- Cut/level 3 level treads into lower side of sloped outcrop, and rock armour/flag adjacent wash zone as 3 low steps to match levels with outcrop.

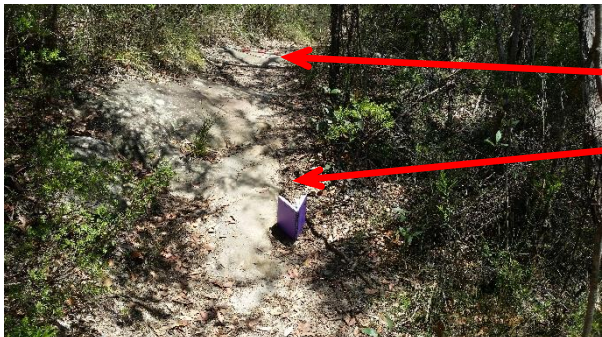
**Site ID: PCT(W) – 10(O)**

**Location:** 336771 6262644 Loose deposited sand and laterite gravel – “run on” deposition area from Perimeter Fire Trail and shared mountain bike circuit 4m upslope (along track) to W.

- Install waterbar.

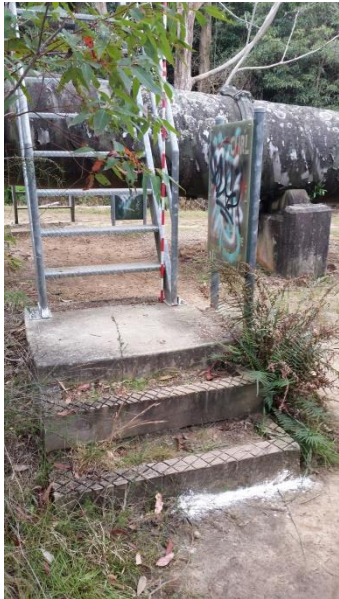
#### **Site ID: N entry/trackhead (at pipeline)**

*Location:* 336737 6263218 Trackhead on S side of pipeline, access via A-frame free-standing aluminium ladder (with handrails) over pipeline, concrete pad on S side with 2 boxed timber steps off. Log post with 2 pictograms (“walkers” and “no bikes”) at start of track, but no track identification and orientation information.

Upgrade signage as per Manly Dam Sign Location Plan, including Park identification and regulatory signage.
