# MANLY DAM WALKING TRACKS AUDIT

for  
**Northern Beaches Council**  
May, 2017

CONTROLLED DOCUMENT  
**“Manly Dam Walking Tracks Audit”**

**FINAL ISSUE**

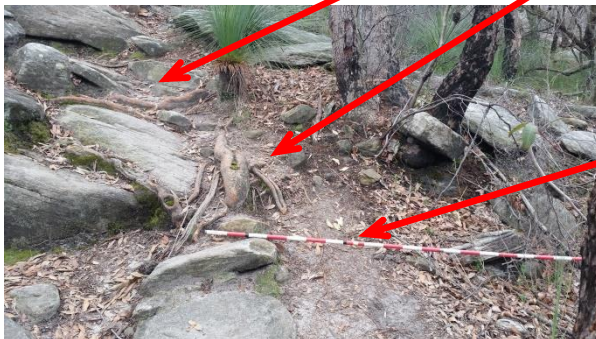
**Site ID: CCT – 1(B)**

**Location:** 336734 6263184 Sloped “chute” between rock ledge and large boulder, 400mm deep, 700-900mm wide with roots and embedded rock, minor trip hazards in top half (including protruding cut stump at top), metal directional arrows on rock, Angophora roots, large sloping outcrop and angled embedded rocks at bottom end of s chute and bend downslope, 17° gradient overall. Faint trample track from bottom of chute running to W along base of rock ledge.

Disguise/block faint trample track

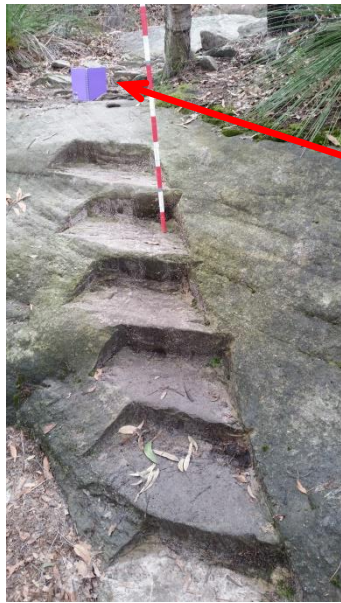
**Site ID: CCT – 1(C)**

*Location:* 336736 6263177 6 cut steps in sloped rock outcrop, 500-700mm wide, 150-200mm riser (mostly), 23° overall gradient on rock outcrop.

Level protruding/angled embedded rock and remove roots (or flagging/armour rocks over roots) to minimise trip hazard at top approach.

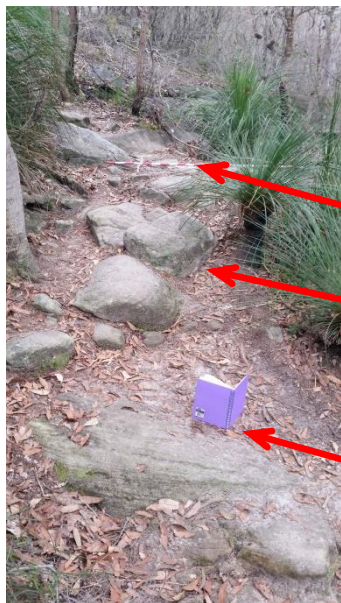
**Site ID: CCT – 1(D)**

*Location:* 336736 6263172 Large embedded boulders upslope (variously rounded, flat and angled) and rock outcrop below, compacted sand with drainage down.

Build waterbar at bottom, onto in-situ rock.

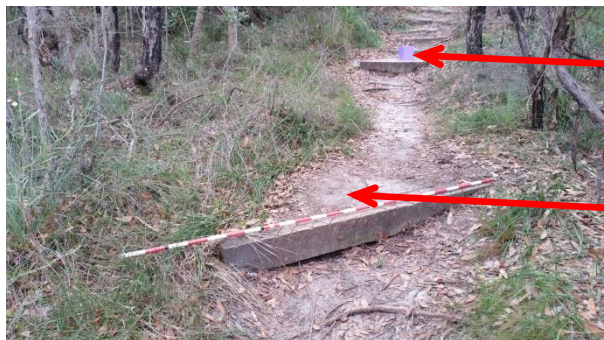
**Site ID: CCT – 1(E)**

*Location:* 336733 6263162 600-900mm wide compacted sand and roots with scored timber sleeper steps and waterbars, drainage down, some scour over steps/waterbars up to 250mm depth, waterbars full of sediment, 6° gradient.

Clean out waterbar (x 1) and cut discharge channel and/or extend or block (with embedded rock) at lower end.

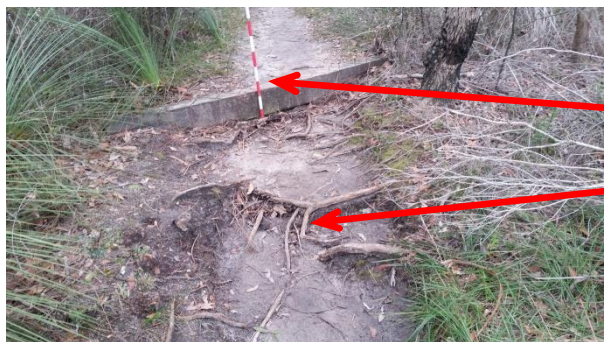
**Site ID: CCT – 1(F)**

*Location:* 336729 6263145 Scored timber sleeper step, with roots below

Extended step-and-run with filled/compacted tread (and boxed edges where necessary for containment) for 2m below waterbar/step over roots.

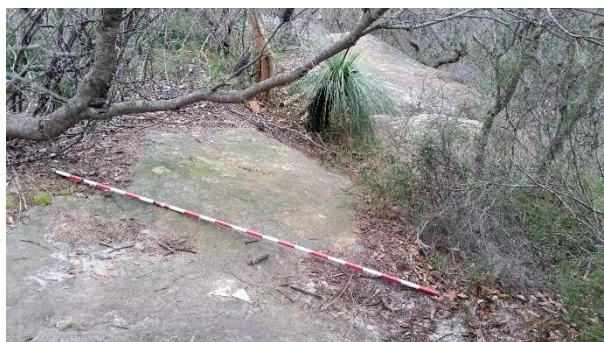
**Site ID: Junction with old/disused loop and waterfall access**

*Location:* 336726 6263138 Rock ledge with old/disused loop and waterfall access joining Curl Curl Track from SE, on bend at E end of rock ledge. Metal directional arrows on bend in main track. Rock ledge slopes off to S/SE then continues at lower level to E (another set of metal directional arrows 10m away on rock shelf on old track, but not easily visible from main track). Entry to old/disused loop is partially blocked by overhanging vegetation and appear very little used.

Disguise entry to old/disused track and remove first set of metal directional arrows (if loop/link is no longer required as part of track network, or as a “there-and-back” spur access to creek and waterfall).

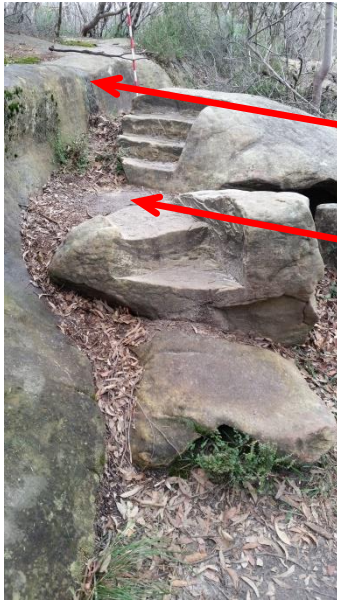
**Site ID: CCT – 1(G)**

**Location:** 336722 6263137 Rock ledge with 5 steps cut into boulders below/off ledge, 550mm drop off upper ledge (and 300mm above top of adjacent boulder) with gap/trench 400mm wide, 3 steps cut in upper boulder and 2 in lower boulder (steps 500-900mm wide with 150-200mm risers) then large slightly sloped rock, 8° gradient overall.

Monitor tread between boulders and off bottom rock for wear away and need for armouring

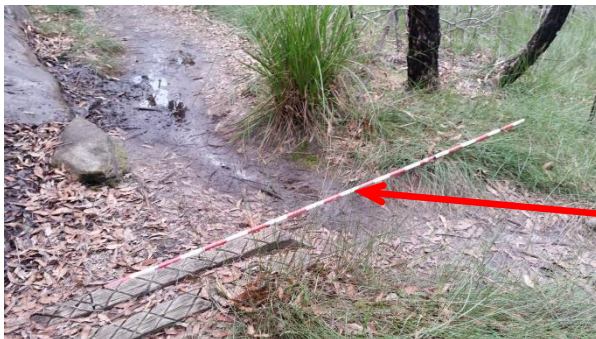
**Site ID: CCT – 1(H)**

**Location:** 336712 6263139 Failed/full cross drain, of parallel scored timber sleepers, with track detouring to low side.

Extend failed cross drain as waterbar (can re-use one in-situ timber sleeper).

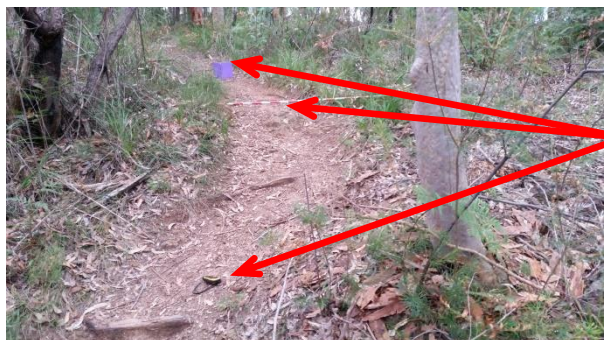
#### **Site ID: CCT – 3(A)**

**Location:** 336642 6263110 Laterite embedded rocks and occasional roots on slightly dished track curving on slope at 9° gradient, drainage flows down track.

Install 3 waterbars/steps on bend (at top of slope, to divert flows before long run of scored timber sleeper steps and waterbars downslope). Build centre waterbar off in-situ laterite rock.

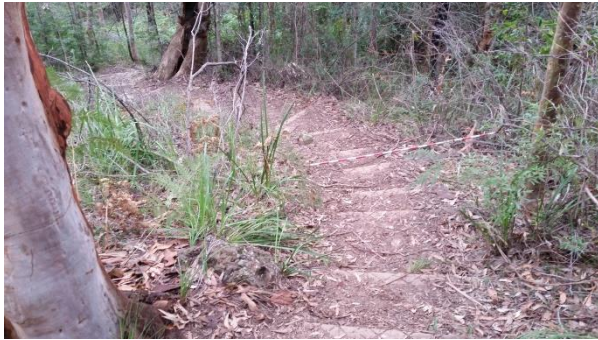
**Site ID: CCT – 3(B)**

“S” curve downslope of 26 steps and 2 waterbars (both full of sediment) all of scored timber sleepers, compacted sand and laterite gravel between steps (on treads and sloped track), 800-1000mm wide, 10-14° gradient, drainage flows down but little erosion or dishing due to curved alignment to spill flows off track and frequent spacing of steps catches sediment and slows flow, good alignment and good condition, minor drainage line at bottom with thick ferns (Site CCT – 3(C)).

Clean out waterbars (x 2)

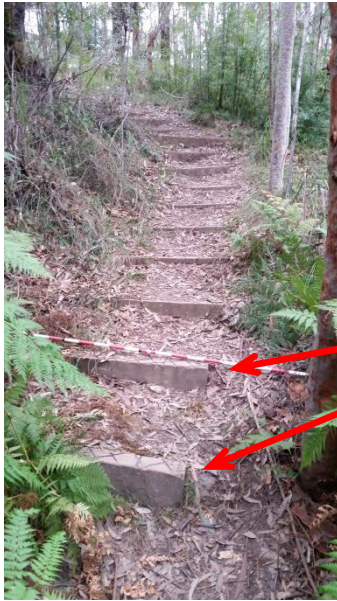
**Site ID: CCT – 3(C)**

**Location:** 336616 6263109 Placed stepping stones across minor drainage line/tributary crossing, stones detoured and track widened.

Relocate and widen drainage line crossing with extra step stones/flagging. Monitor for need for edge definition and containment/barrier (rock rubble).

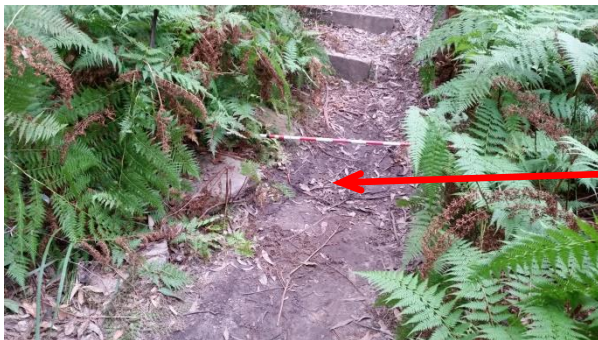
**Site ID: CCT – 3(D)**

*Location:* 336602 6263115 Compacted sandy/clay track 400-700mm wide, directly up/down slope curving between sandstone boulders, occasional roots at top, drainage down track and eroded to 300mm below NSL (at top), , 12° gradient with 2.4m change in level overall over 9m length (on W side of minor drainage line - Site CCT – 3(C)).

4 step-and runs built onto lower outcrop (above drainage line) on inside of curve and boxed on outer side for containment, fill/compact treads, with “wing” on outside of upper tread to prevent/divert flows down/around sides.

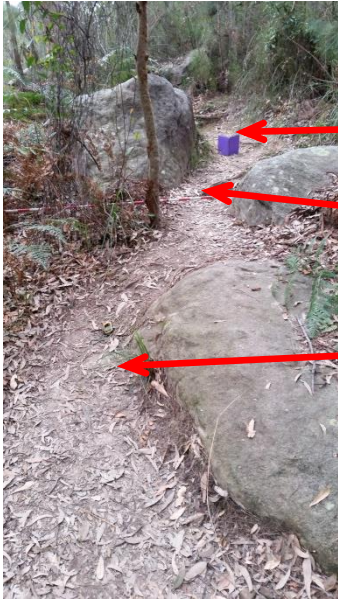
**Site ID: CCT – 3(E)**

*Location:* 336592 6263107 15 steps and 2 waterbars (both full of sediment), all of scored timber sleepers across (up/down) across a 17° gradient slope over 14m length, 800-1200mm wide, compacted sand treads, minor drainage flows down but no scour, lower steps edged or end barriered with rock on outer side, good alignment and good condition.

Extend or block (with embedded rock) existing timber steps to catch flows and minimise erosion around ends. (4 steps, mainly inside ends on lower half of site)

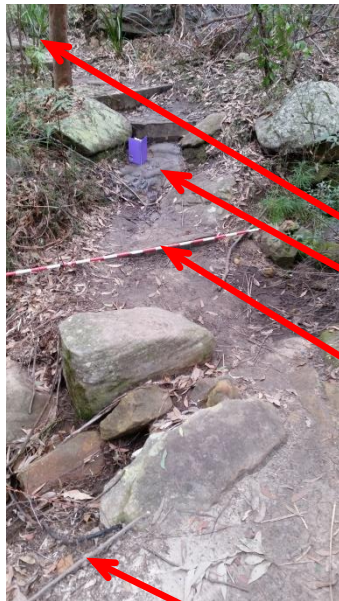
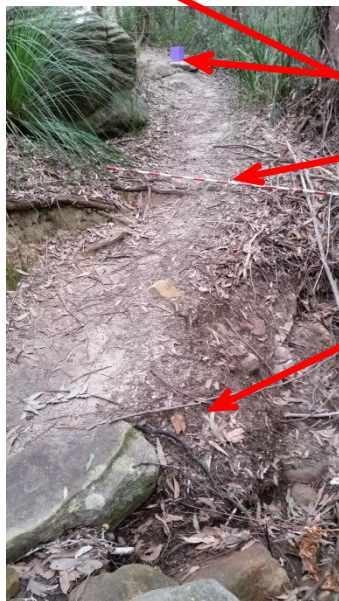
**Site ID: CCT – 3(F)**

**Location:** 336597 6263092 Drainage crossing, 3 scored timber sleeper steps on NW approach (12° gradient) with timber waterbar above and 6m upslope to NW (both full of sediment), 1 large step stone in drainage line (low side), SE approach is compacted sand with minor cross-slope (8° gradient).

- Clean-out waterbars on NW side (x 2).
- Cut/level tread in rock outcrop below sleeper steps on NW side (for safer more stable entry/exit).
- Replace lower/last sleeper waterbar/step on NW side of channel (partially buried) with large stone step, anchored to in-situ outcrop (more durable and less susceptible to erosion during flows).
- 2 waterbars on SW side, at 4m and 10m from drainage line (build on not in-situ outcrop on high side of track).
- Monitor track on SW beside drainage line for undercutting/erosion from larger flows, and possible need to armour.

**(Medium - for passability issues)**

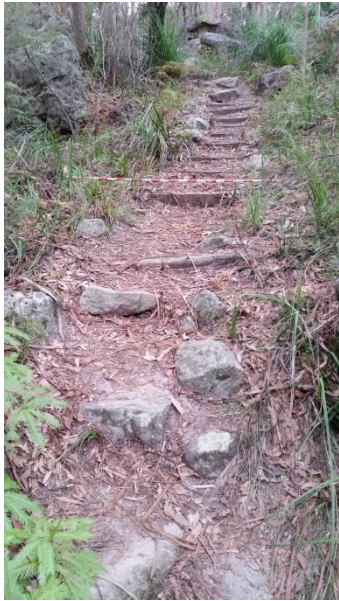
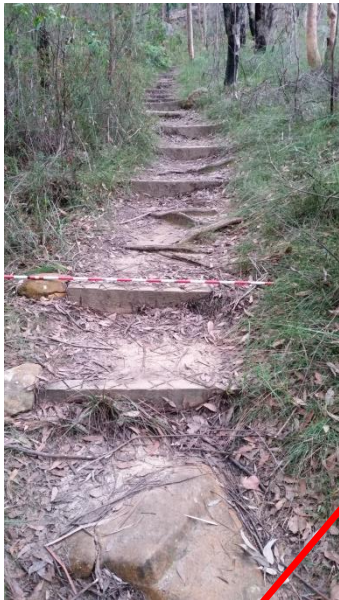
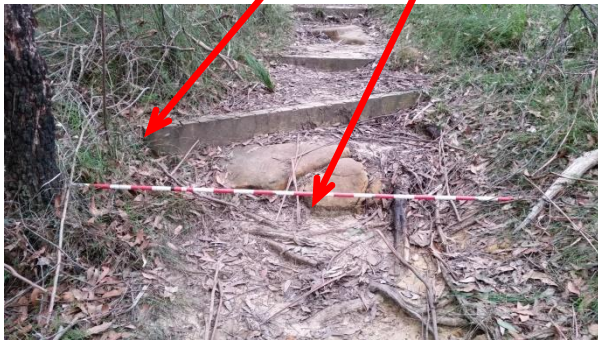
**Site ID: CCT – 3(G)**

*Location:* 336596 6263032 top

42m long section up/down slope, 9° gradient overall, 14 steps/risers (some steps with end rock blocks/barriers) and 3 waters (all full of sediment), steps and waterbars mostly of scored timber sleepers but a few older logs as well, generally in good condition despite drainage flows down, compacted sand track 800-1200mm wide, occasional roots, dished to 250mm below NSL on upper section, embedded rocks on lower end.

Extend lowest waterbar on slope, and install additional step below, with fill/level above over angled broken rock and roots.

**(low)**

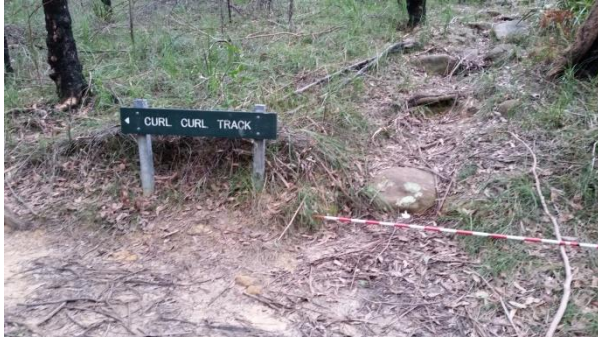
**Site ID: Junction with old/disused loop track**

*Location:* 336580 6263001 Old/disused track joins (via T junction) from E/NE on gentle/moderate slope. Small routed timber sign ("Curl Curl Track" with arrow to N) on galvanised metal posts on main Curl Curl Track (good condition). Drainage flows down old/disused track onto main route (and into next Segment CCT-4). Old/disused track has very little sign of use, despite being very obvious.

**(Medium)**

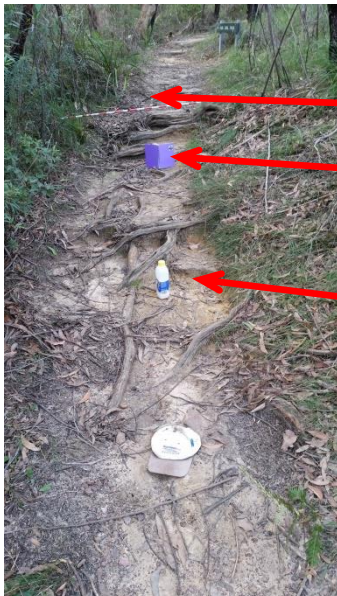
**Site ID: CCT – 4(B)**

**Location:** 336591 6262962 Narrow track over and around two large angled/sculpted boulders at minor crest, gap between boulders with exposed roots, eroded/benched track on downslope/S side with 300mm high benching-in on high side, track surface dishd to 50-75mm below NSL.

Step/waterbar on compacted sand slope below lower boulder, stone-lined invert above with cut channel (or formed/lined gutter) to discharge between adjacent rocks towards creek (required to divert drainage to protect existing and proposed downslope track treatments).

**(low)**

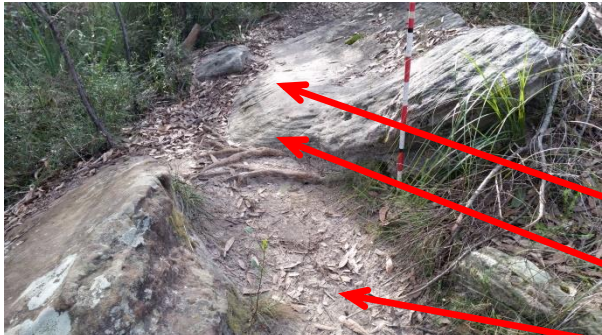
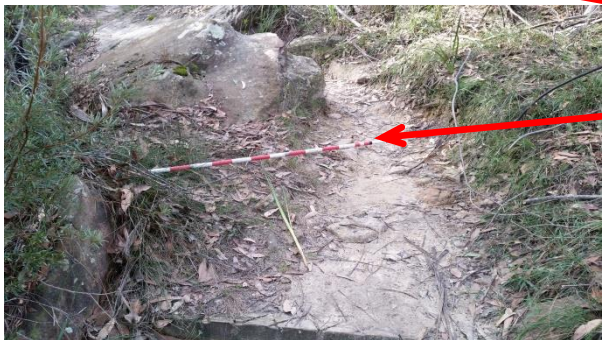
**Site ID: CCT – 4(C)**

**Location:** 336586 6262953 Two sloped rock pavements with large exposed root between, loose rocks placed at base of lower steeper pavement as informal step, drainage flows down track, 9° gradient overall.

Move loose rocks and rock armour/flagging tread off lower end egde of pavement.

**(low)**

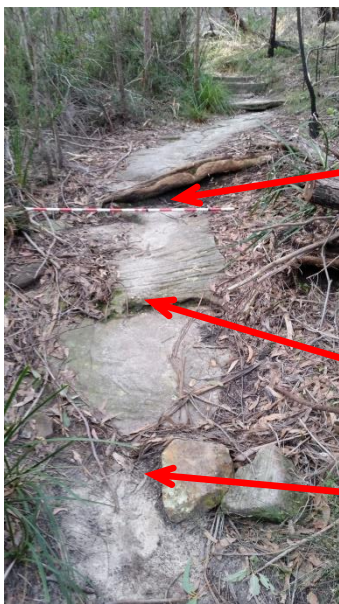
**Site ID: CCT – 4(D)**

**Location:** 336585 6262942 Upper - large angled root retaining compacted sand track above, with 300mm step off onto embedded rock then rock outcrop/pavement, drainage flows over/down. Lower - roots retaining dished compacted sand track, with 150mm step off with ponding area, then gently sloped pavement (track may be subject to flood flows from adjacent creek). 7m length overall.

Boxed stone step-and run (above) and step (below) anchored onto rock pavement below root, backfill over root and fill/compact both treads, rock armour/flagging on both tread (to protect from scour during possible flooding by creek flows).

**(Medium – for passability and sustainability/impact issues, to protect track against creek flows)**

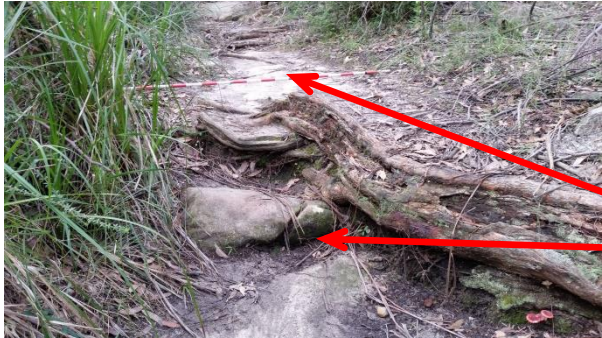
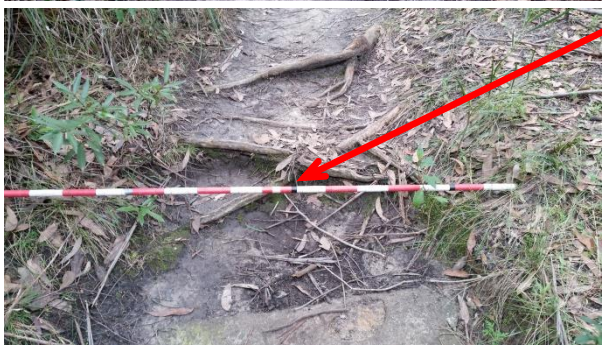
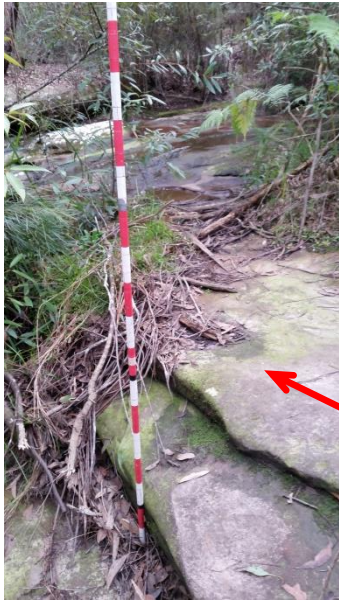
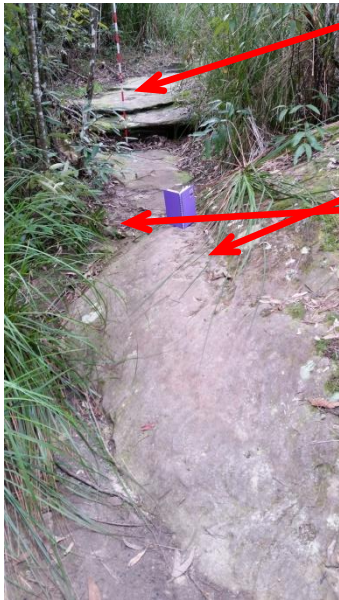
**Site ID: CCT – 4(E)**

**Location:** 336587 6262937 Upper - gently sloped rock ledges above (with short track to creek cascade) with lip and 250-300mm step off to pavement outcrop, 2 metal directional arrows on rock, likely to be subject to creek flows diverted onto/down the track in medium flows (creek is only 2m to W of track and at almost the same level). Lower - rounded boulder/outcrop, minor tread (approx. 200mm wide) cut into highest part of outcrop, but slopes off to S and evidence of walkers (and creek flows) along low side of outcrop.

Monitor upper rock ledges for moss and slippery conditions, may need to cut/level treads (or build stone step) if becomes a safety issue.

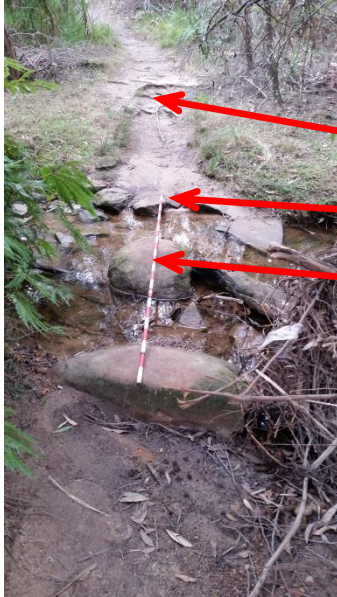
**Site ID: CCT – 4(G)**

**Location:** 336588 6262901 Minor/ephemeral drainage line flowing onto track from upslope then “captured” to flow down/along track for 9m before discharging to E at low point, eroded/exposed roots and track widening to 1.4m.

- Pull in track width (away from roots on high side) with edge containment/definition (both sides).

**(Medium – for sustainability/impact issues issues)**

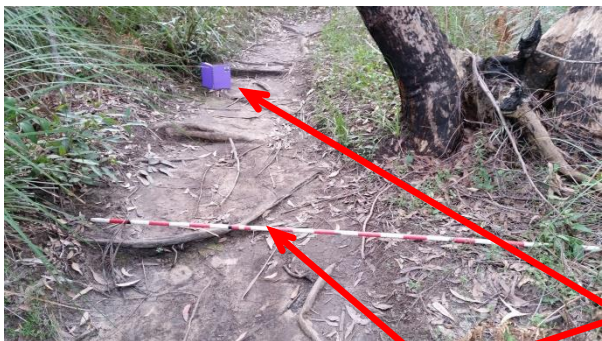
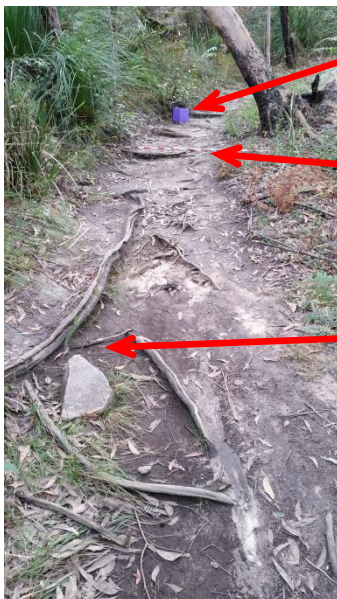
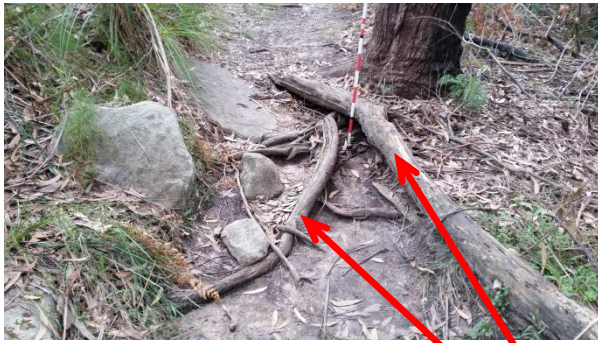
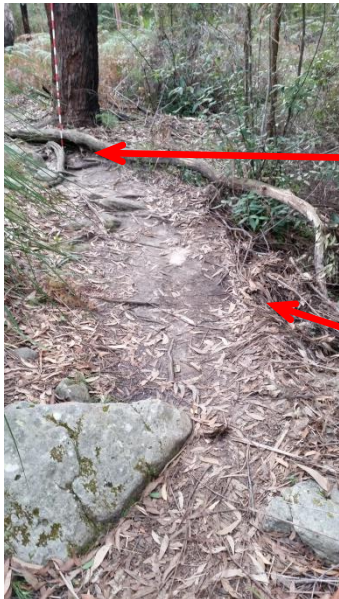
**Site ID: CCT – 4(H)**

**Location:** 336595 6262895 Angled rock outcrop and protruding embedded rocks on track and on high side, track 1,000-1200mm wide, large Eucalypt adjacent low side with roots running over the outcropping rocks, creekside of track retained by fallen branch with 400mm slope down/off, drainage flows down track. Track on bend below/SE runs beside creek, 8-10m section has steep slope (+1m high) to flood bench below, with potential for undercutting/erosion during high flows.

**(Medium - for passability/safety issues, and monitor for flood damage and need for post-flood maintenance/repair)**

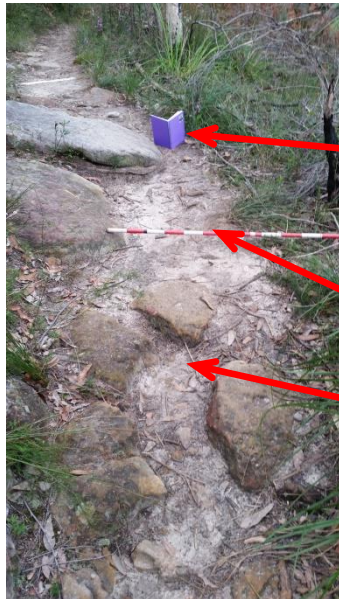
##### **Site ID: CCT – 5(A)**

*Location:* 336625 6262864 Angled rock outcrops and embedded rocks.

Rock infill and armour gap between, and to same level as, embedded rocks to form small stone step.

**(low)**

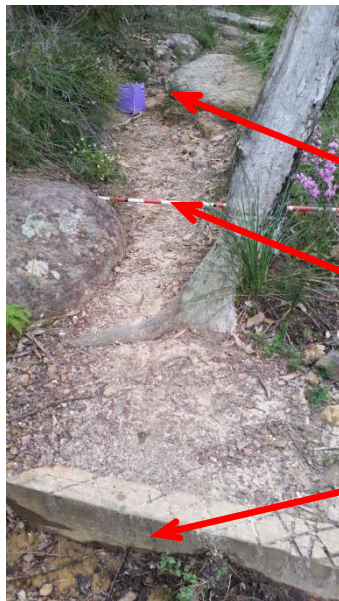
##### **Site ID: CCT – 5(B)**

*Location:* 336629 6262859

Boulders/outcrops upslope with compacted sand track and loose stones/gravel, scored timber sleeper waterbar/step (full of sediment and scour over) at lower end (below dead tree), 8° gradient overall.

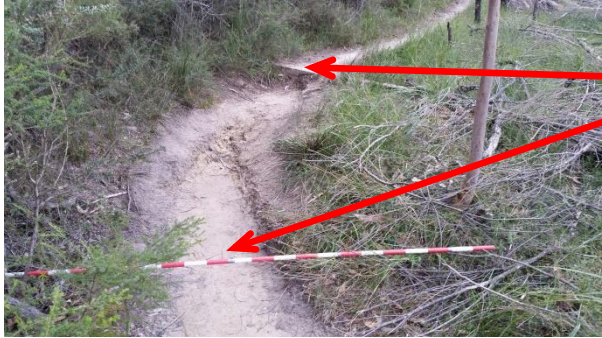
**Site ID: CCT – 5(D)**

*Location:* 336644 6262843 Large rock ledge above (flat/rounded, slippery due to loose sand from upslope) with 450mm step off to compacted sand bench/gap (400mm wide) with exposed roots on downslope edge (from adjacent multi-stem tree), then boulder on high side of track with root and flat rock pavement (at NSL) extending down track on low side, most walkers use route on low side of rocks, drainage flows over and around rocks with some surface erosion, 13° gradient and 900mm drop overall, metal directional arrows on upper ledge.

Waterbar in shallow sandy area at rear of upper ledge (if insufficient depth to instal timber sleeper waterbar may need to excavate broad shallow drainage channel into upper side of ledge). Cut 2 steps into lower face of upper ledge. Rock armour/flagging in gap below ledge, to fill and level gap between ledge and boulder. Level top of boulder as flat tread. Stone step-and-run off low side of boulder with 2 steps at end anchored onto lower flat rock pavement, boxed on low side for containment, fill and rock armour all treads (to protect against likely continued drainage over site from adjacent slope).

<p>Pull-in track width with edge definition and containment/barrier (rock rubble) to prevent "avoidance" and widening.</p> <p><b>(Medium - for passability/safety issues)</b></p>

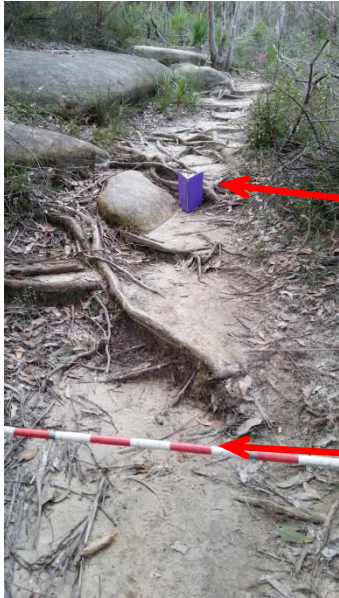
<p><b>Site ID: CCT – 5(E)</b></p> <p><i>Location:</i> 336647 6262838 Tangle of exposed/protruding roots in compacted and loose sand, some embedded rock, drainage flows down track, rock ledges on upslope side, 3° gradient overall.</p> <p><i>Works:</i></p> <ul style="list-style-type: none"> <li>2 steps built onto embedded rock and outcrop on high side of track, boxed on low side for containment with retaining/edging extending back upslope along low side of track, fill above steps (over roots) and compact, include stone-lined invert butted onto adjacent/upslope rock ledge.</li> <li>Waterbar/step, fill above (over roots) back upslope to steps above, retaining/edging on low side if required.</li> </ul> <p><b>(low)</b></p>

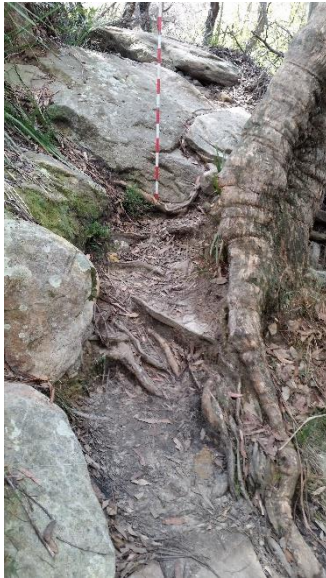
**Site ID: CCT – 5(G)**

**Location:** 336655 6262816 Large flat angled rock slab/boulder at top, with step off to sloping gap/channel of loose sand (200mm wide), then onto very large angled and sloping boulder with 500mm high angular face on low side – 1,700mm drop overall over 3m length. Broken rock slabs on low side of track above moderately steep sandy slope. Below angled/sloping boulder is compacted sand track with smaller boulders along upslope edge and some embedded rocks and protruding roots, entrenched 200-400mm below NSL, extends 2.5 m to placed rocks at top of next site (CCT-5(H)), large tree (with trunk cavity/deadwood facing track) on low side of track. 9m total length, 17° gradient overall.

Cut 4 steps, in a gentle curve, along higher side of angled/sloping boulder (to avoid crack on low side while minimising cut depth, and away from steep sandy slope).

Run of 8-9 fibreglass reinforced plastic steps and short landings (1.3m drop over 3.8m), anchored onto large angled/sloping boulder at upper end (above steep face/drop), and extending past (upslope) of large tree, to bottom landing at existing track level and anchored onto concrete pad or footings (bottom landing is at top of following site (CCT-5(H)), with extra step off E side of landing to line up for existing steps in CCT-5(H) if required). Avoid excavations or loadings that may compromise roots or stability of large tree (avoid falling/uprooting that would damage track treatments).

**(HIGH – for passability/safety issues)**

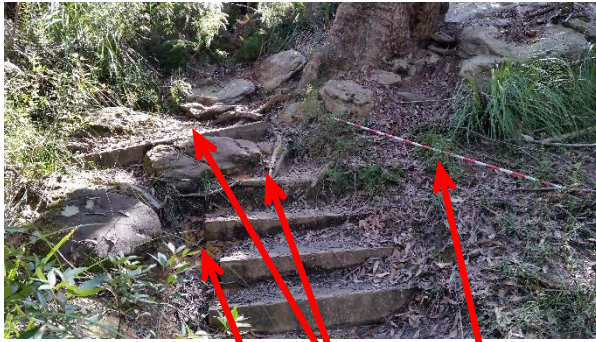
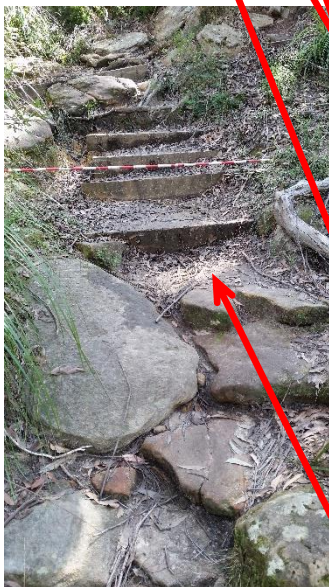
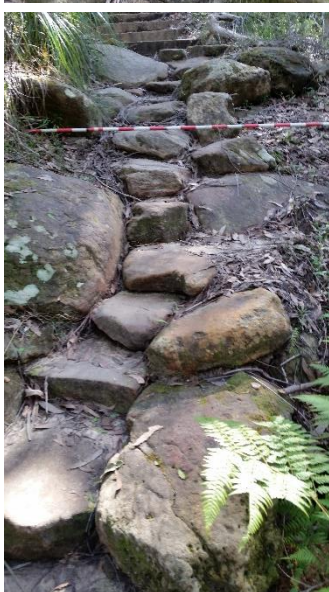
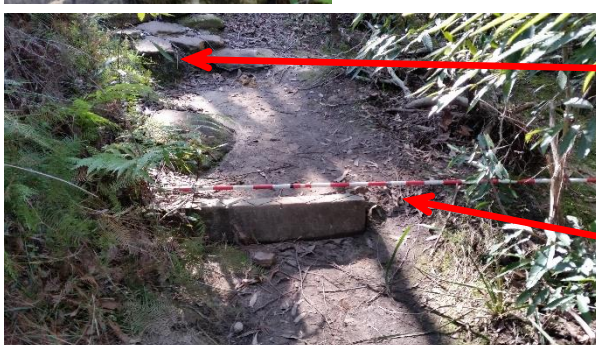
**Site ID: CCT – 5(H)**

**Location:** 336656 6262813 top  
336664 6262809 bottom

Extended run of steps for 16m directly up/down an 18° gradient slope above creekline. Waterbar at top (at bottom of Site CCT-5(G) above), full of sediment and failed with gap at N end, with retaining root forming a step and embedded/broken rocks below. Then 3 scored timber sleeper steps and 1 step-and-run on top third of slope (eroded to 250mm deep at/around lower ends), and 16 built/placed stone steps on lower two-thirds (built onto and around in-situ small boulders on slope) 300-800mm wide, most in fair to good condition and stable/secure. Drainage flows down all stone steps, but little erosion/scour. Large step off lowest rock step to compacted sand track on flood terrace beside creek (appears regularly inundated), with trample track to NE to creek. Waterbar at base beside creek (track along flood terrace).

Remove roots and broken rock, replace with 2 boxed stone steps with armoured treads. Pull in track width and edge barrier (rock rubble) to prevent “avoidance”.

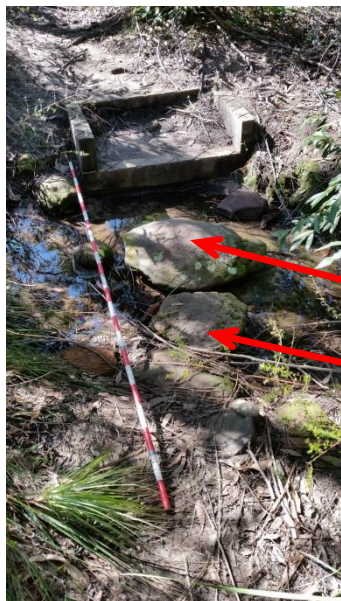
##### **Site ID: CCT – 6(A)**

**Location:** 336665 6262766 Tributary crossing with 2 boxed scored timber sleeper steps on N side, large central rock/step stone (stable but rounded top), small rock off S bank (loose), embedded rock on S bank and gentle compacted sand track on S approach.

- Cut/level flat tread in top of central stepping stone (check/ensure stability after works).
- Secure/anchor smaller rock off S bank, or replace with 2 with larger stable stepping stones

**(Medium – for passability/safety issues)**

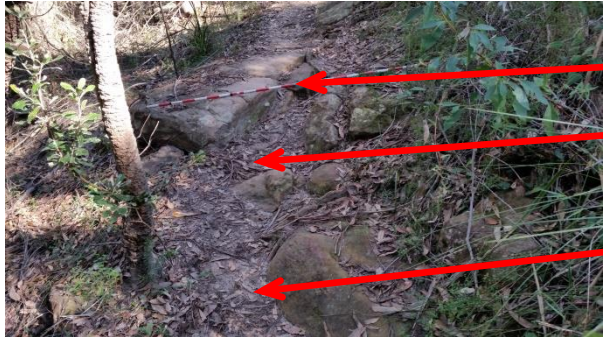
<p><b>Site ID: CCT – 6(B)</b></p> <p><i>Location:</i> 336663 6262746 Outcrops and embedded rocks and roots, gap 400mm wide between rock, with drainage flows down/between.</p> <p><i>Works:</i></p> <ul style="list-style-type: none"> <li>Rock infill to gap, anchor to in-situ outcrop, and level top as small step.</li> <li>Remove protruding roots and level embedded rocks below, and rock armour/flaggin step off below.</li> <li>Waterbar downslope, built onto in-situ embedded rocks.</li> </ul> <p><b>(low)</b></p>

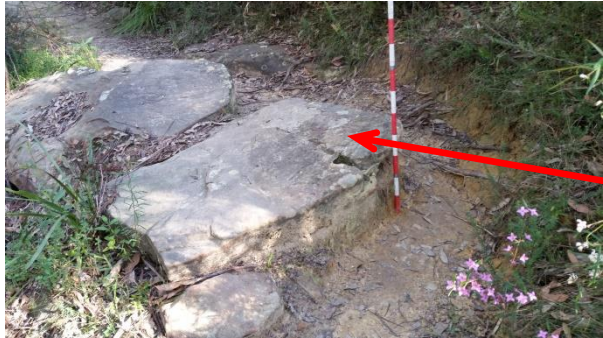
<p><b>Site ID: CCT – 6(C)</b></p> <p><i>Location:</i> 336664 6262731 Track detouring around protruding flat boulders with 200-300mm faces, eroding into upslope side of track to 400mm below NSL, minor crest (and watershed).</p> <p><i>Works:</i></p> <ul style="list-style-type: none"> <li>Cut edge of upper boulder (potentially using existing fracture line) and straighten track (use excess stone at previous site – CCT -6 (B) – if intact).</li> </ul> <p><b>(low)</b></p>

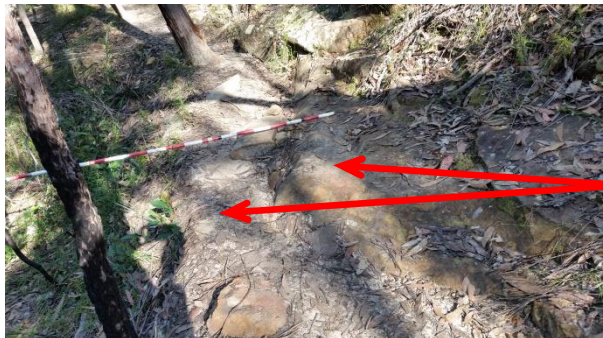
<p><b>Site ID: CCT – 6(D)</b></p> <p><i>Location:</i> 336669 6262716 Low uneven rock outcrop forcing narrow track to widen along downslope side (as walkers avoid outcrop) above moderate slope away from track, embedded rocks</p> <p><i>Works:</i></p> <ul style="list-style-type: none"> <li>Level uneven outcrop and remove/level protruding embedded rock. Close and block/barrier (rock rubble) “avoidance” alignment along lower side.</li> </ul> <p><b>(low)</b></p>

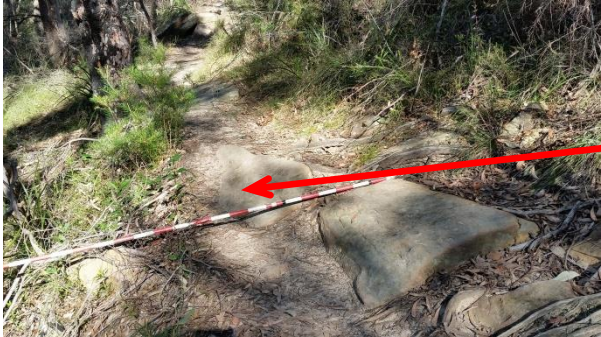
**Site ID: CCT – 6(E)**

**Location:** 336699 6262689 Angled outcropping/embedded rocks (x 2) with S outcrop forcing narrow track to widen along downslope side (as walkers avoid outcrop). “Avoidance” alignment is very narrow (<200mm tread width) above moderate slope away from track.

Level or remove S outcrop, and close and block/barrier (rock rubble) “avoidance” alignment along lower side (or build a rock bench onto low side of this angled outcrop with rock step at N end).

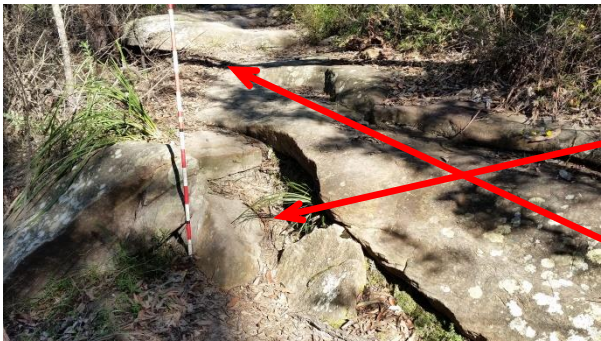
**Site ID: CCT – 6(F)**

**Location:** 336705 6262687 Sloped rock ledge with broken slab downslope, current track aligned via gap between ledge and slab with 2 placed/embedded rocks as informal steps (flat upper rock, angled lower rock) then natural rock steps/ledges above, drainage flows down/over ledges.

2 stone steps in gap between ledge and slab, formalise and upgrade/widen existing steps to fill entire gap.

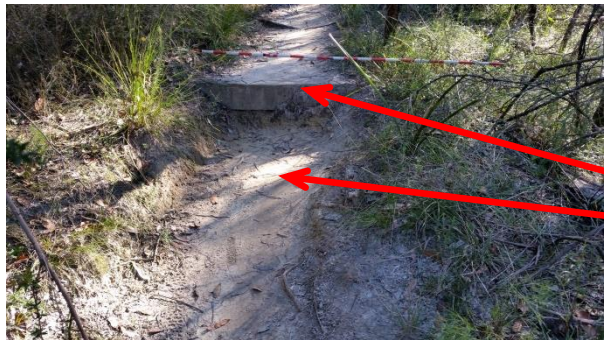
**Site ID: CCT – 6(I)**

*Location:* 336747 6262642 Scored timber sleeper step, full of sediment and failed, with drainage flows around ends and flows over, scoured to 350mm over step then entrenched track 300-150mm below NSL for 2m deep

- Replace with extended waterbar/step.
- Step-and-run 1m below new waterbar/step and fill/compact behind (fill could be delivered via nearby Perimeter Fire Trail).

**(low)**

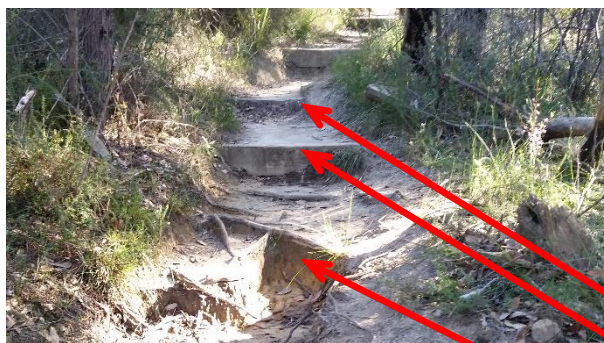
**Site ID: CCT – 6(J)**

*Location:* 336754 6262645 Scored timber sleeper steps/waterbars (x 2), both full of sediment and failed, flows over upper step and around end of lower step. Downslope to retaining roots forming a step in compacted sand/clay, then gutter to 300mm below NSL for 2m to sculpted rock outcrops (near Perimeter Fire trail junction), with track widening on N side to avoid.

- Clean-out upper step/waterbar.
- Replace or extend lower step/waterbar, and clean-out.
- Build 2 steps onto sculpted rock outcrop (at end of gutter) and fill/compact to level of adjacent track and over roots back to step/waterbar (box low side if necessary for containment).

Pull-in track width with edge definition and containment/barrier (rock rubble).

**(low)**

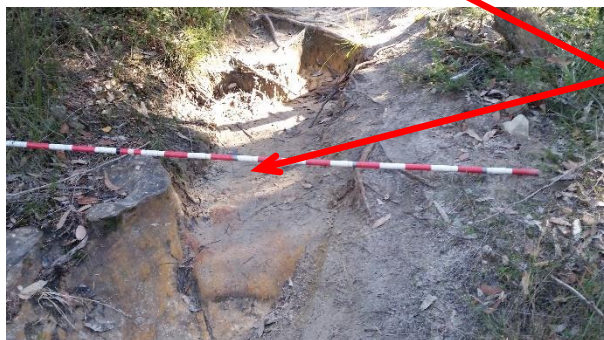
**Site ID: Trackhead at Perimeter Fire Trail (S end of Curl Curl Track)**

*Location:* 336759 6262645 Junction of Curl Curl Track and Perimeter Fire Trail / Shared Path (and N trackhead of Park Circuit Track (West) opposite). New signage/directional totem – identifies Mountain Bike Circuit (and Fire Trail) and Park Circuit Track (West) to S, but no identification or orientation information for Curl Curl Track. Drainage and loose sand out onto Perimeter Fire Trail. Potential for walkers exiting Curl Curl Track to encounter high-speed (downhill) mountain bikers on Perimeter Fire Trail / Shared Path

Additional identification or orientation signage/information for Curl Curl Track.

**(Medium)**

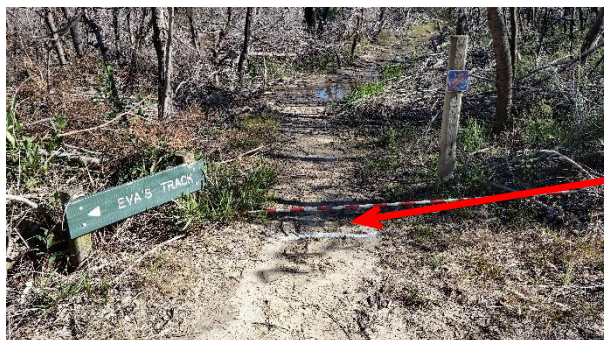
**Site ID:** ET – 1(A), and eastern end of segment

**Location:** 337261 6262903 Junction with North-western Fire Trail

Install rollover drain across start of track (at junction, along edge of fire trail) to prevent drainage inflows from upslope section off fire trail to NW.

**(low)**

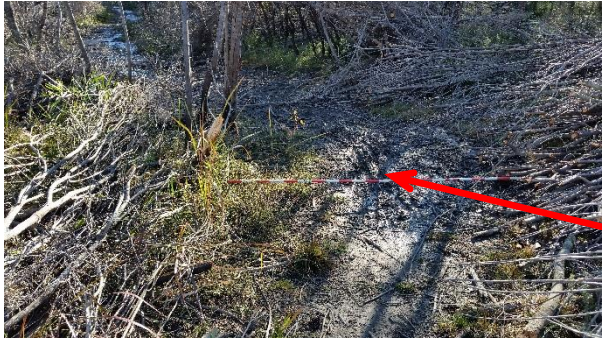
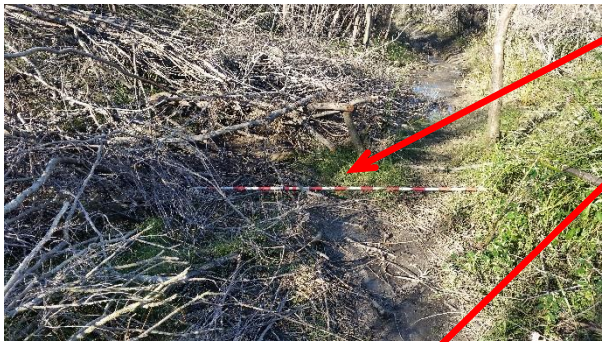
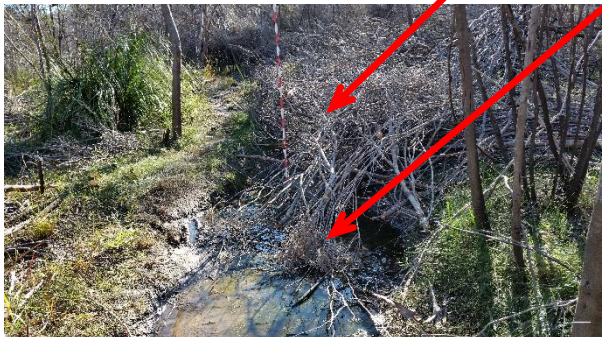
**Site ID: ET – 1(D)**

*Location:* 337223 6262910 Wide muddy track above bend, with drainage run-on from upslope track and seepage from adjacent rock shelf upslope, 1° gradient.

Pull-in and define/contain track edges (branch barrier bundles – using lots of dead/fallen shrubs available in surrounding area).

**(Medium - for sustainability/impact issues, including to divert surface flow and protect treatments downslope at site ET – 1(C) )**

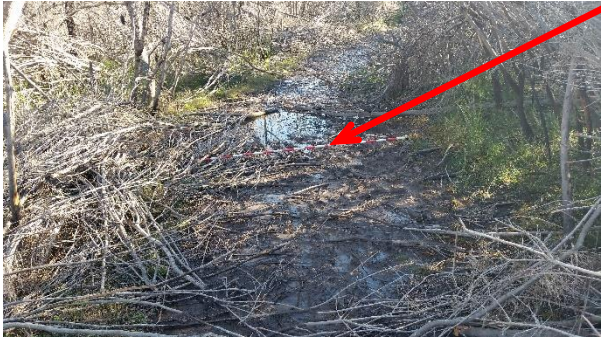
**Site ID: ET – 1(E)**

*Location:* 337218 6262909 Flat rock outcrop with drainage run-on from upslope track and intercepted seepage from upslope side of track (track acts as “catch drain”, and sub-surface flows also “pushed” to surface by shallow rock shelves and pavements).

Cut broad shallow invert/spoon drain across rock outcrop and reinforce with low built rock waterbar onto outcrop on downslope side, extend/excavate outlet to discharge well off track.

**(Medium - for passability issues)**

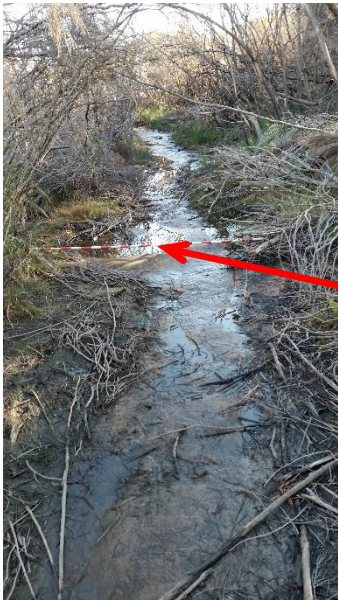
**Site ID: ET – 1(F)**

*Location:* 337170 6262905 Large rounded/rough rock outcrops with central gap/channel with drainage flows down, low rock ledge upslope above, 7° gradient overall.

Rock infill and level gap/channel between lower outcrops, with rock step off and armoured/flagged tread below.

**(Medium - for passability and sustainability/impact issues)**

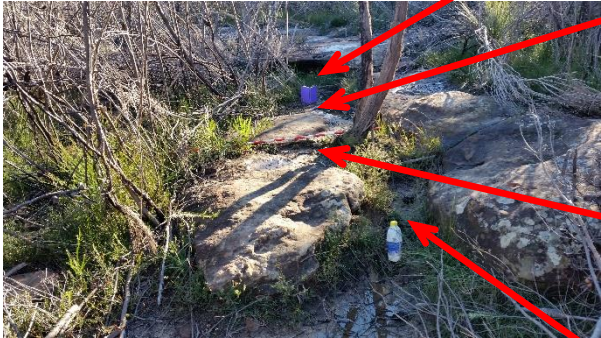
**Site ID: ET – 1(G)**

*Location:* 337137 6262899 Angled edge of low rock ledge, with gap/channel along high side, 900-1,100 mm wide, former track runs along base of ledge but wet/seepage and blocked (closed ?) by small fallen branches, angled ledge is current “used” alignment.

Block/barrier former, disused, alignment below ledge.

**(low – and monitor for slip hazard and possible need to increase to medium priority works)**

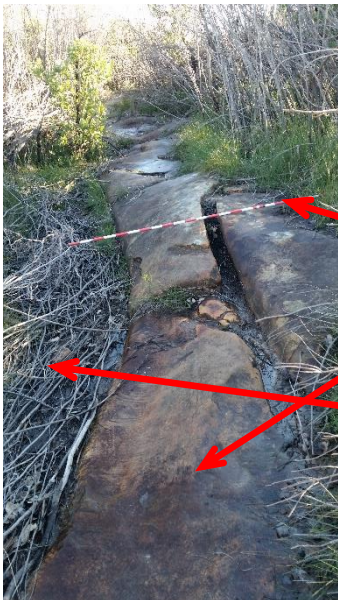
**Site ID: ET – 1(H)**

**Location:** 337122 6262894 Compacted sand/clay below/downslope of track junction at rock ledges, above bend to E, slightly dished with drainage flows down from rock ledges above.

Waterbar, 2.5m below track junction (rock ledges) and above bend to E, discharging to SW.

**(Medium - to divert surface flow and protect sites/treatments downslope on ET – 1)**

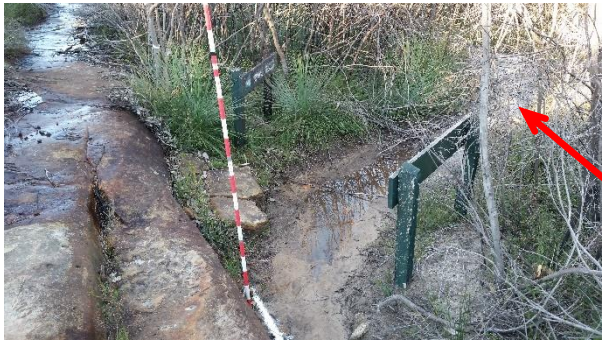
**Site ID: W end of Segment**

**Location:** 337118 6262895 Rounded rock ledge at junction with ET-2 to W, and ET-10 to E. Large placed stone steps on E side but main “used” alignment cuts corner to W to step 500-600mm up onto split rock ledge and bench, ponding below and 2 routed timber signs.

Pull-in track width with edge definition and containment/barrier (rock rubble) to define T junction”, mainly on W side.

**(low)**

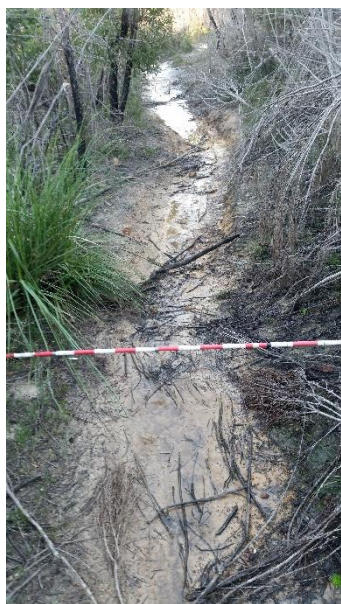
##### **Site ID: ET – 3(A)**

*Location:* 336992 6262871 Compacted sand and laterite gravels with squared gutter 200-300mm deep on 7° gradient slope.

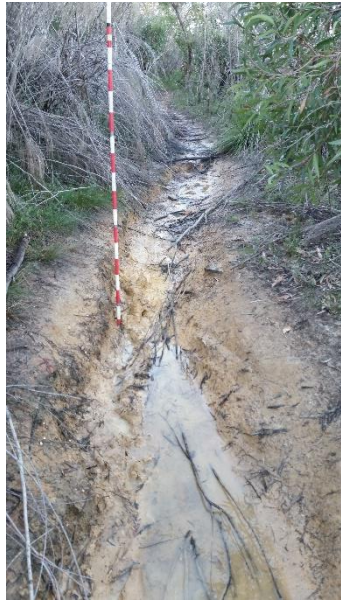
**Site ID: ET – 3(B)**

*Location:* 336987 6262868 Wide gutter eroding into 7° gradient clay/sand slope, eroded to 400mm below NSL.

Open windrow on low side edge of track downslope.

**(Medium - for sustainability/impact issues - to divert surface flow and prevent erosion, and sediment source, for large deposition area downslope at Site ET – 3(C) )**

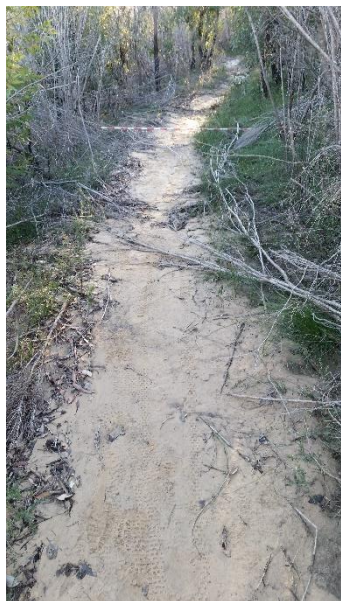
**Site ID: ET – 3(C)**

*Location:* 336961 6262863 Low point and large sand/sediment deposition area, from erosion off adjacent upslope sites to E and NW (Site ET - 3(B) to NE and Site ET - 4(A) to NW), extends 16m along track 800-1,200mm wide. Sediment spilling off low side of track 5m into surrounding bushland (arrowed).

Deny sediment source by works at adjacent upslope sites to NE and NE – see Site ET - 3(B) and Site ET - 4(A).

Sediment could be used as a source of fill for track treatments at adjacent/nearby sites.

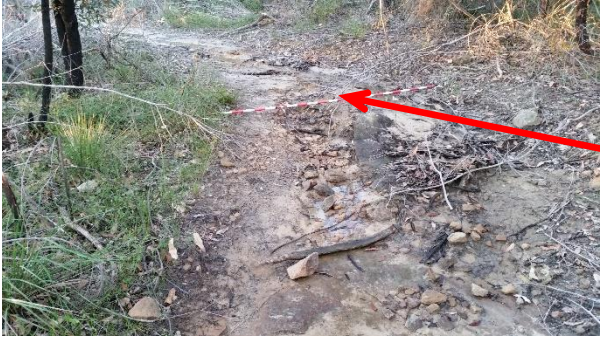
<p><b>Site ID: ET – 4(B)</b></p> <p><i>Location:</i> 336948 6262915 Bend with considerable drainage down wide track of compacted sand and loose rocks, some embedded rock and pavement below.</p> <p><i>Works:</i></p> <p>Waterbar on bend, with extended outlet to discharge well off track and avoid backflow to track downslope.</p> <p><b>(Medium - to divert surface flow and protect sites/treatments downslope at ET – 4(A) )</b></p>

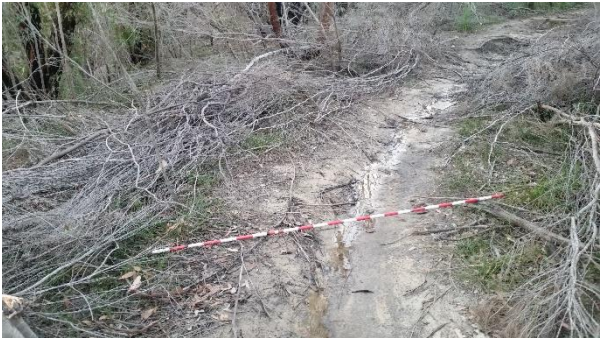
<p><b>Site ID: ET – 4(C)</b></p> <p><i>Location:</i> 336946 6262920 Compacted sand 1,100mm wide with central “V” shaped shallow gutter and considerable drainage down (from Site ET - 4(D) upslope).</p> <p><i>Works:</i></p> <p>Waterbar, with extended outlet to discharge well off track.</p>

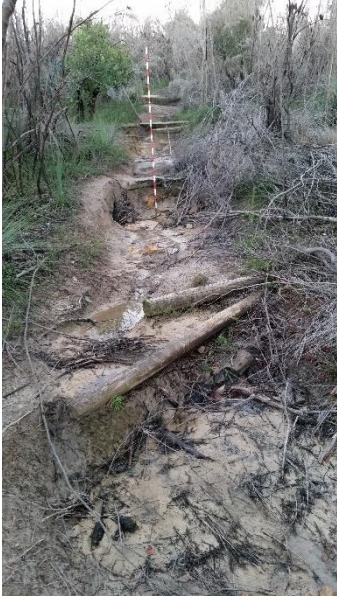
<p><b>Site ID: ET – 4(D)</b></p> <p><i>Location:</i> 336947 6262928 bottom/SW 336962 6262953 top/NE \ (and segment junction)</p> <p>33m section of deeply eroded track up/down 6-7° gradient slope, compacted sand on lower half (including loose/deposited sands) and compacted sand/clay and rock outcrops on upper half, drainage capture and considerable flows downs (with some ponding in scour pools), central gutter 300-700mm deep within wider deeply dished track 900-1,800mm wide, 3 sets of failed log waterbars and steps (upper, middle and lower) full/failed and some also burnt/replaced most with flows/scour over), upper set of steps previously boxed, step 500mm up onto rock ledge at top of site, incised track also intercepts seepage (especially at top).</p>

Throughout - use in-situ benches/risers around failed waterbars/steps, and in-situ rocks in middle section, as basis for replacement/upgraded treatments.

Rock step, built onto rear of upper rock ledge, and compacted/filled tread upslope back to track level with boxed/edged for containment, and waterbar above.

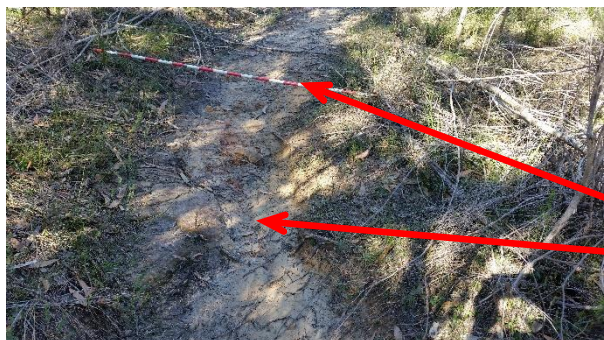
### Site ID: ET - 5(A)

**Location:** 336942 6263002 900mm wide sandy/clay track eroded to 75mm below NSL with flows down track, and outcropping rocks.

Build rock step on in-situ outcrop, and fill/compact above.

**(low)**

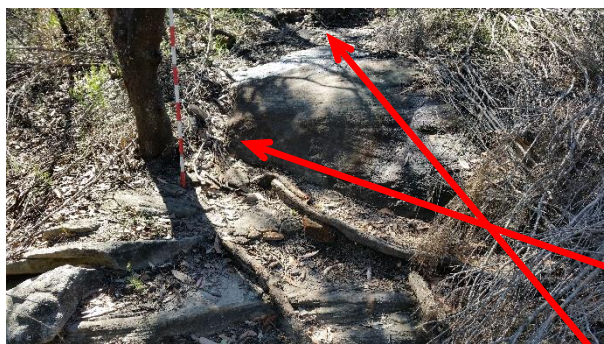
### Site ID: ET - 5(B)

**Location:** 336935 6263022 3 sleeper steps and track edging (good condition) below, then steep faced rock outcrop 400-500mm high face (covering 90% of track) with gap to tree on downslope side, sloped rock outcrop 400mm high (covering 90% of track) with tree and small “natural” step on downslope side, compacted and loose sand and tree roots, 10° gradient overall.

Stone-lined invert on bench above upper rock outcrop, with extended outlet to avoid backflows down outcrops.

**(low)**

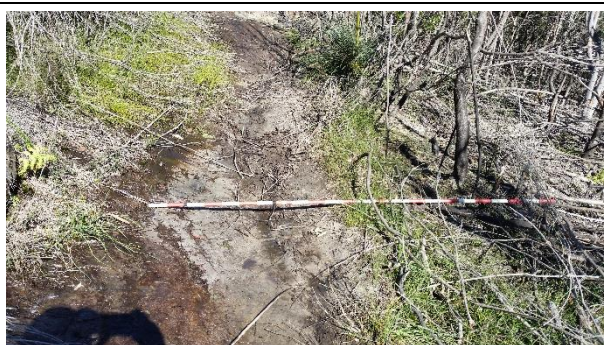
### Site ID: ET - 5(C)

**Location:** 336925 6263073 1,000mm wide dished track with seepage from hillslope and upslope rock pavement and sloped outcrops.

Waterbar, built onto in-situ rock.

**(low)**

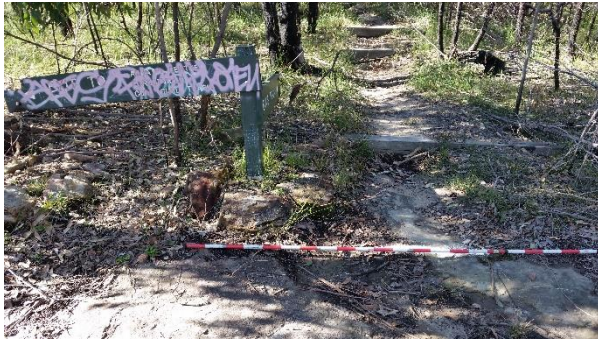
**Site ID: Junction of ET - 5 and ET - 6**

**Location:** 336904 6263118 T-junction with small paired routed timber identification and wayfinding signs (very poor condition, unserviceable – burnt, missing posts and grafittied).

See Segment ET - 6 below.

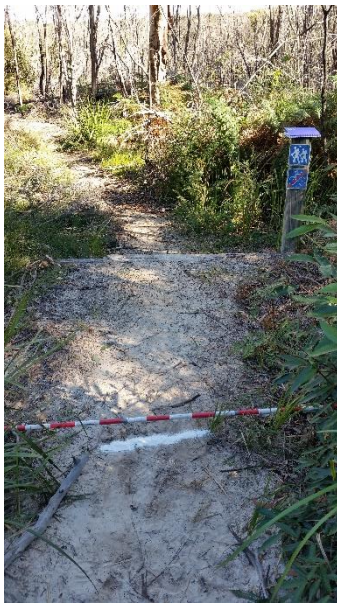
**Site ID: N end of Segment (at pipeline)**

**Location:** 336894 6263179 Trackhead on S side of pipeline (access via crawl/crouch under pipeline), log post with 2 pictograms (“walkers” and “no bikes”) but no track identification and orientation information, sleeper step.

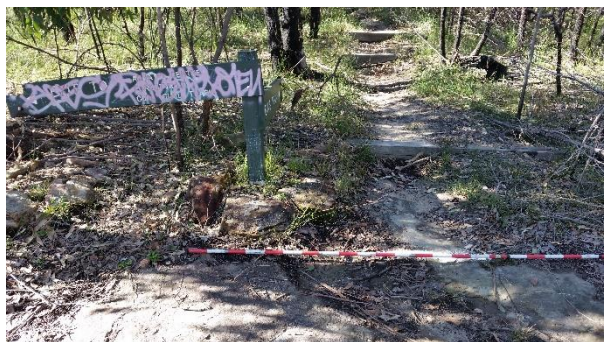
### **Site ID: Junction with ET – 5 (W end of segment)**

*Location:* 336904 6263118 T-junction with Segment ET – 5, with small paired routed timber identification and wayfinding signs (very poor condition, unserviceable – burnt, missing posts and grafittied).

Replace/upgrade signage as per Manly Dam Sign Location Plan.

**(Medium)**
