# MANLY DAM WALKING TRACKS AUDIT

for  
**Northern Beaches Council**  
May, 2017

CONTROLLED DOCUMENT  
**“Manly Dam Walking Tracks Audit”**

**FINAL ISSUE**

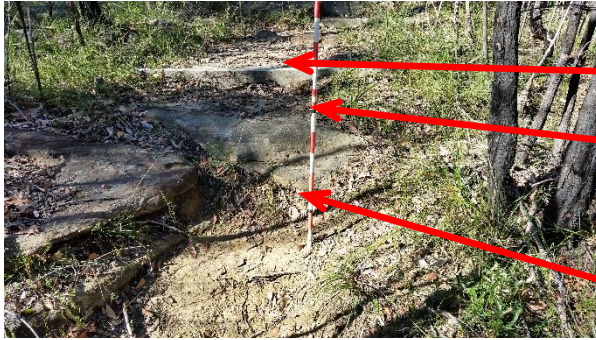
**Site ID: ET – 6(A)**

*Location:* 336928 6263132 Sloped rock outcrop 500mm high.

Build rock step onto sloped rock outcrop.

**(low)**

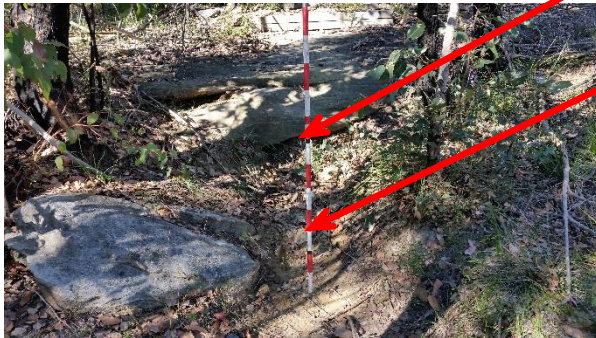
**Site ID: ET – 6(B)**

*Location:* 336936 6263131 Angled and sloped rock ledge 800mm off with drainage over and scoured track below, embedded boulder to N side of track.

Infill scour as step-and-run built onto embedded boulder with rock step off end (and boxed lower/S edge for containment, if required) and rock armour/flagging tread, include invert/dip on tread surface to discharge to S (cut outlet channel to discharge well off track).

**(low)**

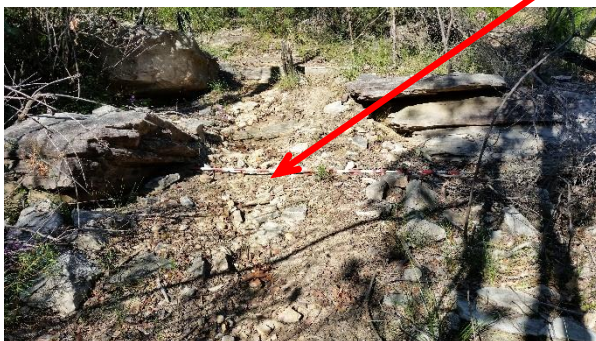
**Site ID: ET – 6(C)**

*Location:* 336945 6263128 Rubbly loose rocky slope, with occasional outcrops and embedded rock, between boulders and rock ledges, existing sleeper waterbars/steps above and below site.

Clean out existing sleeper waterbars/steps.

**(Medium - for passability issues)**

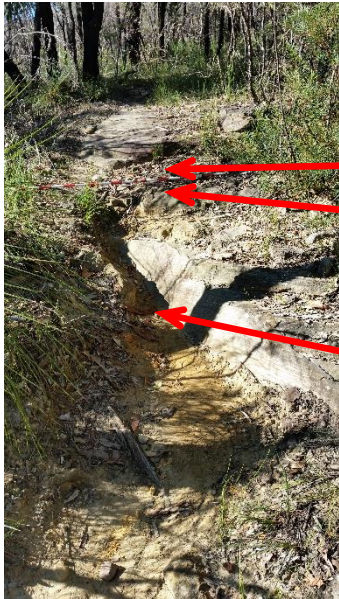
**Site ID: ET – 6(D)**

*Location:* 336952 6263129 Angled rock outcrop/ledge with erosion gutter to 300mm below NSL angled across track, drainage capture and flows down from rock pavement and track upslope.

- Stone lined invert between rock ledges/gutter and upslope pavement.
- Extend in-situ outcrop as single rock step, infill/compact above (with boxed edge for containment, if required) with rock armour/flagging matching back to stone-lined invert.
- Rock infill and level gutter, build onto and match adjacent rock outcrop, with rock step off lower end and armour/flagging tread off/below step.

**(Medium - for both passability issues and sustainability/impact issues)**

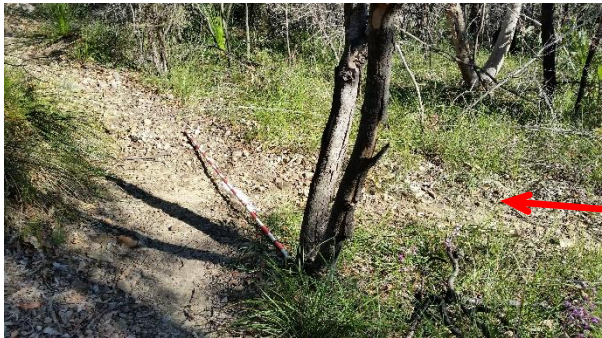
**Site ID: Junction with ET – 7 (E end of segment)**

*Location:* 336996 6263143 Slightly angled T-junction with Segment ET – 7, slightly dished compacted sand and loose stones track 700-900mm wide with drainage down from N to S track (ET – 7) above, no identification or orientation/wayfinding signage.

**(Medium)**

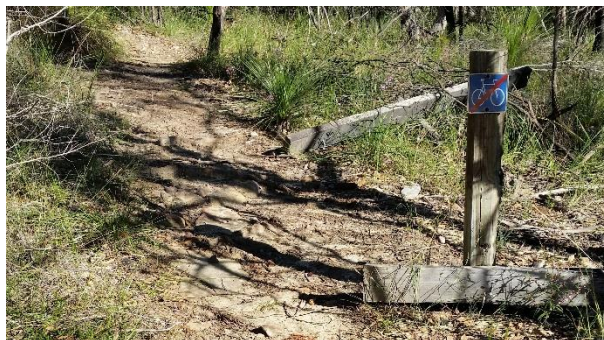
**Site ID: N end of Segment (at pipeline)**

**Location:** 336997 6263153 Trackhead on S side of pipeline midway up hill (access via crawl/crouch under pipe), log post with “no bikes” pictogram (good condition), dis-used/discarded timber sleepers beside track. No Park identification, or track name and orientation/wayfinding, signs.

Relocate/re-use old/discarded sleepers.

**(Medium)**

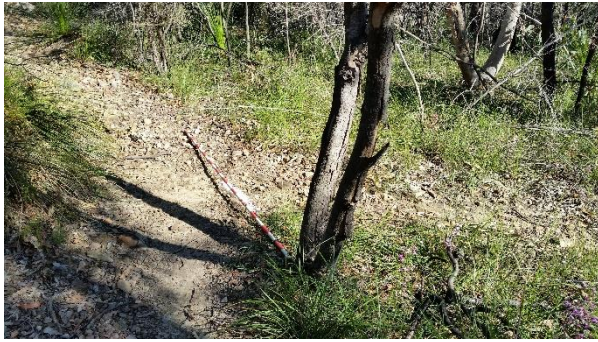
**Site ID: Junction with ET – 6**

**Location:** 336996 6263143 Slightly angled T-junction with Segment ET – 6 (to downslope/W), no identification or orientation/wayfinding signage.

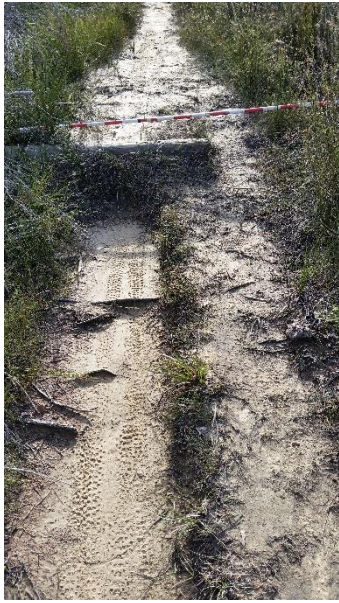
**Site ID: ET – 7(B)**

*Location:* 337085 6263072 Old log waterbar/step, bypassed with track widening.

Replace or extend waterbar/step, and clean out.

Block/disguise widening track (with branch barrier bundles) and rehabilitate.

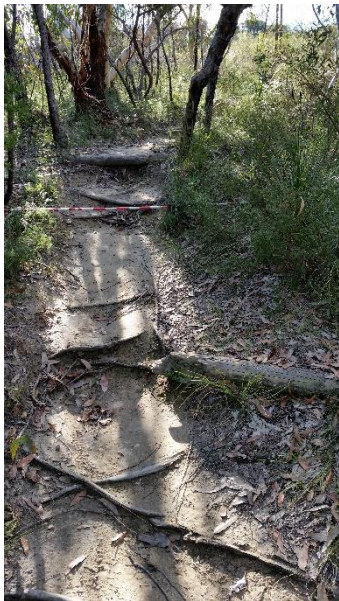
**Site ID: ET – 7(C)**

*Location:* 337094 6263064 top/NW  
337100 6263047 bottom/S

20m section of deeply dished track, to 150mm below NSL, in compacted sand with considerable flows down track, 7° gradient, multiple eroding “knick points” and roots retaining track surface, 600-900mm wide, 4 log waterbars (2 burnt out and 2 failed/full, lowest waterbar on slope has 300mm drop off).

Replace 2 burnt (non-functional) waterbars. 2 new waterbars, spaced between burnt (non-functional) waterbars.

Install 3 waterbars on new alignment (relocate/reuse log waterbars already on site).

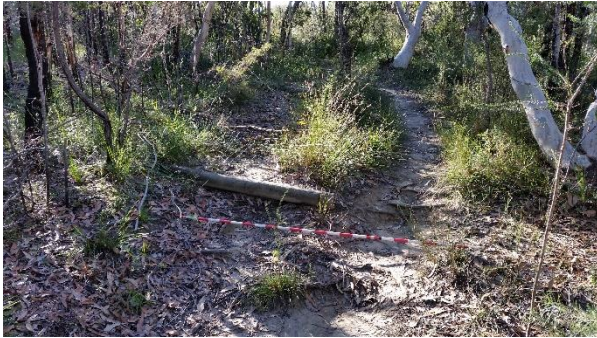
**Site ID: ET – 7(E)**

*Location:* 337115 6263017 2 failed/full log waterbars with track widened/detoured past ends, short steep scoured sand/clay slope (slippery) below lower waterbar onto rock pavement below, drainage capture and considerable flows down track and ponding at lower end.

Replace/reinstate waterbars.

3 boxed rock steps on lower sand/clay slope (below waterbar) with rock armoured treads, pull-in and contain/barrier (rock rubble) adjacent widened/detoured track.

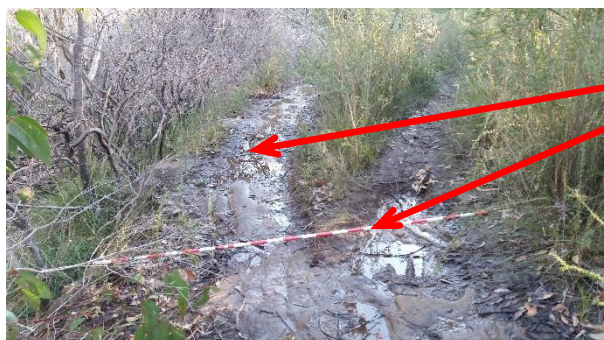
### Site ID: ET – 8(A)

*Location:* 337149 6263024 10m section of dual/braided track, high/N alignment on dished compacted sand with seepage, low/S alignment along edge of low rock ledge/shelf with intercepted seepage and frequent ponding.

Close/block and disguise low/S alignment. Rock waterbar (or broad cut channel) at E end of site, across both alignments, on rock ledge/pavement and discharging to SE over ledge.

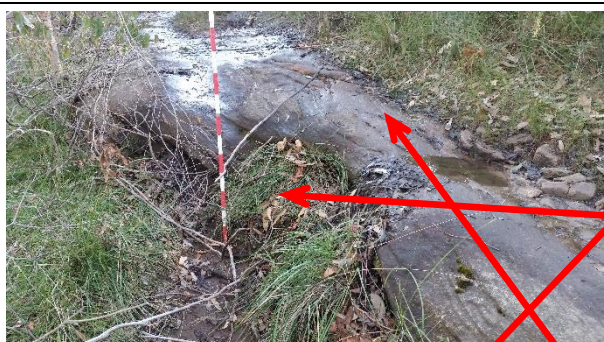
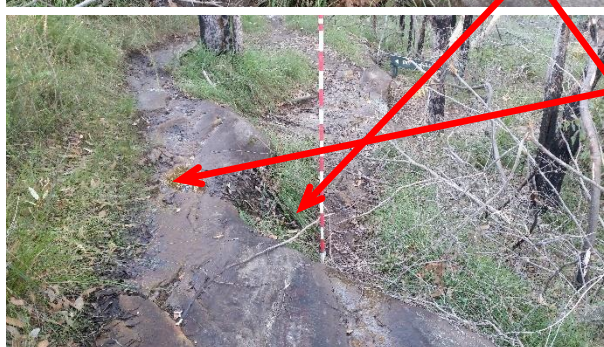
### Site ID: ET – 8(B)

*Location:* 337156 6263027 600mm drop off rounded rock ledge with flows/seepage over edge.

Build 2 rock steps off edge of ledge, boxed/contained on low side and built into continuation of ledge on high side – armour treads, and tread off lowest step, to protect against continued flows/seepage over steps.

Close/block and disguise continuation of ledge to E (on high/N side) no used as alternative alignment to junction with ET- 9.

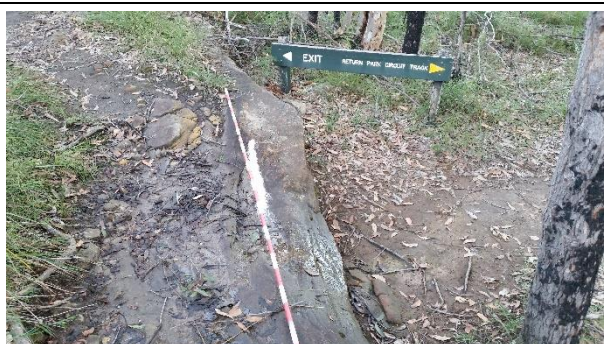
### Site ID: Junction with ET – 9

*Location:* 337161 6263032 T-junction with Segment ET – 9 (off rock ledge downslope/W), small routed timber identification and wayfinding sign (old, fair condition).

See Segment ET - 9 below.

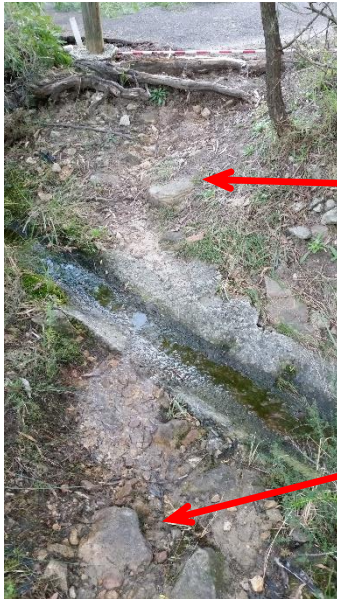
**Site ID: ET – 8(C) and trackhead/entry**

**Location:** 337188 6263044 Short slopes of compacted sand, embedded rock and loose stone and rubble down to rough concrete dish drain, flows down both slopes, steeper/higher E bank also receives run-off from adjacent private road and is more deeply dished also with scouring off end of road pavement and protruding roots. Log post with “walker” and “no bikes” pictograms at entry to track from private road, but post dislodged (poor condition – damaged). No Park identification, or track name and orientation/wayfinding, signs.

Repair existing trackhead signage.

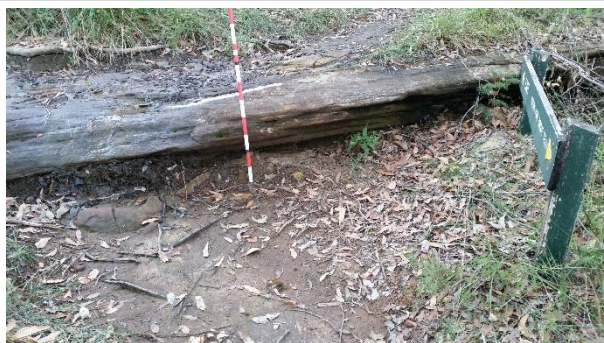
### **Site ID: Junction with ET – 8**

*Location:* 337161 6263032 400mm high rock ledge and track widened to 1,800mm at T-junction with Segment ET – 8 (along top of rock ledge), wide compacted sand track below with drainage off ledge, small routed timber identification and wayfinding sign (old, fair condition).

Upgrade signage as per Manly Dam Sign Location Plan.

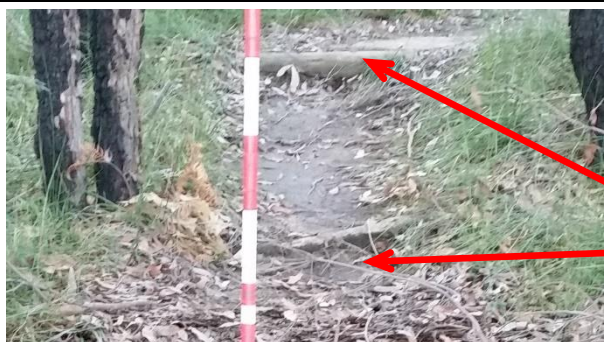
### **Site ID: ET – 9(A)**

*Location:* 337164 6263026 Log waterbar/step, full/failed with flows over.

Reinstate/replace existing waterbar/step and extend outlet to discharge well off track.

Additional waterbar 2-2.5m downslope, with extended outlet to discharge well off track.

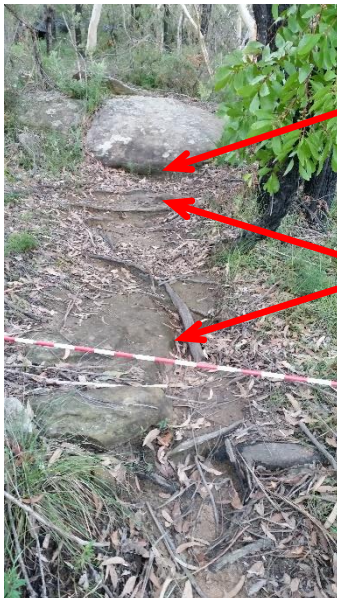
**Site ID: ET – 9(B)**

**Location:** 337164 6263012 10-12m track section curved up/down slope over rock ledge and outcrops/boulders, 8° gradient overall. Low squared rock ledge, 400mm high, at upslope end. Then track runs along upslope side of angled rock outcrop/boulder with drainage flows down track. Large sloping rounded rock outcrop/boulder downslope (with metal directional arrow). Sloped compacted sand track with drainage flows down, and exposed roots and embedded rocks, for 4-5m at bottom of site below rounded rock outcrop/boulder.

Rock armour/flagging to infill/level track surface between embedded rock and outcrops.

Build rock waterbar onto in-situ outcrop (discharge to SE, with extended outlet to

discharge well off track and prevent backflow if required).

Rock armour/flagging to infill/level track surface between embedded rocks, and/or to reinforce “natural” steps – where required.

Install marker post at power pole stay wire pole – to highlight as trip hazard.

Set infill rock onto outcrop on downslope side of stay wire anchor point to square off as step (levelled to adjacent in-situ rocks).

Open/reinforce gap between outcrops, to “catch” and redirect surface flow, and rock armour/flagging for protection.

Build rock waterbar off high side of lower rock outcrop, discharging to SE.

Build rock step off lower side of rock outcrop, below waterbar, and match to rock outcrop, rock armour tread off step.

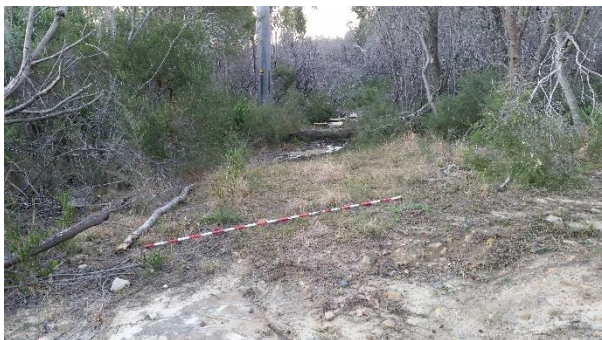
**Site ID: Trample track to fire trail via power pole**

Well-used trample track, and drainage/discharge line, E from Eva’s Track linking though to fire trail (at bend), widens at E end as service access to power pole, wet boggy dip in centre of link.

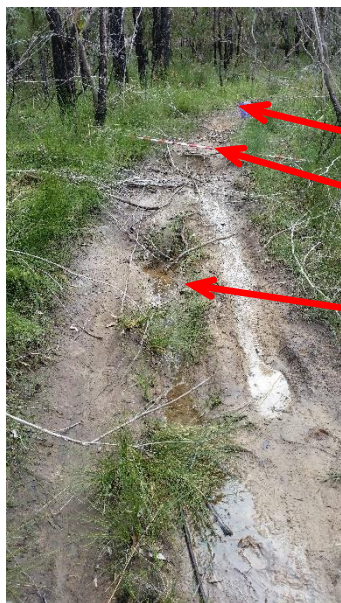
**Site ID: ET – 9(D)**

*Location:* 337150 6262970 Clay/sandy track, retaining roots at top and dual/split track on slope with ponding at bottom, 1,200mm wide, drainage capture and flows down, ongoing erosion, slippery when wet.

3 step-and runs with filled/compacted treads, boxed edges for containment, and with regular “wings” to prevent/divert flows down/around sides. Pull-in track width, disguise/rehabilitate and block/barrier (such as with rock rubble) redundant track.

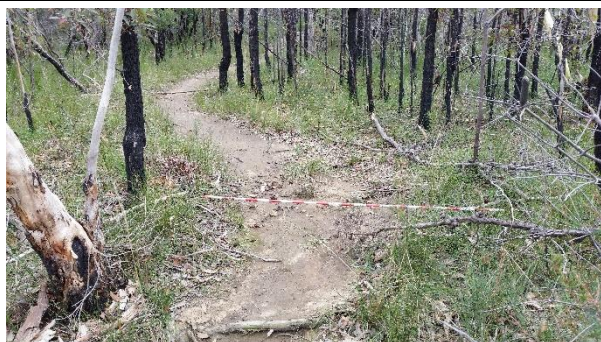
**Site ID: ET – 9(E)**

*Location:* 337160 6262952 Compacted clay/sand 1,00mm wide on bend, drainage capture and sheet flows down track.

Waterbar on bend.

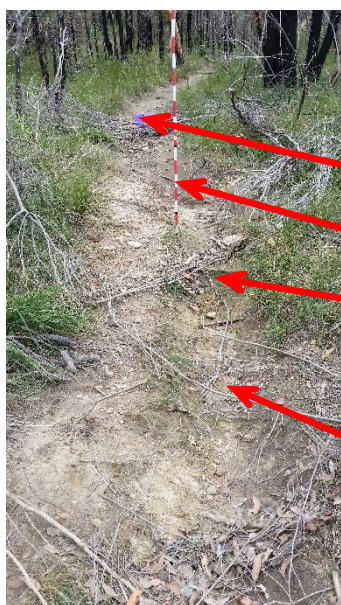
**Site ID: ET – 9(F)**

*Location:* 337162 6262938 Slope of deposited/loose sand and buried stones/rocks with central gutter 600mm wide eroded 200-300mm below NSL, 2 knick points, or “cascades”, into eroded plunge pools, area of loose/depositional sand on bend downslope below.

Short boxed step-and-run below lower plunge pool.

<p>Pull-in track width, disguise/rehabilitate and block/barrier (such as with rock rubble) redundant track surface.</p> <p>Waterbar on bend below (to divert flows and protect treatments at downslope site ET – 9(G)).</p> <p><b>(Medium - for both passability issues and sustainability/impact issues – and monitor for need for rock armouring/flagging on extended treads, if drainage issues persist and compaction is problematic)</b></p>

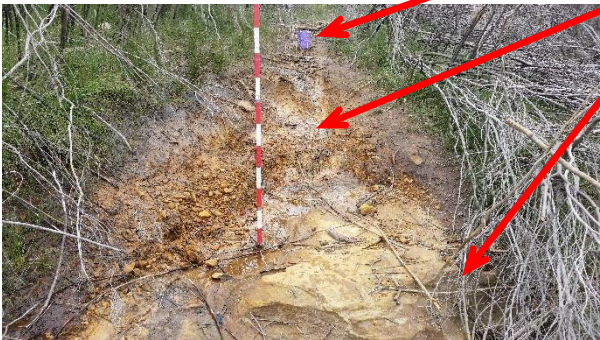
<p><b>Site ID: ET – 9(G)</b></p> <p><i>Location:</i> 337157 6262925 Steep 700mm high slope eroding into a lobe of clay and stones onto exposed rock outcrop/pavement below, eroded to 400mm below NSL, drainage capture and considerable flows down, remains of galvanised pipe (former waterbar/step ?).</p> <p><i>Works:</i></p> <ul style="list-style-type: none"> <li>Waterbar above to catch/divert flows, discharging to S.</li> <li>4 rock steps on erosion slope, anchored onto rock pavement below.</li> <li>Open low side windrow below steps, to allow free drainage off rock pavement.</li> <li>Disguise and stabilise/rehabilitate redundant track surface on slope, and block/barrier (such as with rock rubble) to prevent avoidance/detouring.</li> </ul> <p><b>(Medium - for both passability issues and sustainability/impact issues)</b></p>

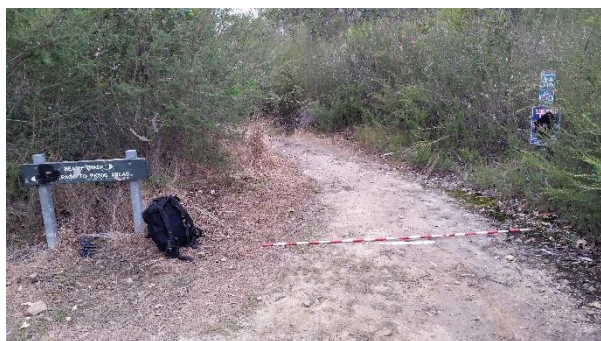
**Site ID:** Segment start, south-eastern trackhead

*Location:* 337718 6262143 Large routed timber identification and wayfinding sign (fair condition - vandalised/graffitied), and post with “walkers” and “no bikes” pictograms (good condition) and “Track Closed to Bikes” regulatory sign (poor condition only - vandalised/graffitied and partly illegible). No orientation information.

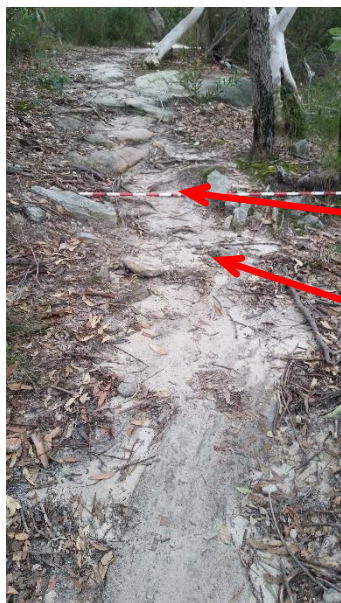
**Site ID:** HT – 2(A)

*Location:* 337741 6262087 Embedded rocks and tree roots at bottom of sloped rock outcrop, with drainage capture and flows down.

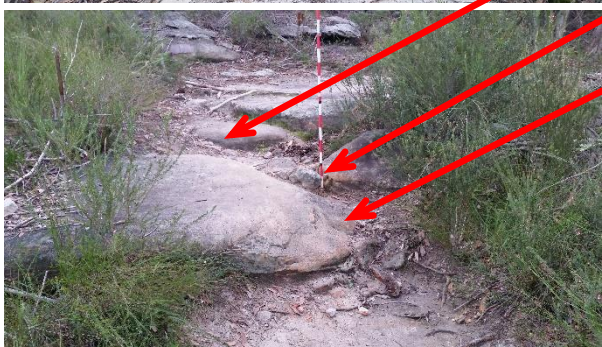
**Site ID: HT – 2(C)**

**Location:** 337726 6262043 Rock pavement above sloped curve, 10° gradient, with rock outcrops/boulders and embedded protruding/rounded rocks, compacted sand, drainage capture and flows down, 6m overall.

Build rock step off rounded lower outcrop/boulder, with boxed edge on low side for containment, and rock armour landing/tread below.

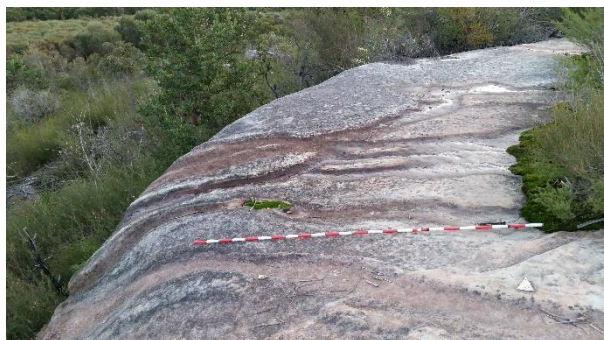
### **Site ID: HT – 3(A)**

*Location:* 337722 6262021 Rock ledge/pavement with drainage channels (with seepage at many times) and slightly sloped uneven surface, adjacent to edge with drop of +2m, directional arrow on pavement, moss and low heath over pavement on upslope side.

Edge/fall hazard warning signs (low-key pictogram style) required on approaches from both sides.

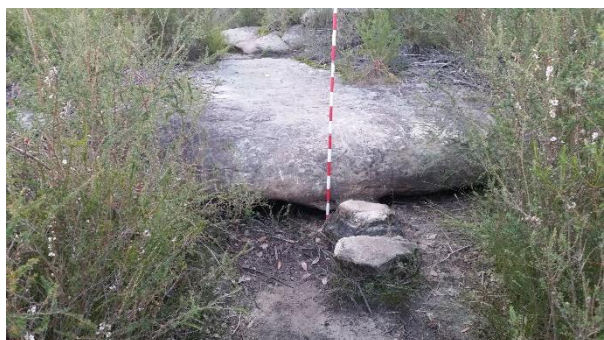
### **Site ID: HT – 3(B)**

*Location:* 337704 6262028 Abrupt rock ledge 900mm high with 2 placed rock steps/pedestals, but track widening through step avoidance.

Install edge definition and containment/barrier (rock rubble) to track to prevent avoidance/widening.

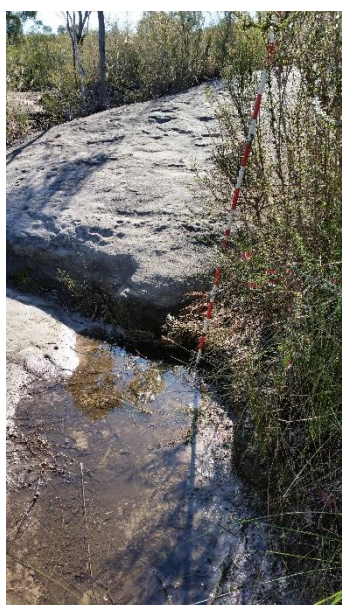
### **Site ID: HT – 3(C)**

*Location:* 337649 6262038 Sloped rock outcrop/ledge (15° gradient) with 400mm step off bottom edge, track below benched into slope to 200mm deep on high side with ponding of flows off rock ledge.

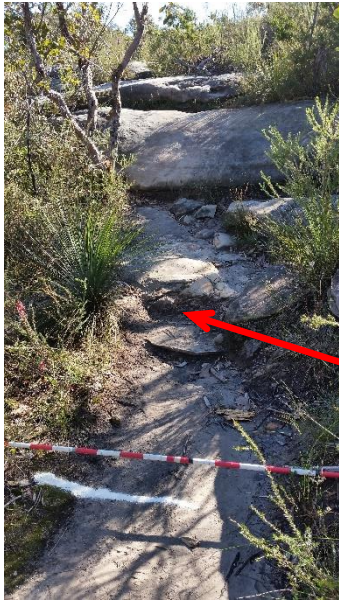
**Site ID: HT - 4(A)**

**Location:** 337584 6262064 Drainage down/over rock outcrop and crumbly embedded rock, compacted sand track and rock pavement for 3m upslope to a steeply sloped rock ledge 1,200mm high and 2,400mm wide (walkers grab adjacent small Eucalypt to assist them up/down ledge, steep and slippery due to film of dry sand), low rock ledge and high "natural," step above.

Build wide rock step off upper rock ledge.

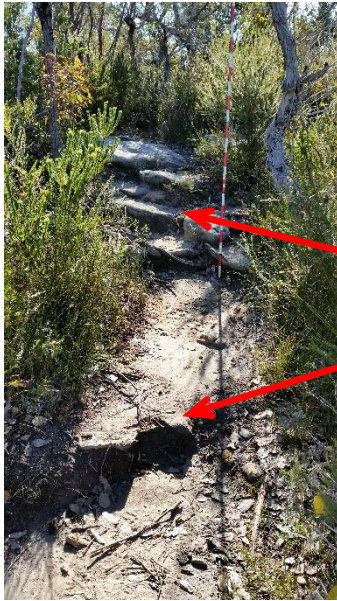
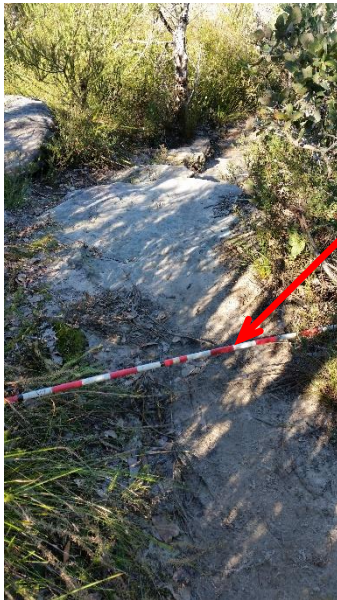
**Site ID: HT - 4(B)**

**Location:** 337551 6262076 Angled sloping rock outcrops and small ledges plus embedded rocks, protruding roots, drainage capture and flows down, 11° gradient overall.

Waterbar abutting off low rock outcrop beside track 2.5m above/upslope of main rock ledge (also to catch divert flows from next site HT – 4(D) upslope).

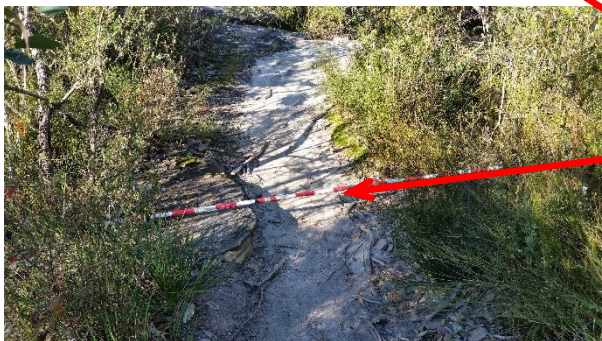
**Site ID: HT - 4(D)**

*Location:* 337534 6262082 Series of rock ledges/outcrops over 11m on a slope of 9° gradient, 2 large lower ledges with central channel and placed stone step below then roots retaining slope/step of compacted sands below, considerable drainage capture and flows down, upper area of large embedded ricks with rock bench/pavement above with drainage capture and flows down from pavement (track bends to N/NW on crest).

Install edge definition and containment/barrier (rock rubble) to track to prevent step avoidance and track widening, and to align track for steps upslope.

Reinforce existing rock step, and infill level gutter with 2 new rock steps and armoured treads (to harden steps against continued flows over ledges), cut/level adjacent ledges as required to widen/extend steps.

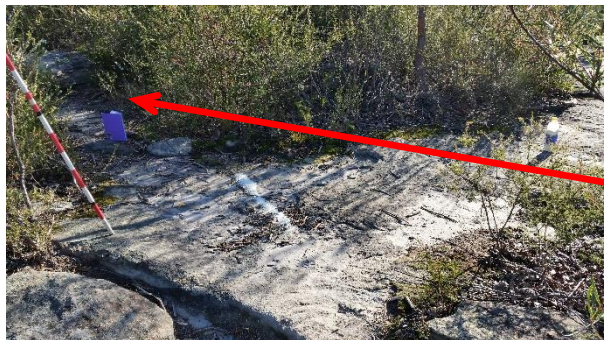
##### **Site ID: Segment 4/5 junction on crest**

**Location:** 337528 6262081 Segment start/end point at track junction on crest and rock pavement. Directional arrow on rock pavement indicates SW to former “official” track alignment onto/around low rocky knoll, but far more heavily used (and more apparent/logical) track leads NW along rock pavement and down rock ledges and “natural” rock steps to NW. Former “official” track heads SW from junction to curve around rocky knoll, but is indistinct in places and not well-used, to rejoin the NW “as-used” track (at 337505 6262098) on NE slope of knoll.

Remove arrow at junction (and replace with directional sign to SW track as “lookout access” – see Site HT - 5(A) below).

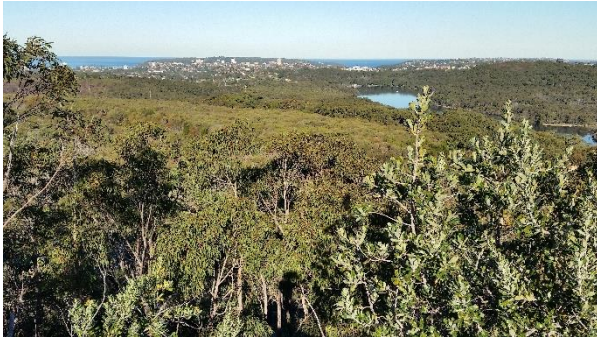
**Site ID: HT – 5(A) lookout**

*Location:* Informal track to lookout point, SW from start of Segment 5 (337528 6262081) (first 10m approx. is part of former “official” track alignment) to lookout on end of rocky point (337512 6262059). Informal track is predominantly along edge of level/undulating rock ledge (face of ledge is stepped, so negligible fall hazard) to lookout offering very good views SE to SW – over park/dam, Manly, ocean and North Head, City high skyline, and Chatswood CBD).

Install directional sign to lookout/track at junction with main Heath Track.

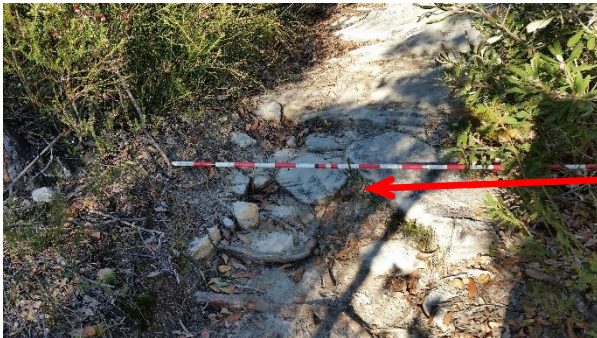
**Site ID: HT – 5(B)**

*Location:* 337497 6262107 Rock outcrop with broken/crumbly lower edge.

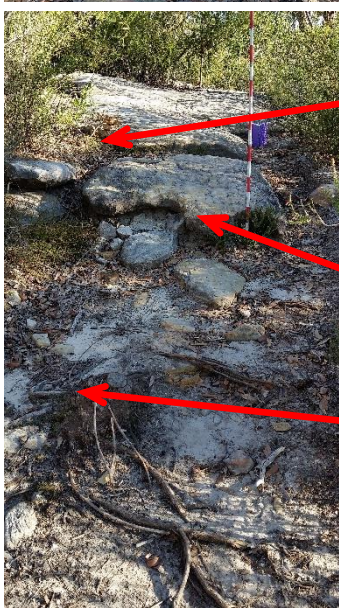
**Site ID: HT – 5(D)**

*Location:* 337497 6262125 Sloping tessellated rock outcrop with 400mm step off, with placed rock step but irregularly shaped and loose/unstable. Old dis-used track runs N/NW off lower side of outcrop and continues downslope below, and also acts as (and appears as) a drainage discharge.

Formalise and widen rock step off lower outcrop.

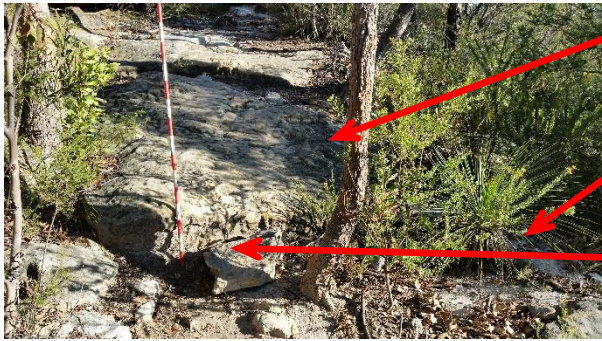
**Site ID: HT – 5(E)**

*Location:* 337515 6262140 2 large sloped/smooth rock outcrops on bend with moderate slope, compacted sand slope with rubble and roots between outcrops large boulder and grass tree to E of bend, embedded rocks then compacted sand track at base, drainage capture and flows down.

Install edge definition and containment/barrier (rock rubble) to track to prevent avoidance/widening

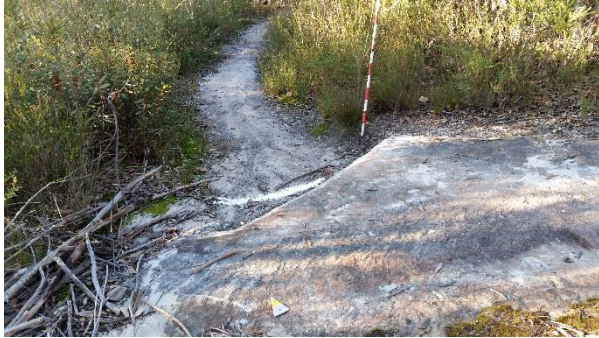
**Site ID: Segment end**

*Location:* 337511 6262149 Faint little used track joins main Heath Track from W - links back to site HT – 5(D), metal directional arrow on rock pavement (indicating bend in Heath Track), evidence of previous attempt to block/disguise faint track.

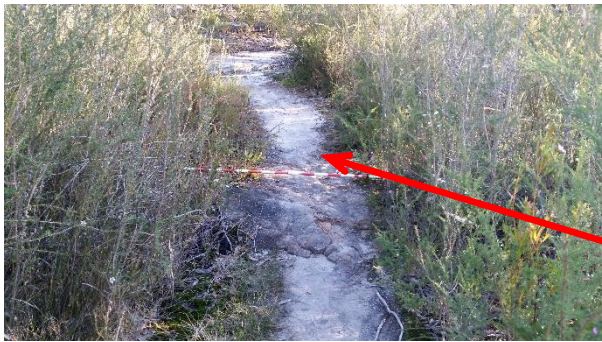
**Site ID: HT – 6(A)**

**Location:** 337513 6262154 Low rock outcrop in dished track of compacted sand, considerable flows down track from segment HT - 5 upslope.

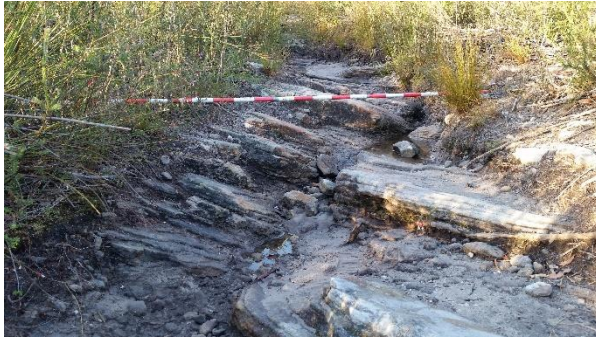
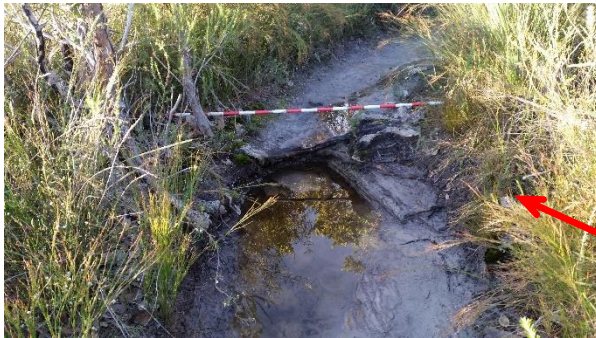
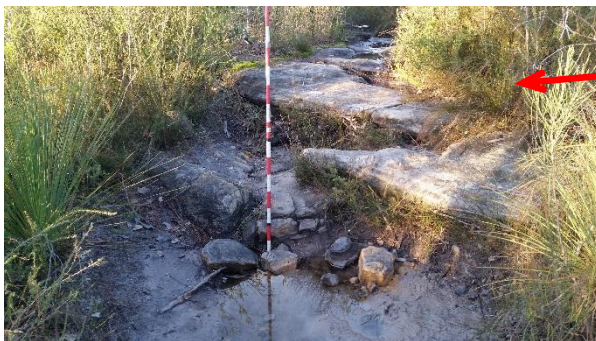
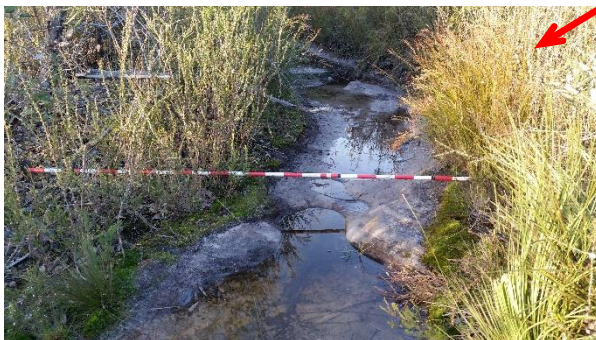
**Site ID: HT – 6(B)**

**Location:** 338278 6261587 bottom/SW  
338276 6261578 top/NE

27m section of guttered track with series of angled and sloping low rock ledges, exposed/protruding roots, embedded/loose rocks and intervening areas of compacted and loose sand - 800-1,400mm wide.

Extensive drainage capture (including intercepted seepage from upslope side of track) and flows down track, erosion and nick-point scouring with gutters to 300-400mm below NSL, considerable ponding. Lower/SW 16m, and upper/NE 6m, are worst. Area of loose/deposited sand below.

Alternative treatment, if fill cannot be provided to site – install timber waterbar at shallow point, extend waterbar and excavate discharge channel to match NSL and allow free outflows (waterbar acts as a holdpoint for progressive sediment infilling of erosion gutter above, but is also a minor trip hazard until filled).

**(Medium – for passability and sustainability/impact issues)**

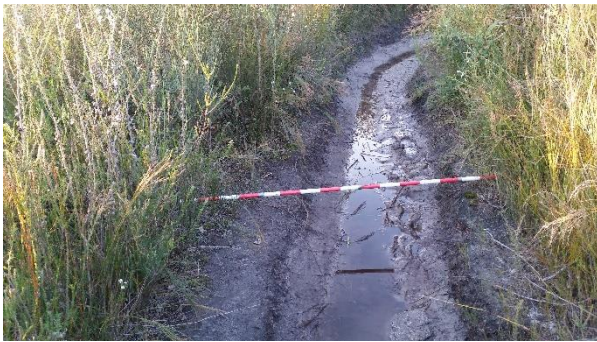
**Site ID: HT – 6(D)**

*Location:* 337569 6262188 Root angled across track eroded to 150mm below NSL, eroding nick-point and ponding downslope to 400mm below NSL. Smaller retaining root and ponding area 1.5 m upslope.

Same waterbar and step treatment at root/ponding site 1.5m upslope – but with single rock step only.

**(Medium – for passability issues)**

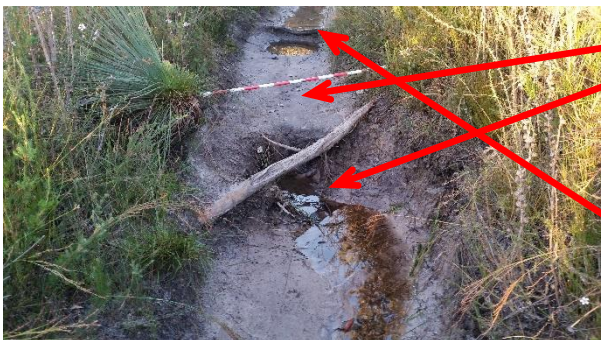
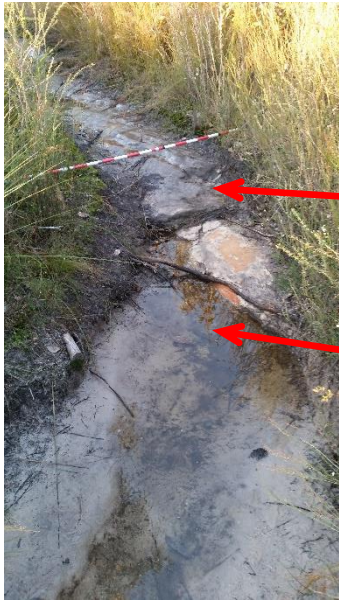
**Site ID: HT – 6(D)**

**Location:** 337577 6262189 Rounded rock pavements with ponding area below on bend, to 150mm below NSL.

**(Medium – for passability issues, and to divert surface flows and seepage before entrenched section of track and sites downslope)**

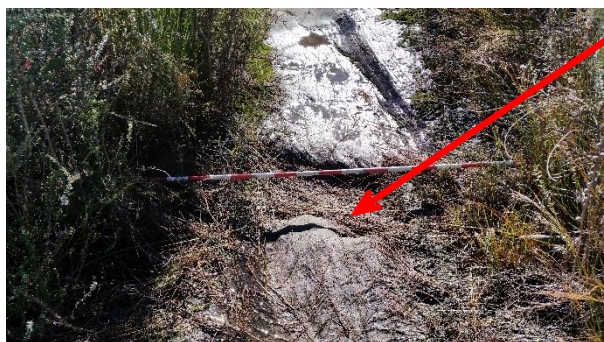
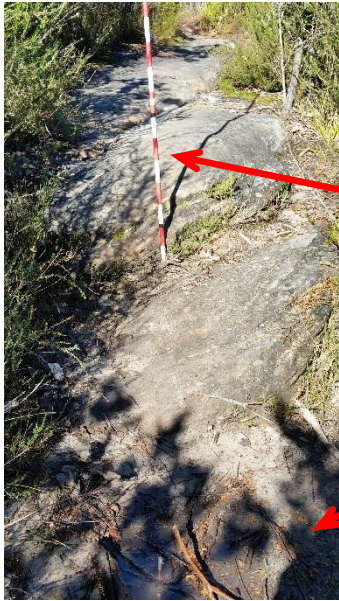
**Site ID: HT – 7(B)**

*Location:* 337577 6262213 Angled rock ledges (x2) diagonally across track, 300mm drop off middle ledge. Ponding on track past/downslope of ledges.

Open windrows on low side of track past/downslope of ledges.

**(low)**

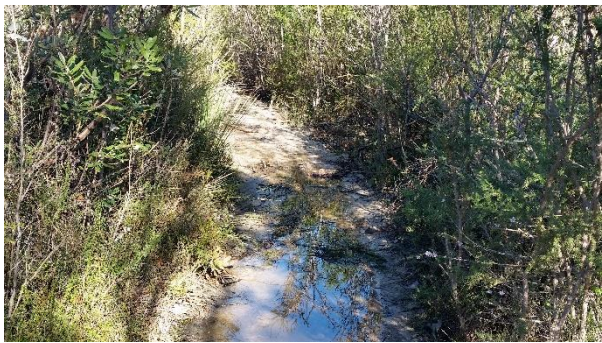
**Site ID: HT – 7(C)**

*Location:* 337582 6262219 16m section of flat compacted sand track, dished with windrow low side, drainage along track from both ends of site, extensive ponding.

Cut 2 broad shallow invert/spoon drains in rock pavement above site, at 2m and 4.5m above upper ledge (caution required in cutting inverts across pavement to avoid trip hazard).

Open windrow on low side of track to drain ponding area (infill and compact if required after windrow opening) and armour tread off last built step.

**(Medium – for passability issues)**

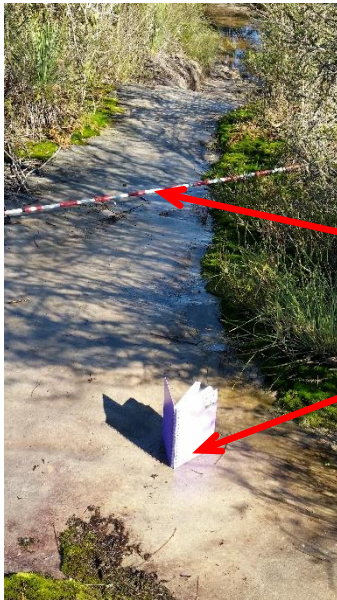
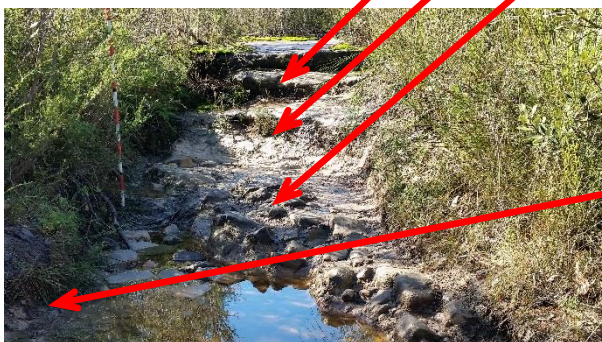
**Site ID: Segment junction (7/8), and un-named track junction**

*Location:* 337612 6262276 Track junction on wide rock pavement, Heath Track turns +90° runs S/SW to SE, and well-used un-named track joins from N/NW. Heath Track route (bend) marked by 2 directional arrows on pavement.

Upgrade wayfinding signage at junction.

**(low)**

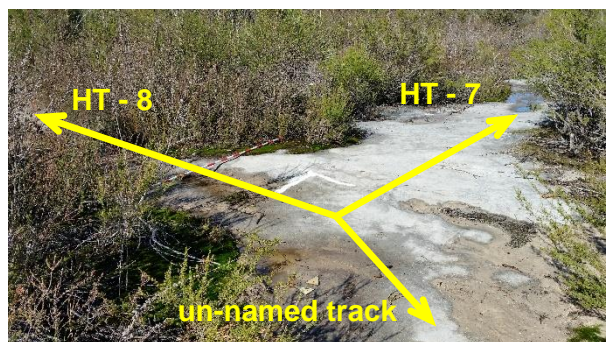
##### **Site ID: Segment junction (7/8), and un-named track junction**

**Location:** 337612 6262276 Track junction on wide rock pavement, Heath Track turns +90° runs S/SW to SE, and well-used un-named track joins from N/NW. Heath Track route (bend) marked by 2 directional arrows on pavement.

Upgrade wayfinding signage at junction.  
**(low)**

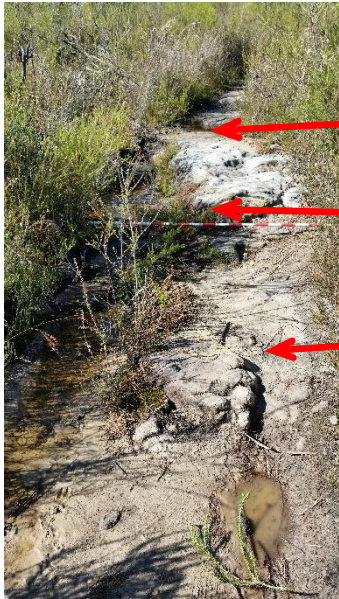
**Site ID: HT – 8(A)**

*Location:* 337617 6262273 Outcropping and embedded rocks with broken/uneven edges and surfaces, 3° gradient with drainage/flows down and minor ponding, track widening to 1,500mm.

Install edge containment/barrier (rock rubble) to track to prevent avoidance/widening.

**(low)**

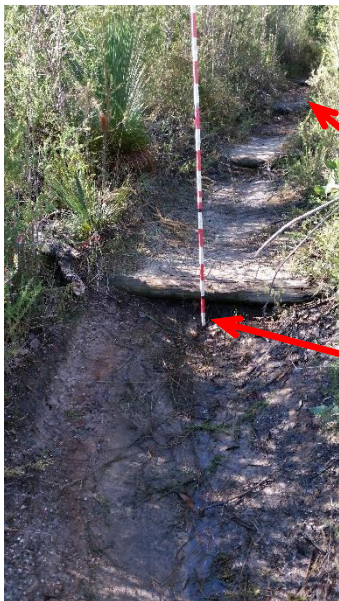
**Site ID: HT – 8(B)**

*Location:* 337654 6262263 Run of log steps on 5° gradient, all full/failed with drainage over and flows down track, lowest log step has a 400mm drop off low side and dished track below to 200-300mm below NSL.

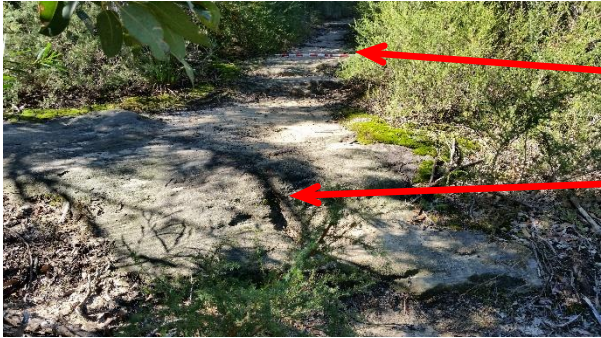
**Site ID: HT – 8(C)**

*Location:* 337668 6262262 Stepped rock outcrop with slight slope, and rock pavement with low ledges above. Located off SW corner of tennis courts, informal well-used track joins from N/NW and runs along W side of courts.

Waterbar or stone lined invert upslope of stepped low ledges, extend outlet to prevent backflow onto track.

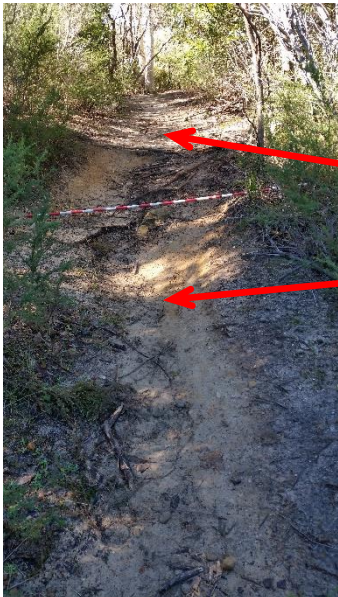
**Site ID: HT – 8(D)**

*Location:* 337681 6262258 Dished track of compacted sand/clay, roots and embed rock on 5° gradient, drainage flows down.

Waterbar above slope to catch/divert flows.

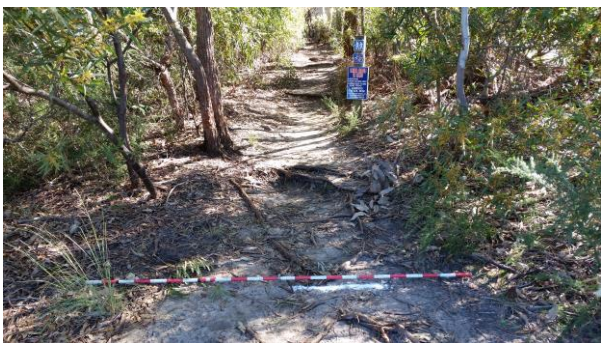
**Site ID: Segment end, northern trackhead**

*Location:* 337722 6262241 Trackhead off Allambie Heights management track (from Roosevelt Avenue) at SE corner of tennis courts, track surface of compacted sand and stepped roots with grass to service trail in E. Post with “walkers” and “no bikes” pictograms and “Track Closed to Bikes” regulatory sign (good condition). No track name/identification or orientation information.

Upgrade signage – track name/identification or orientation – as per Manly Dam Sign Location Plan.

**(Medium)**

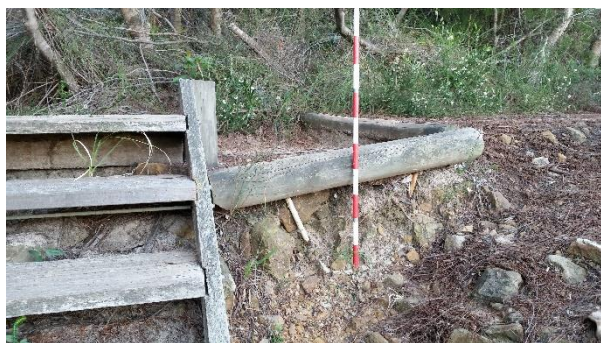
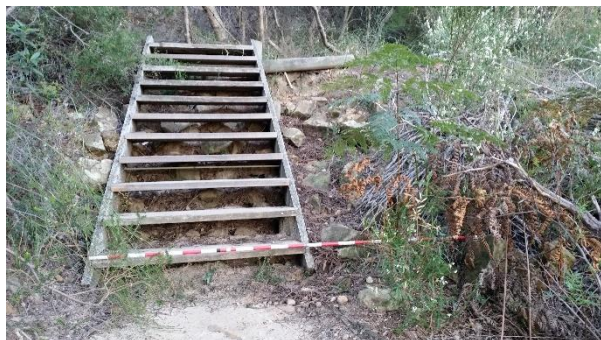
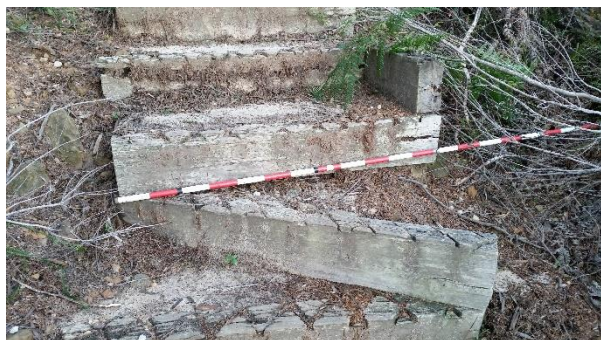
*Location:* 338496 6260830 11 timber stairs off-ground, 1,200mm wide - fair/good condition but upper landing undercut on low side. 19 timber steps, most boxed but some open-sided, 900-1,200mm wide – fair condition. 3 log waterbars, all full and ineffective. Flows over/down steps, some side scour, and washout of some open-ended steps. Steep 20.5° gradient. Log post with small pictograms (“walkers” and “no bikes”) at base of steps. Three well-used trample tracks radiate from base of steps – NW to dam shore, SE to below dam wall (semi-formal track), and E/NE along contour then gradually upslope. None signposted.

Replace undercut log edge to upper landing with rock retaining wall and armour landing (**safety issue**). Timber “wing” at base of stairs to divert flows down along/side.

Box in eroded open-ended steps with rock or timber, fill/level and compact. Timber “wings” off side of steps to divert side flows/scour – at least 2 wings on upper, and 2 on lower, run of steps. Extend and fill lower 3 steps.

**(HIGH)**

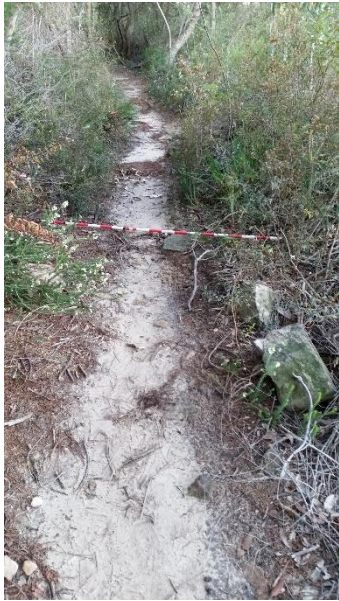
**Site ID: PCT(E) – 1B**

*Location:* 338499 6260848

*Works:* Waterbar (can use excess rock from nearby quarry site – if no heritage constraints)

**(Medium – for additional drainage protection for stairs and steps at site PCT(E) – 1A downslope)**

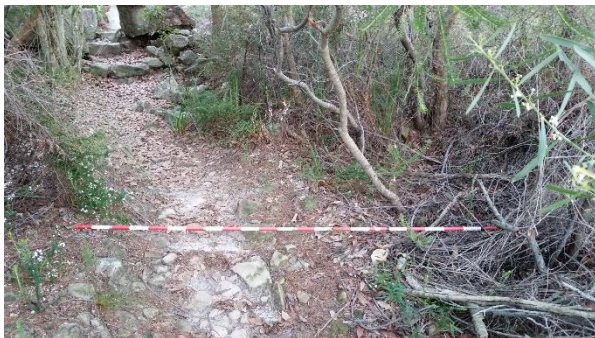
**Site ID: PCT(E) – 1C**

*Location:* 338504 6260859

*Works:* Waterbar (can use excess rock from nearby quarry site – if no heritage constraints).

**(low)**

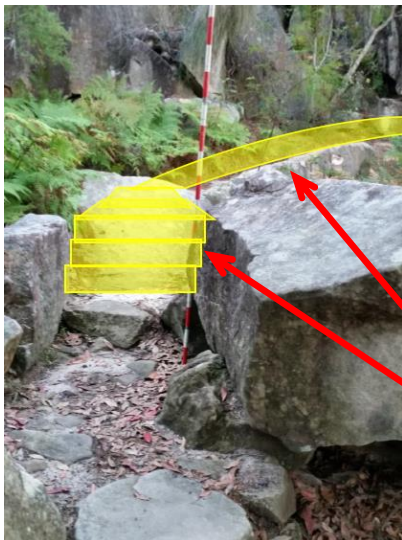
**Site ID: PCT(E) – 1D**

*Location:* 338507 6260871 Cut rock ledge 600-900mm wide, uneven, curved and sloping down to SW for 7m then large angled rock slab 2.5m long. Rock face and boulders on high side, drop 800-1000mm to cut/broken rock and bracken on low side. Cut boulders and 3 “natural” rock steps at S/SW end over 5m. Large rounded rock/ledge at NE end, steep 700mm face to track. Gentle/moderate 9.5° overall gradient.

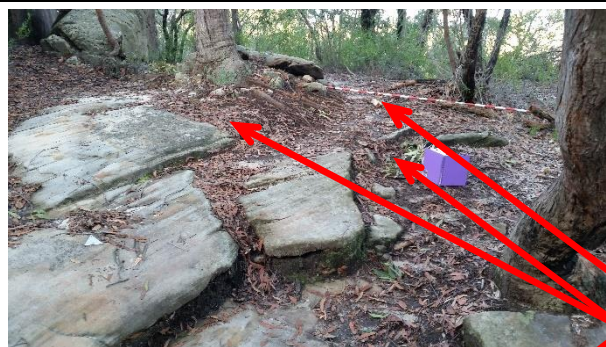
Probable former quarry site, possible interpretive interest.

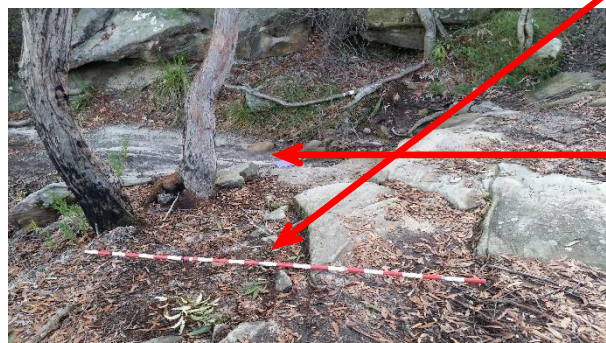
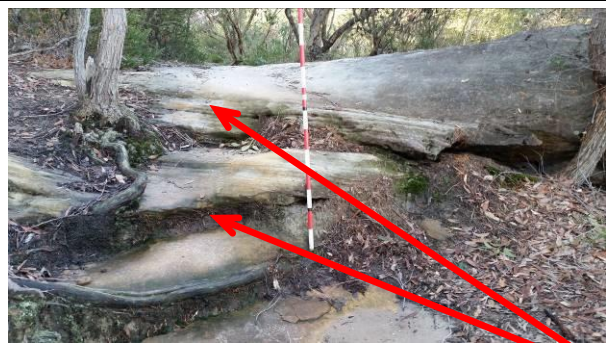
**Site ID: PCT(E) – 1E**

*Location:* 338526 6260911 Braided track around tree and angled boulder (lower route more regularly used), then 5° slope over angled outcrops, and down 2 natural rock steps into small flat sandy drainage line.

Close/block and rehabilitate upper track (less used).

**(low)**

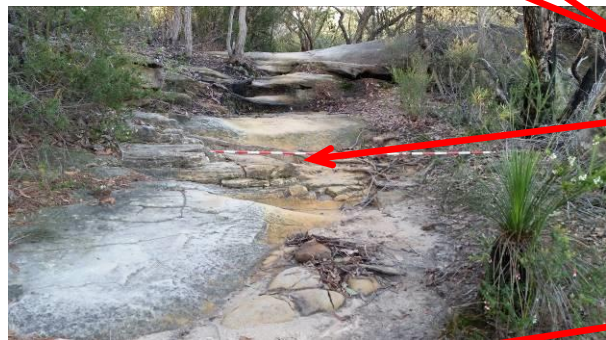
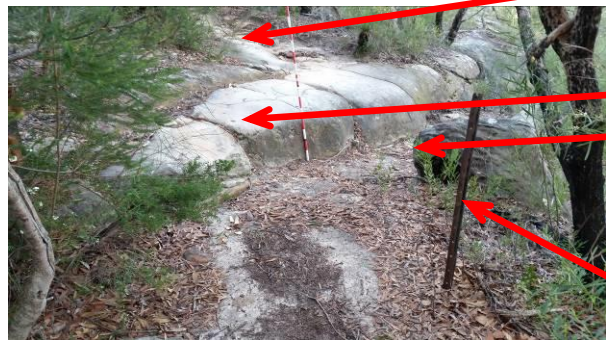
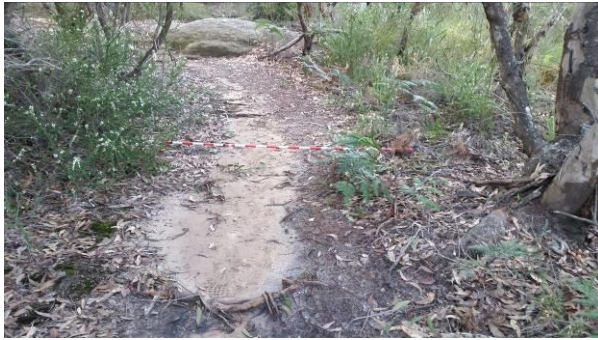
**Site ID: PCT(E) – 1F**

*Location:* 338536 6260927 Series of rounded rock ledges above (stepped to 900mm high), sloped rock pavements with embedded/broken rock and roots and loose sand, then lower rounded rock ledge 500mm high. 8° gradient, with considerable drainage capture and flows down track. Track width varies from 600 to 2,200mm.

3 step-and-runs (with compacted fill) built onto sloped/broken outcrop, with edge containment/definition to track. Fill upper tread to natural surface level and armour with stone-lined invert draining to E (or waterbar as alternative).

Remove star picket beside track below lower rock ledge.

**(HIGH - safety issue).**

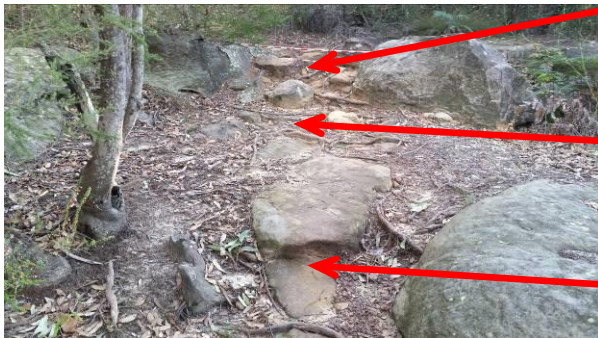
**Site ID: PCT(E) – 1H**

*Location:* 338523 6260946 Sculpted upper rock outcrops, with embedded rocks and roots and flatter/rounded outcrops on slope below. 8° gradient, with considerable drainage capture and flows down track. Eroded to 300mm below NSL. Trample track heads E along rock shelf to APZ, not signposted.

2 stone steps built onto flatter outcrops on lower section.

**(Medium).**

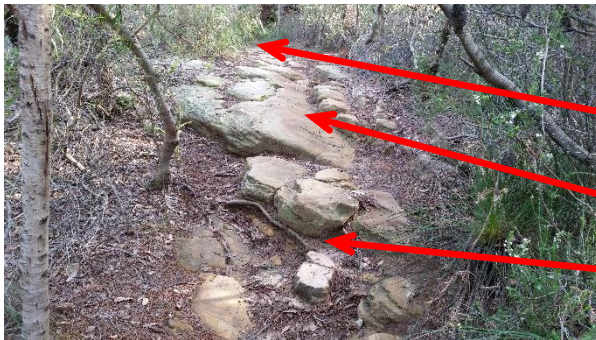
#### Site ID: PCT(E) – 2B

Location: 338493 6260924 Angled rock outcrop, moderate slope at 10°, 1,500mm wide, broken/embedded rock at base, drainage capture and flows down track

2 boxed step-and-runs, with compacted fill, over broken embedded rock at base of outcrop.

Edge containment/definition to track.

(low).

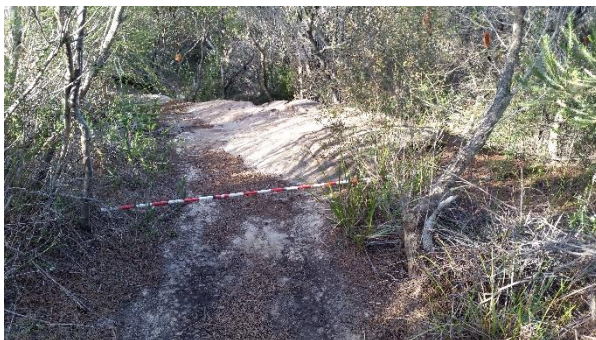
#### Site ID: PCT(E) – 2C

Location: 338482 6260919 Sloped rock outcrop, 1,200mm high

Cut 3 steps into sloped rock face, and build 3 stone steps onto base of outcrop with edge containment/definition to track.

(Medium)

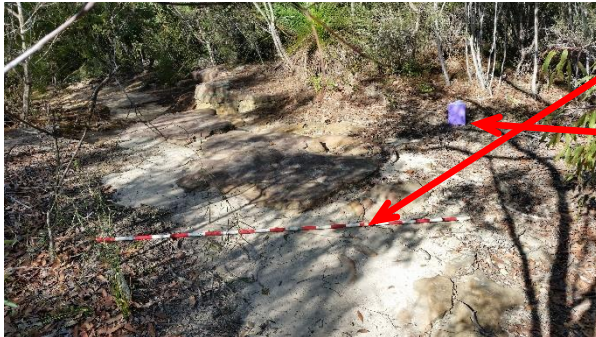
**Site ID: PCT(E) – 2E**

**Location:** 338425 6260926 “Natural” embedded rock steps and angled outcrop, moderate 12° gradient, with flat rock outcrops above. Some drainage down track over rock steps/outcrops.

Block/barrier (with embedded rock) ends of two in-situ “natural” rock steps.

**(low)**

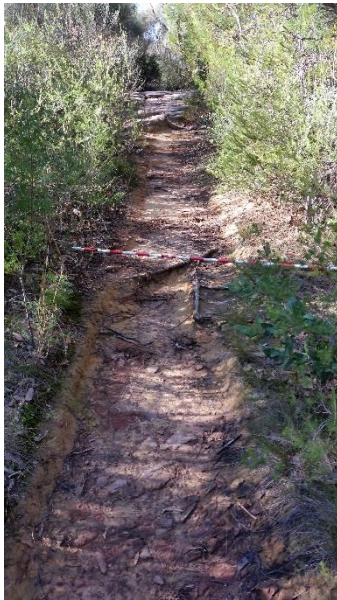
**Site ID: PCT(E) – 2F**

**Location:** 338396 6260917 Entrenched track 100-150mm deep, 700-900mm wide with occasional roots, gentle/moderate 6° gradient.

Block chute to S of boulder with embedded rock to minimise erosion around side.

**(low)**

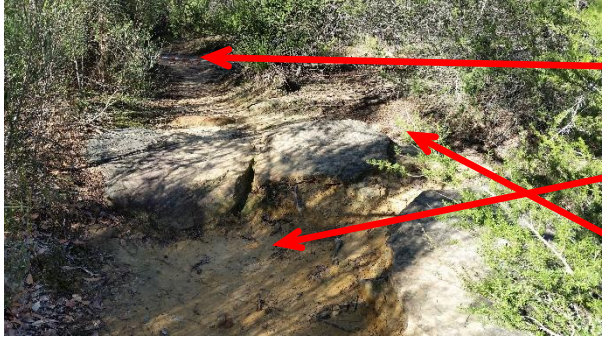
**Site ID: PCT(E) – 2H**

*Location:* 338378 6260920 Gutter 100-150mm deep through embedded rocks, and exposed rock pavement below, gentle/moderate 6° gradient.

2 step-and-runs (stone preferably, or timber) infilled with gravels and compacted fill upslope to NSL, and waterbar above.

**(low)**
