# MANLY DAM WALKING TRACKS AUDIT

for  
**Northern Beaches Council**  
May, 2017

CONTROLLED DOCUMENT  
**“Manly Dam Walking Tracks Audit”**

**FINAL ISSUE**

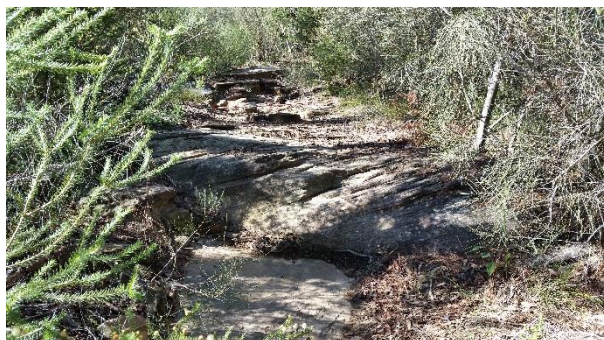
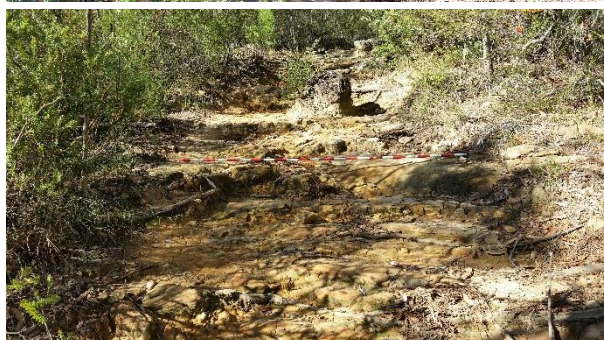
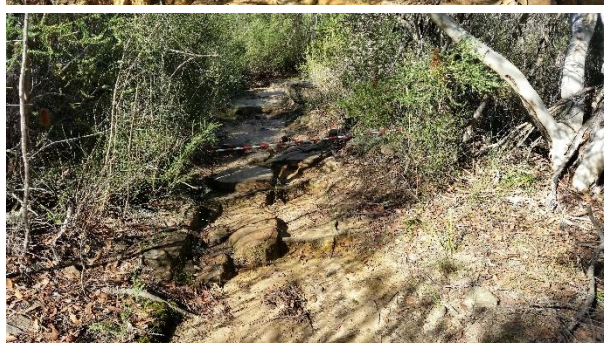
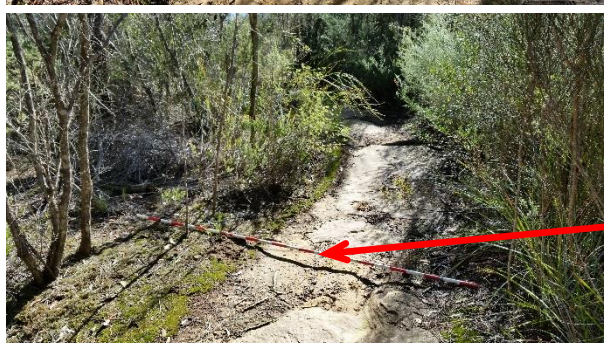
### Site ID: PCT(E) – 3A

Extended section of track directly up/down moderate slope (8-12°), with gentle/moderate slope at top (4-5°). Total length 96m (approx.). Eroded track 900-2,400mm wide over rock ledges/outcrops and embedded rocks, with compacted sandy/clay plus some laterite gravels and exposed roots. Significant drainage capture and flows down, erosion to 300mm below NSL in places with occasional remnant rock “pedestals” and smaller broken embedded rocks on upper section, with rock pavement at top. Approximate total change in elevation of 14m. No existing infrastructure or improvements (other than metal directional arrows on rock outcrop at base of slope).

- 28 stone steps – built onto in-situ rock ledges/outcrops (3 steps could be cut into existing rock ledges);
- 17 stone steps – as stand-alone step/steps;
- 11 waterbars (some could be combined with the above stand-alone steps);
- 2 stone lined inverts;
- 2-3 block/fill side scour channels;
- rock armouring of sloped sections with loose stones/rocks (10m approx.); and
- pull-in wide/braided section of track and provide edge containment/definition, rehabilitate flanks where required.

Stone-lined invert built onto in-situ rock/pavement, at top of site.

**(HIGH - for both passability/safety issues and sustainability/impact issues)**

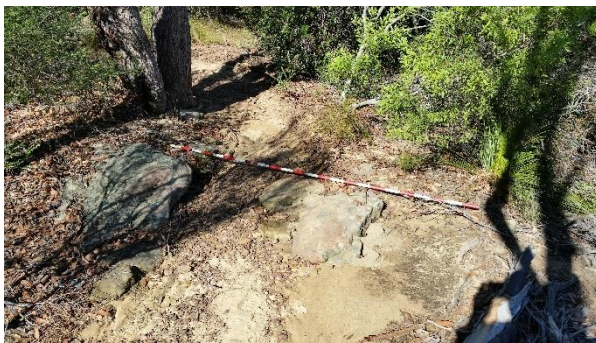
**Site ID: PCT(E) – 3C**

*Location:* 338282 6260962 Flat rock outcrops, sand and gravel/stone - with run on form site above (PCT ( E ) – 3A).

Waterbar, built off in-situ rock outcrops.

**(low)**

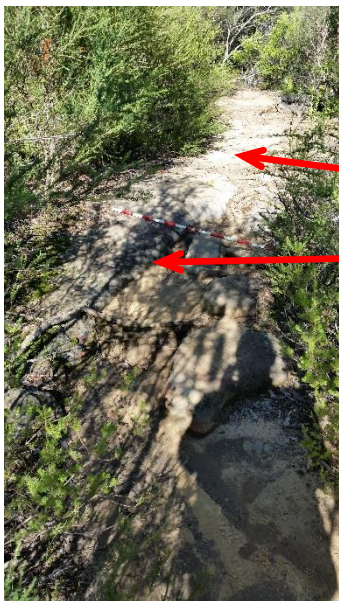
**Site ID: PCT(E) – 3D**

*Location:* 338280 6260969 Rounded flat rock outcrops with central gutter/trench 100-200mm deep.

Stone step at bottom of trench, between rock outcrops, an fill/compact trench above (rock armour if required).

**(low)**

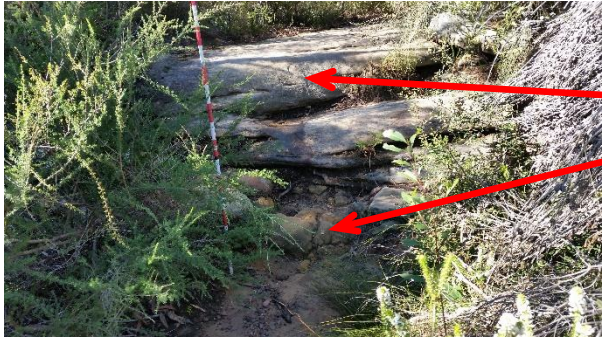
**Site ID: PCT(E) – 3E**

*Location:* 338278 6260978 Dual, slightly-angled, rock ledges with broken embedded rock below to eroded/concave track surface. 1,100mm high in total.

3 boxed steps (stone preferably due to flows down, or timber) infilled with gravels and compacted fill, off lower ledge - with regular “wings” to prevent/divert flows down/around sides. Elongate bottom tread over eroded track section.

**(Medium)**

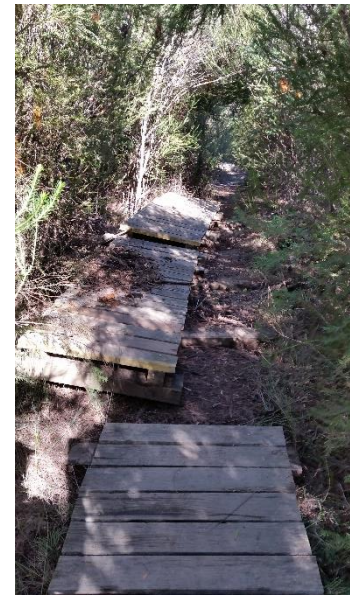
Timber “floating” boardwalk 900mm wide, gently curving, 37m long (approx.) at 338253 6261069 (approx. centre). Good condition (when originally assessed - but

displaced/damaged in part following major rainfall event of 4-6 June 2016).

- Repair displaced/damaged boardwalk after storm event (right). **(HIGH - passability/safety issues)**
- Upgrade signage/wayfinding as per Manly Dam Sign Location Plan.
- Monitor trample tracks to shorelines, for increased impacts and need to manage/close where necessary.

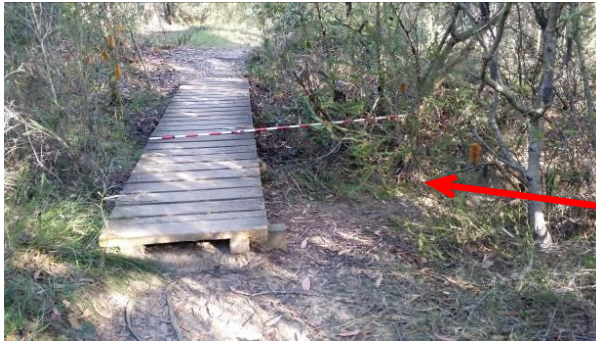
#### Site ID: PCT(E) – 5A

*Location:* 0338245 6261277 Closed and disused old track along drainage line, downslope of low timber boardwalk (N end)

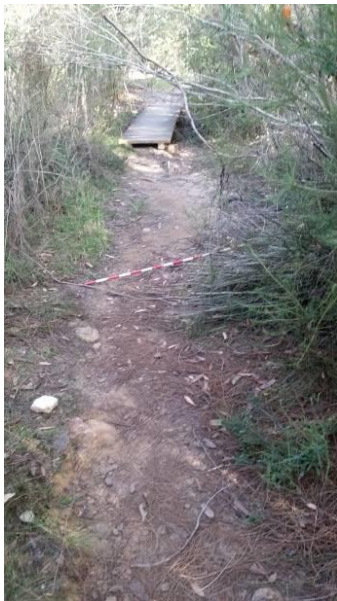
Reinstate/replace existing top step as step/waterbar, extend/anchor well into upslope bank and extend outlet well off track on low side, fill and level/compact above (upslope to new step/waterbar).

Block (with embedded rock) wash around at high end of middle step.

*Location:* 337677 6260620 Entrenched track to 150mm below NLS on high side, 6m long site, 700-900mm wide, 8° slope, compacted sand and loose sediment/gravel and regular protruding roots. 2 log waterbars - lower log detoured (worn path runs high side of log over root as “natural” step), upper waterbar full of sediment and failed, drainage over and wash around end.

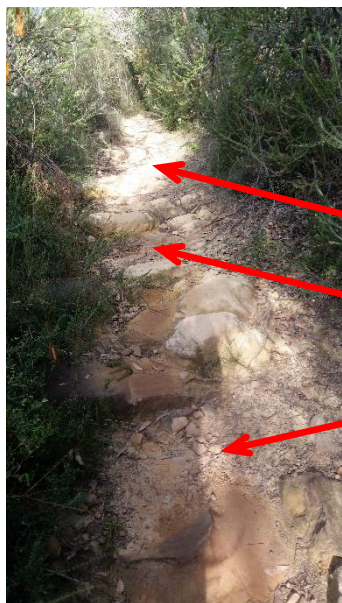
**Site ID: NT – 5(E)**

Build rock step at upper end, built on in-situ rock.

Build 2 step-and-runs with filled and compacted treads, boxed/edge to retain on downslope side.

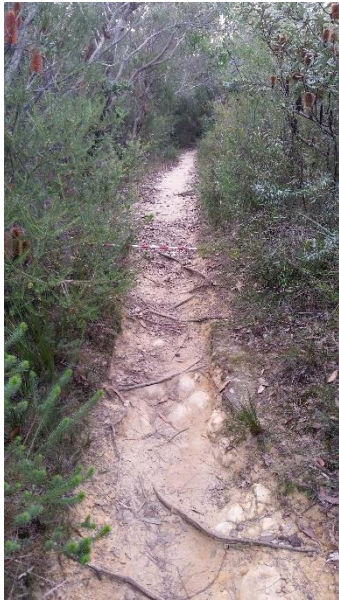
**(Medium - for sustainability/impact issues, to contain track widening)**

**Site ID: NT – 5(G)**

338258 6260435 top (and bottom of Site NT – 5(H))

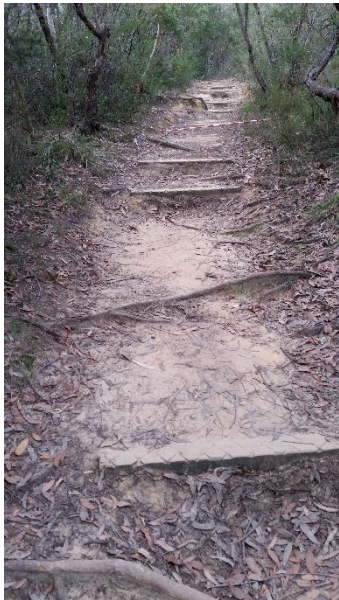
*Works:*

Build 2 steps, then a step-and-run upslope/above for 2-2.5m long with filled/compacted tread and boxed/edge to retain on downslope side.

Rebuild 6 rock steps, rock armour all treads, and new stone-lined invert on extended tread in middle of steps.

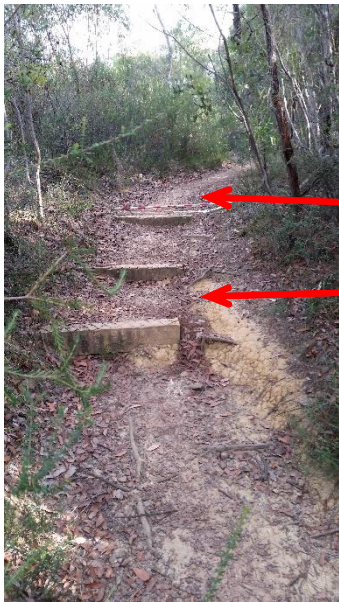
**Works:**

Build 2 rock steps off low side of rounded boulder and level top as tread, cut/level wider tread on upslope side of boulder.

Remove logs and build step-and-run with extended tread upslope/above, box/retain tread on low side and rock armour/flag tread to prevent scouring from continued drainage from above (little chance to direct drainage way due to upslope gutter – Site NT – 5(K)).

Install extra stone step at base of existing bottom step.

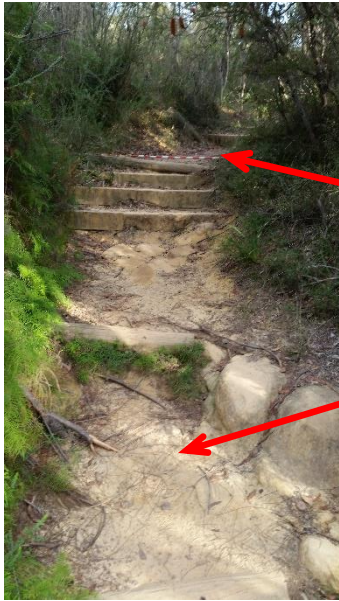
Monitor existing rock steps for stability.

**(Medium)**

**Site ID: NT – 5(K)**

**Location:** 338225 6260468 Gutter between two rock ledges.

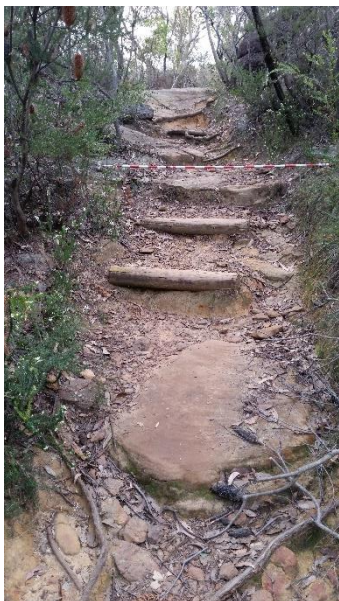
Cut/level tread up onto high side ledge at high point (at embedded rocks in gutter, before dip to SE).

Clear vegetation back to widen path along upper ledge, for 2.5-3m.

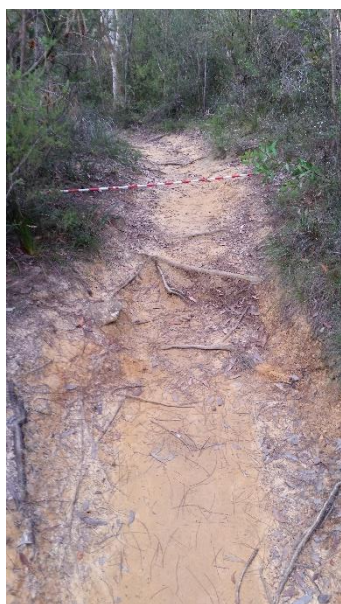
*Works:*

Boxed step at bottom (retain along lower edge), fill compact tread.

7 rock steps upslope of tree – 3 as extension/shaping of in-situ outcrops, and 4 new/built steps, rock armour treads.

Stone-lined invert on wider tread near upper end.

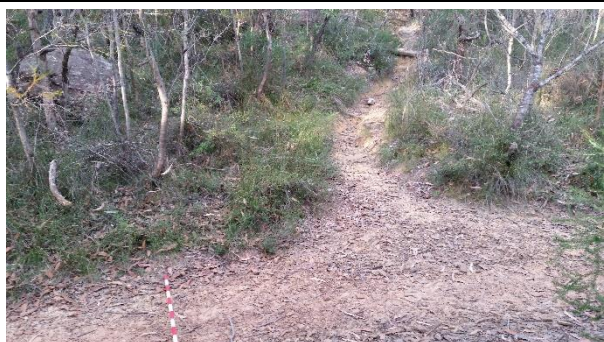
Level top of large rounded boulder at top of site (to allow turn onto lower route at next Site NT – 6(E) above).

**(Medium – for sustainability/impact and passability issues)**

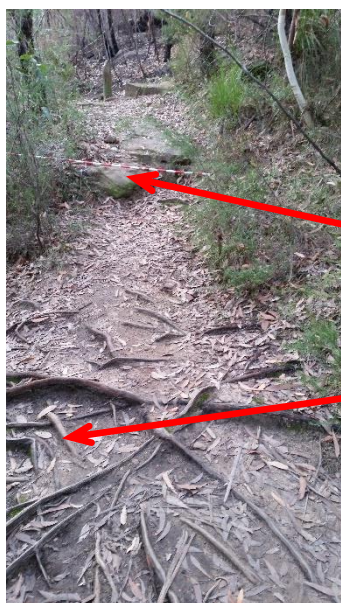
Remove/level protruding rocks on crest. Build informal rock step using in-situ outcrops, and rock waterbar or small gutter below.

**(low)**

*Location:* 338163 6260540 Large flat boulder sloping off low side of track, at top of 11.5° gradient slope, embedded and protruding rocks in compacted sand.

*Works:*

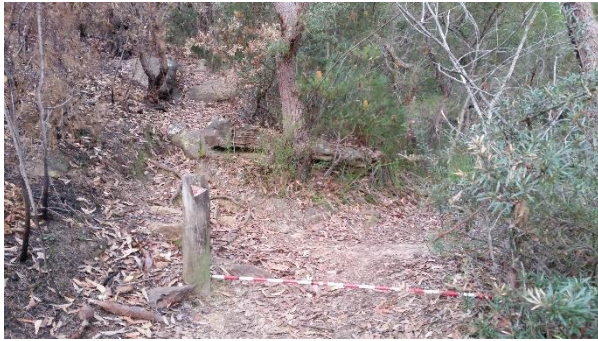
Build waterbar off high side of large midway boulder, extend upslope to base of rock ledge/shelf collect drainage from both alignments.

Barrier/block (rock rubble) low side alignment and disguise (will also protect trackside Angophoras).

**(Medium)**

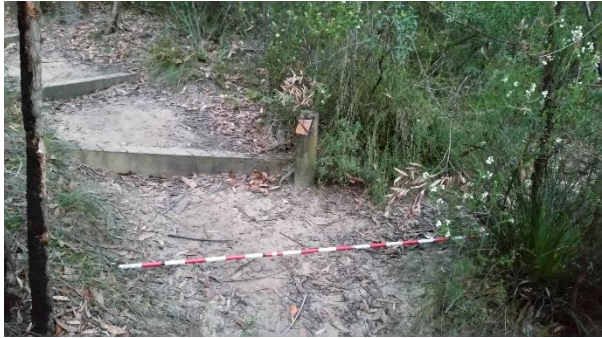
Reinforce, or replace, existing 2 lower steps.

**(Medium – for passability issues)**

**Location:** 338151 6260563 Large Banksia root at top, then sloped rounded rock ledge (4.5m 600mm wide) with narrow footpad along low side, ledge steepens at NW end, curve downslope 16° gradient with 3 small boulders in compacted sand/clay with embedded rocks and 1 or 2 (?) placed rock steps (including brick waste), track braids/widens each side of small boulders, drainage down track with scour to 200mm below NSL, 10m and 10° gradient overall.

**Works:**

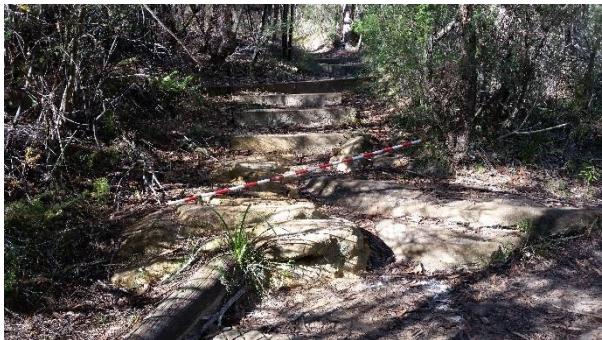
Cut a broad shallow cross drain at NW end of rock ledge (above steeper section, at existing drainage crossing point) with stone-lined invert as extended outflow channel.

Cut/level 3-4 treads into NW half of rock ledge, more closely spaced on steeper end.

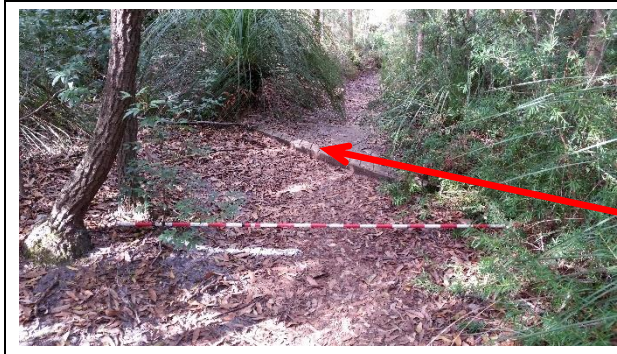
*Location:* 338143 6260577 top  
338142 6260581 bottom

14m section of rocky slope with boulders and large embedded rocks (including “pedestal” rock) in compacted sand, roots, rockier on upslope section with 500mm steps off larger rocks/boulders and 2 placed stone steps, some loose rock. 16° gradient overall (more gently sloped central section), 3.6m overall elevation change. Drainage flows down track and track braiding or widening at obstacles. Old interpretation panel high side of track (poor condition).

Level/cut tread in top outcrop.

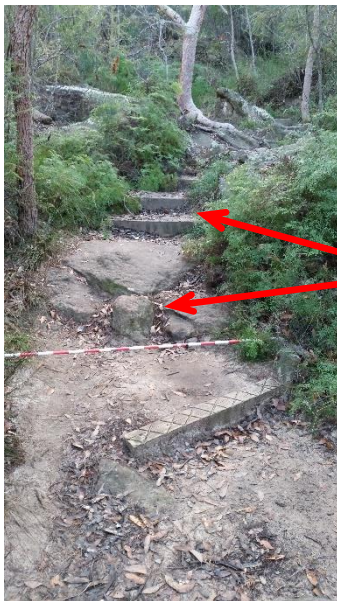
**Key Issues:** Continued drainage capture and scour, and undercutting of rock steps. Unstable rocky sections. Track widening/braiding to avoid obstacles and steps, and associated environmental impacts. Unmarked junctions with informal tracks, and enforcing informal track closures. High/moderate maintenance section. Track intersects and "captures" flow from ephemeral drainage line at Site NT - 7(D).

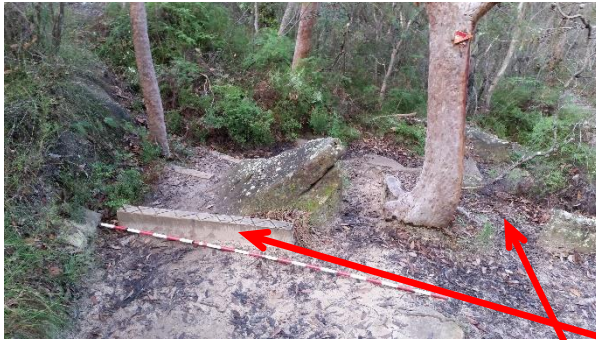
**Site ID: PCT(E) – 12B**

*Location:* 337977 6261518 Angled rock outcrop with protruding timber sleeper step above (flows/eroded around ends), track braided around Angophora. 2 large flat rock outcrops upslope, with 2 timber sleeper stapes onto lower outcrop and embedded (loose) rock above upper step.

- Extend protruding timber step to also function as waterbar, with compacted/levelled fill above.
- Block braided track/detour around Angophora.
- Stone-lined invert above upper outcrop.
- Cut step into larger upper outcrop.
- Stabilise embedded rock above timber steps.

**(Medium - for both passability issues and sustainability/impact issues)**

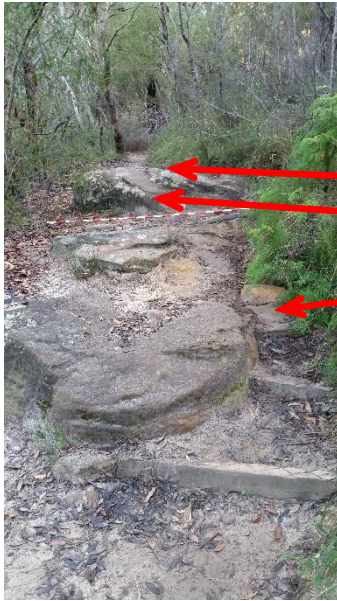
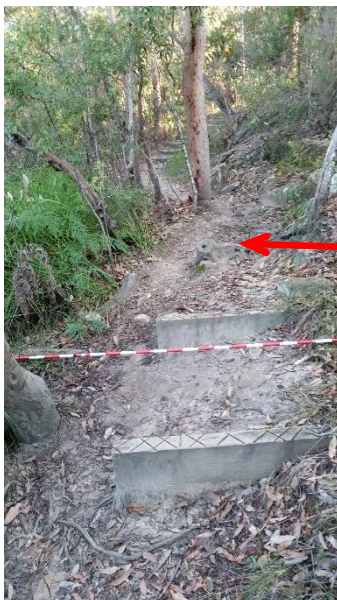
**Site ID: PCT(E) – 12C**

*Location:* 337947 6261497 Failed timber sleeper steps/waterbars, considerable flow and erosion around downslope ends.

- Extend steps/waterbars.
- Stone-lined invert upslope of upper step.

**(Medium – to protect downslope site PCT(E) – 12B, by diverting drainage off track)**

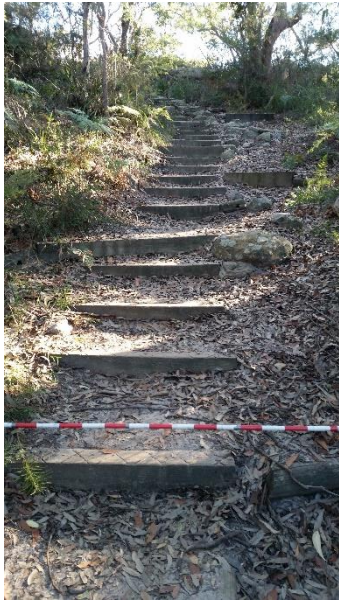
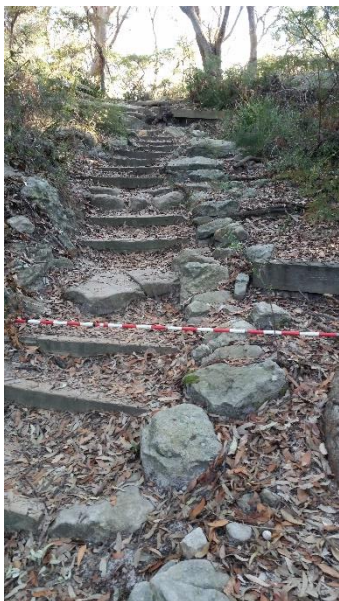
**Site ID: PCT(E) – 12D**

*Location:* 337926 6261487 (centre of site)

Long run of timber sleeper steps and occasional waterbar and embedded rocks, 30m long (approx.). 11-15° gradient. Generally in fair/good condition for most appt, little erosion despite some drainage down steps. Waterbars full of sediment and ineffective.

Additional placed log barriers on former track.

**(Medium – sustainability/impact issues)**

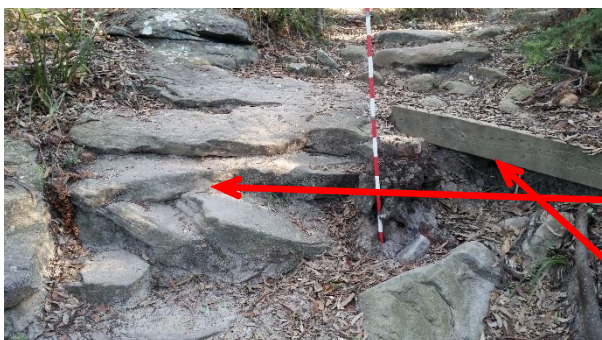
**Site ID: PCT(E) – 12E**

*Location:* 337916 6261479 Shelved and angled rock ledges offering “natural” steps, and adjacent timber sleeper waterbar is undercut (also full of sediment and ineffective) and potentially hazardous, at top of site PCT(E) – 12D.

Waterbar, built onto in-situ rock outcrops and embedded rocks.

**(Medium – to protect downslope sites PCT(E) – 12D & 12E, by diverting drainage off track)**

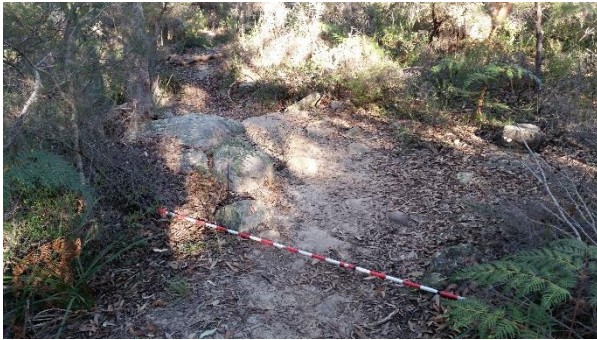
**Site ID: PCT(E) – 12G**

*Location:* 337898 6261522 (centre of site) Entrenched track 200-400mm below NSL with protruding roots, embedded rocks and loose gravel – hazardous. Fallen tree trunk angled across track acting as waterbar. 16m long, more deeply entrenched at upper end, with undercut timber sleeper step (500mm high) and braided track around tree at top. 7° gradient

Retain fallen tree trunk as “natural” waterbar and step and build waterbar off end, with edge containment/definition to track.

**(Medium - for both passability issues and sustainability/impact issues)**

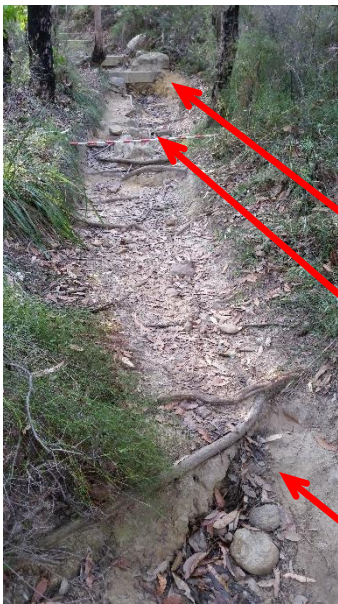
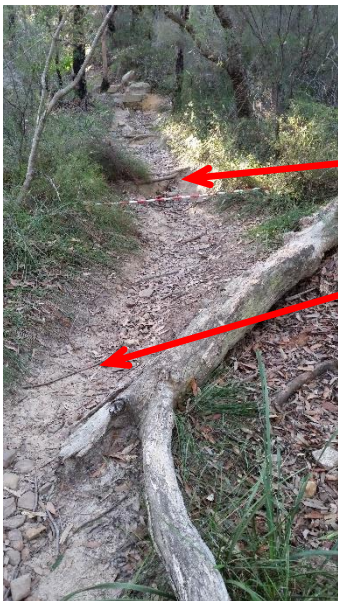
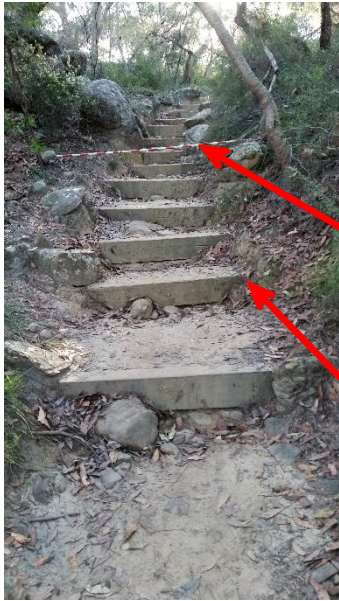
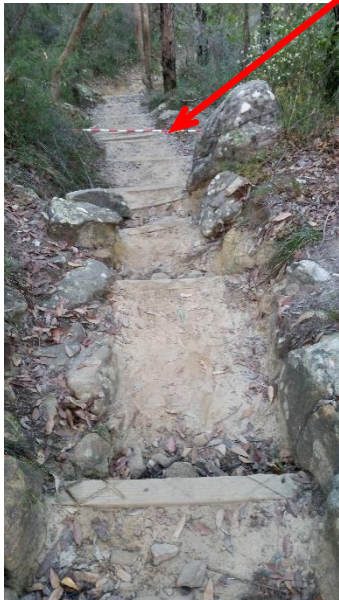
**Site ID: PCT(E) – 12H**

*Location:* 337883 6261529 (centre of site)

Run of timber sleeper steps 600-1,200mm wide up/down eroded “chute” - 150mm below NSL on lower apt and up to 350mm deep on upper part. 11° gradient. Between and contained by embed rock and boulders, especially on upper section. Drainage down. Fair condition.

Remove loose cobbles and stones from treads, rock armour where necessary

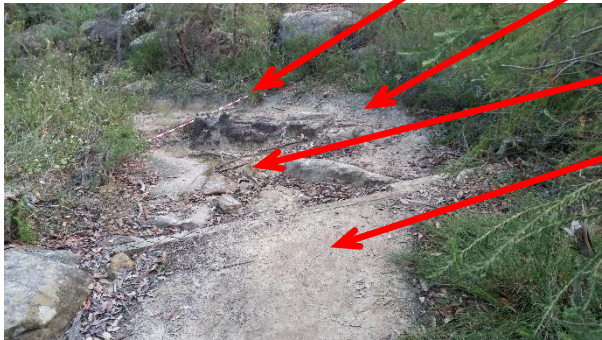
**Site ID: PCT(E) – 12J**

*Location:* 337882 6261545 Low rock ledges/outcrops and embedded rocks, “natural” steps, drainage down on 8° gradient.

Waterbar, or stone-lined invert, built onto in-situ rock at upper end.

**(Medium – to protect downslope sites PCT(E) – 12I and PCT(E) – 12H by diverting flows off track)**

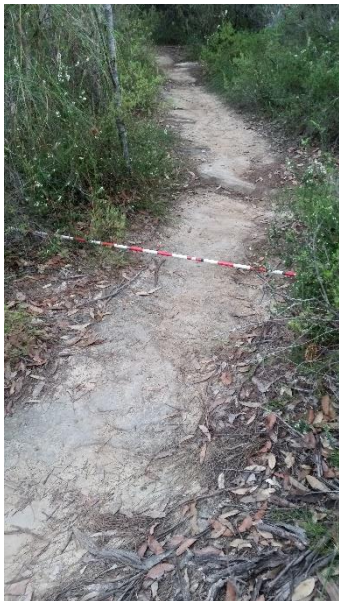
##### **Site ID: PCT(E) – 13A**

*Location:* 337889 6261576 (centre of site)

Waterbars on sandy flats (where NSWL suits) and built onto in-situ rock pavements, x4 approx. over whole length.

**(low)**

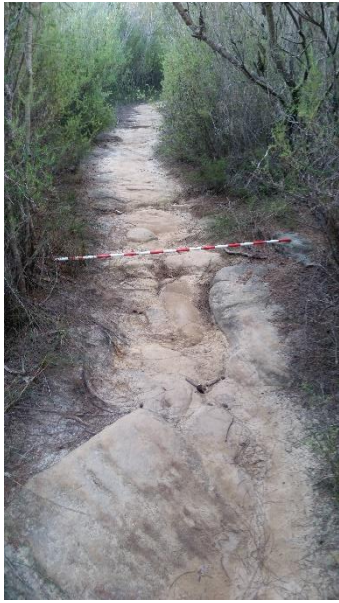
**Site ID: PCT(E) – 13B**

*Location:* 337892 6261595

Uneven/broken rock pavement and embedded rock, 4° gradient and 50-100mm drop off edge of pavement.

Waterbar upslope of rock pavement, built onto in-situ rock.

**(low)**

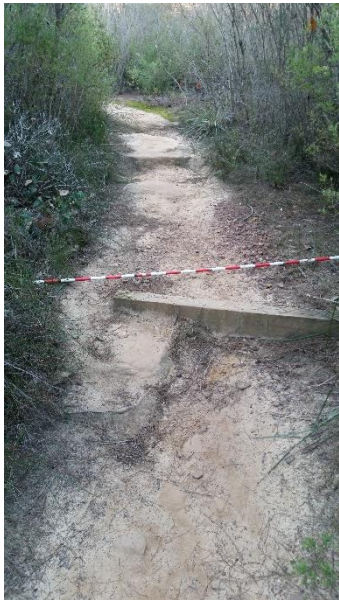
**Site ID: PCT(E) – 13C**

*Location:* 337892 6261608

Extend timber waterbar on upslope side, clean out.

**(low)**

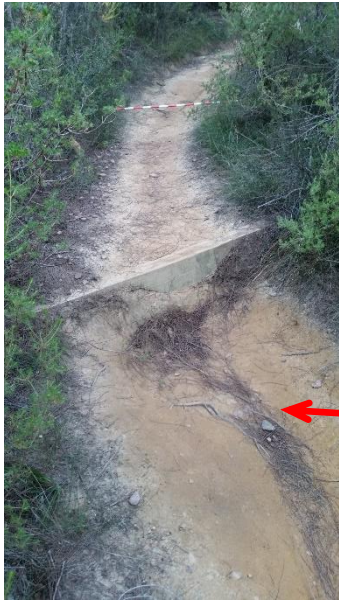
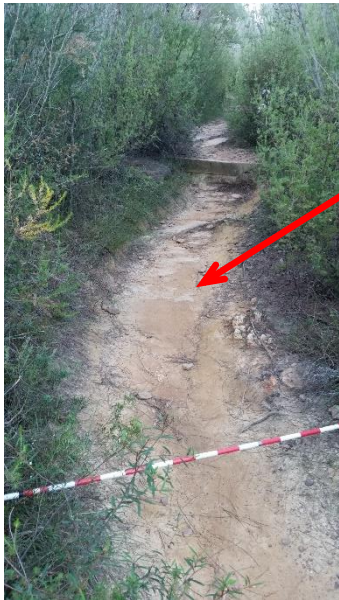
**Site ID: PCT(E) – 13D**

*Location:* 337870 6261645 (centre of site)  
2 full/failed timber waterbars, with dished entrenched track between and below, eroded to 200-300mm below NSL with drainage down. 400mm drop over lower waterbar, 500mm drop at upper waterbar. Occasional outcropping and embedded rock. 15m overall (approx.) at 4° and 5° gradient.

1 or 2 step-and-runs below upper waterbar, infilled with gravels and compacted fill upslope (and reduce step height).

**(low)**

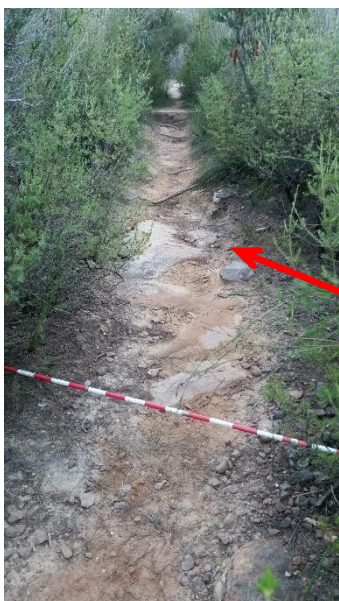
**Site ID: PCT(E) – 13E**

*Location:* 337871 6261662 (centre of site)  
Dished entrenched track eroded to 100-500mm below NSL with drainage down. Full/failed timber waterbar at upper end, with 400mm drop over front. Sandy clay and embedded/broken rock 900-1,000mm wide. 18m overall (approx.) at 4° gradient.

2-3 step-and-runs below waterbar, infilled with gravels and compacted fill upslope (and upper tread butting into waterbar to reduce step height).

**(low)**

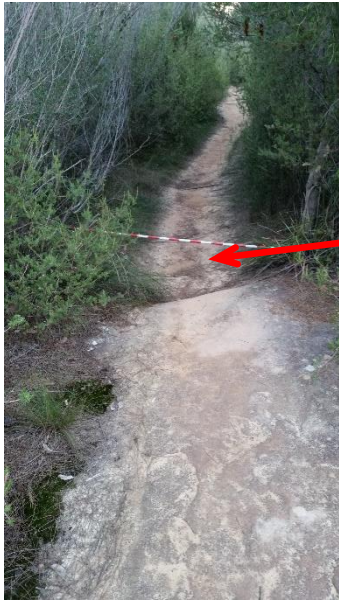
**Site ID: PCT(E) – 13F**

**Location:** 337863 6261684 Large sloped rock outcrop and rock ledge/pavement above.

**(Medium - to divert flows off track and protect downslope works)**

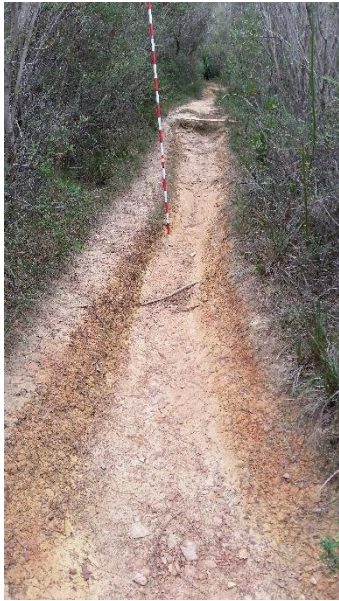
**Site ID: PCT(E) – 14B**

*Location:* 337850 6261757 Eroded channel, 200 below NSL.

Waterbar/step at shallower point in long eroded channel. Extend waterbar and excavate discharge channel to match NSL and allow free outflows. (Fill and compact behind/upslope of waterbar/step, if fill can be sourced, to minimise step/trip hazard).

**(Medium – for passability and sustainability/impact issues, as a hold point for progressive sediment infilling of erosion gutter above)**

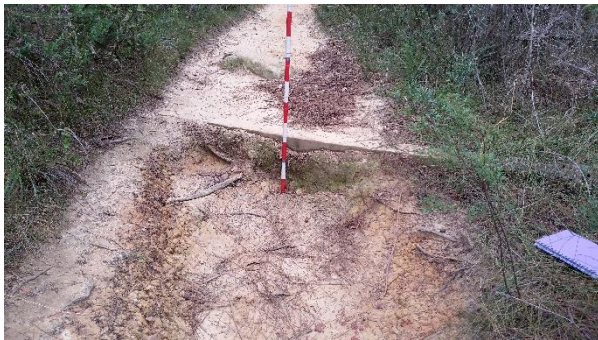
**Site ID: PCT(E) – 14C**

*Location:* 337850 6261762 Timber waterbar/step, full/failed.

Additional waterbar/step 1m below existing, and backfill tread with compacted gravel/fill (butting into waterbar to reduce step height). Extend waterbar and excavate discharge channel to match NSL and allow free outflows.

**(low)**

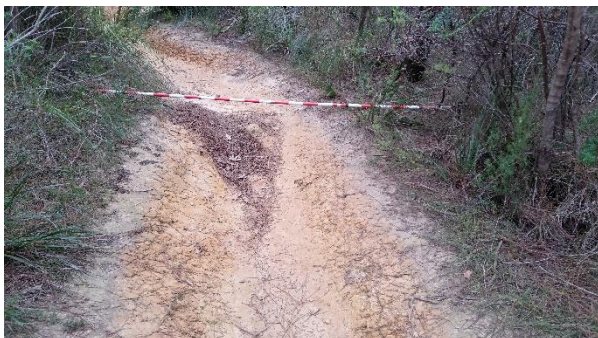
**Site ID: PCT(E) – 14D**

*Location:* 337849 6261771 Head of concave/dished erosion channel down centre of track.

Replace or extend waterbar/step.

Additional waterbar/step below in-situ embedded rocks, and backfill tread with compacted gravel/fill butting onto rocks. Box sides to contain fill if required.

**(Medium – to divert flows off track reducing downslope flows and erosion)**

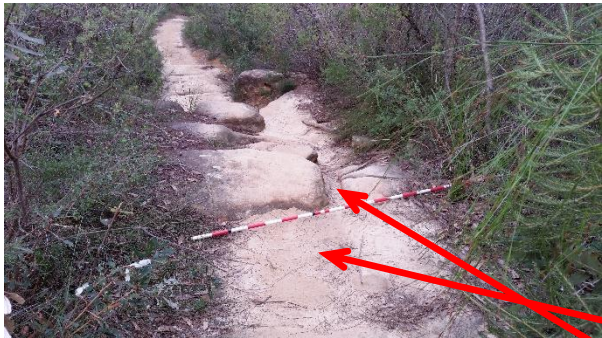
##### Site ID: PCT(E) - 15A

**Location:** 337833 6261784

Extend or block (with embedded rock) lower timber steps to catch flows and minimise erosion around ends.

**(low)**

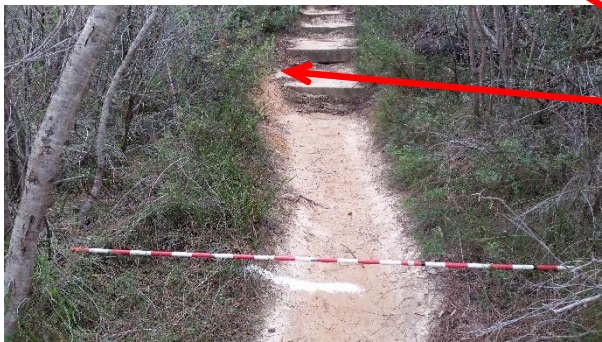
##### Site ID: PCT(E) – 15B

**Location:** 337829 6261792 Squared eroded channel 200mm deep by 300mm wide, within wider concave/eroded track to 400mm below NSL - in sandy clay and loose/deposited sands.

Waterbar/step, and backfill/level behind/ (above/upslope) with compacted gravel/fill (deposited sand on this section of track could be used for fill, if suitably stabilised and compacted). Extend waterbar and excavate discharge channel to match NSL and allow free outflows.

**(low)**

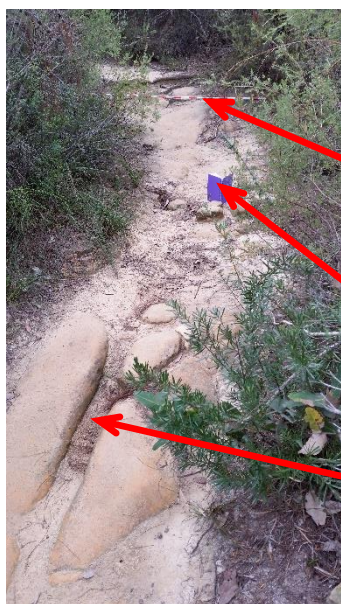
**Site ID: PCT(E) – 15C**

*Location:* 337833 6261800 Broken rock outcrops and embedded rock, including central gap/gutter. Protruding roots retaining loose sands above. 9m long (approx.) and 5° gradient.

Rock fill/armour and level gap in lower sloped rock outcrops.

**(Medium)**

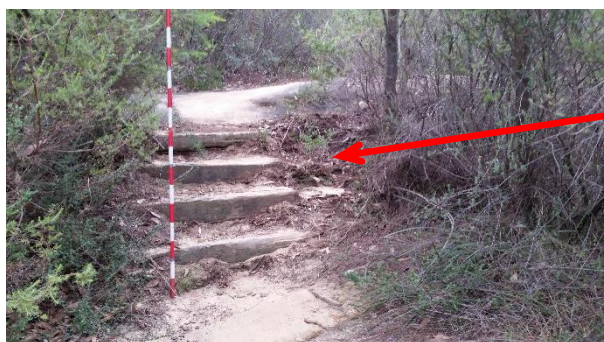
**Site ID: PCT(E) – 15D**

*Location:* 337832 6261805 4 timber steps 1,200mm wide off sloped rock ledge in fair/good condition, 14° gradient. Flow/scour down NE side of steps

Monitor rock ledge above steps for sand deposition and resulting slip hazard, may need to cut 1-2 level treads into rock surface.

**(low)**

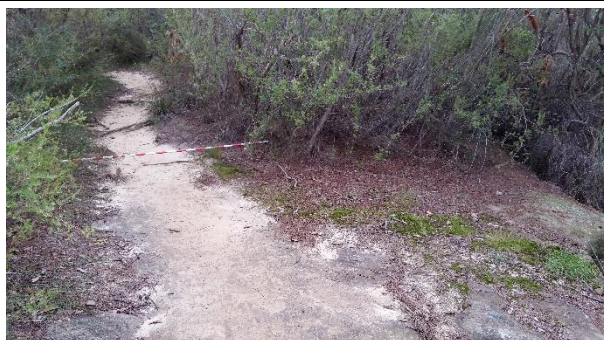
**Site ID: PCT(E) – 15E**

*Location:* 337830 6261816 End of rock ledge, N of site PCT(E) – 15D.

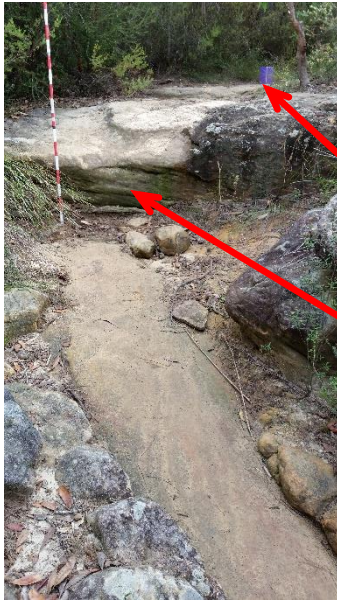
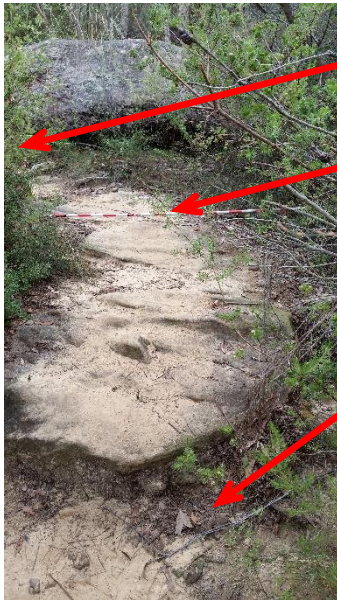
**Site ID: PCT(E) – 15F**

*Location:* 337826 6261823 Rock pavement and ledge above, with 600mm drop off, to sloped rock outcrop/pavement flanked by boulders in centre. Uneven/broken rock outcrop, with occasional roots and deposited sand, below then step off to compacted sand track. “S” curve and 10° gradient over whole site, drainage down, 15m long (approx.).

- Waterbar above, approx. 4m upslope of edge of upper rock ledge.
- Cut level tread into edge of rock ledge and build 2 steps (preferably stone steps), onto face of rock ledge.
- Cut level tread into angled rock pavement, and build step (stone preferably) off pavement – adjacent to roots/boulders.
- Waterbar, built onto in-situ rock, discharge to E, extend discharge if necessary to allow free outflow.
- Armour tread at step off lower rock outcrop (protect compacted sand track).

**(Medium)**

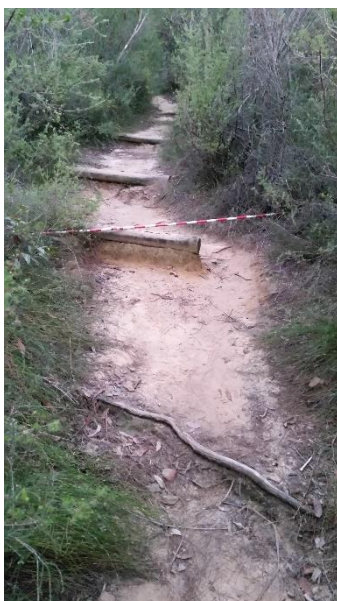
**Site ID: PCT(E) – 15G**

*Location:* 337816 6261833 2 full/failed log waterbars and 1 failed log waterbar with flow/erosion around end and widened track, 4° gradient, compacted and loose/deposited sand.

Clean-out 2 upper waterbars, extend lower waterbar and clean-out. Pull in and edge containment/definition to track at lower waterbar.

**(Medium – to prevent further track widening and sustainability/impact issues)**

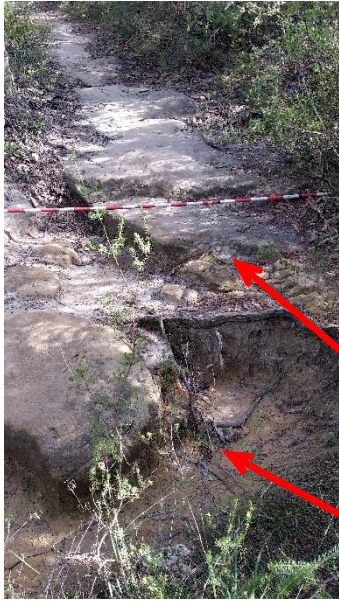
**Site ID: PCT(E) – 15H**

**Location:** 337812 6261847 Flat/ledged rock outcrop stepped down to embedded and broken rocks and above a 90° bed with exposed/eroded boulders both sides and exposed/retaining roots, drainage down/over and eroded to 400mm below NSL, sloped rock outcrop/pavement below and concave/dished track to 100mm deep, 800-1,600mm wide, 15m long at 12° grade on upper section (bend) and 7° grade below.

Stone infill (armour/flagging) top E side of lowest rock outcrop to “square-off” as low step to track downslope.

**(Medium - for both passability/safety issues and sustainability/impact issues)**

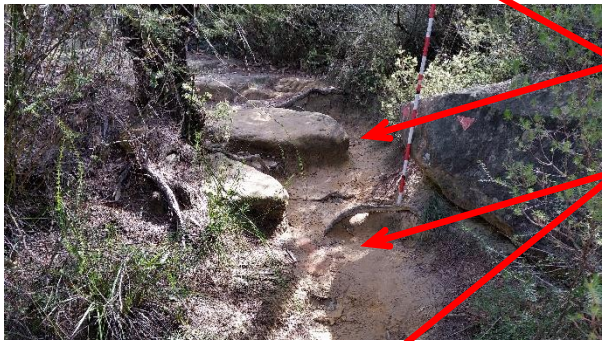
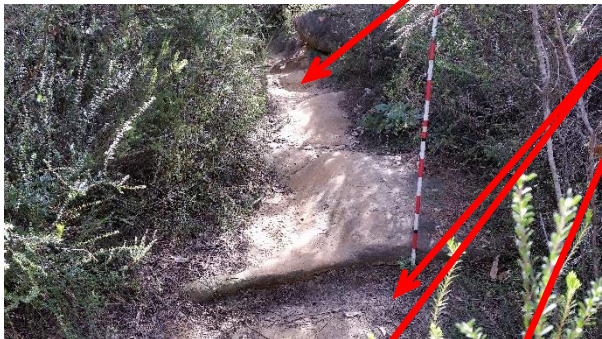
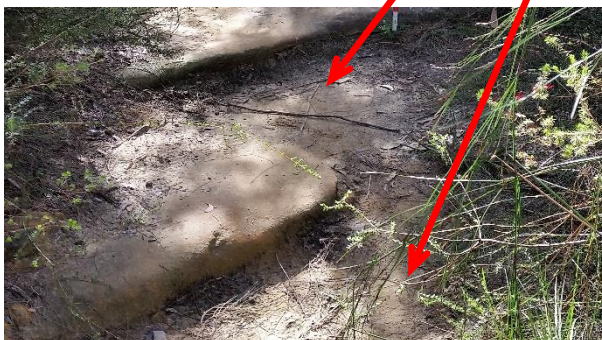
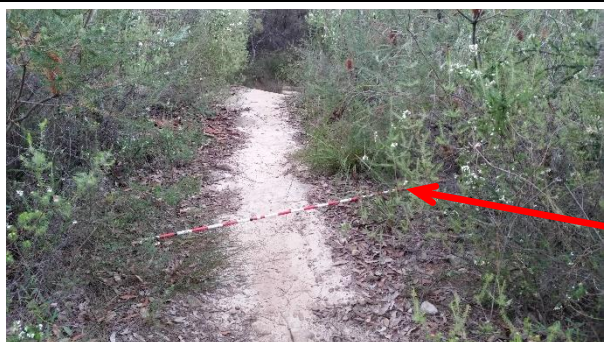
**Site ID: PCT(E) – 15I**

*Location:* 337803 6261847

Open/remove low mound on low side of track to allow outflows, excavate broad shallow drain if necessary.

**(Medium - low)**

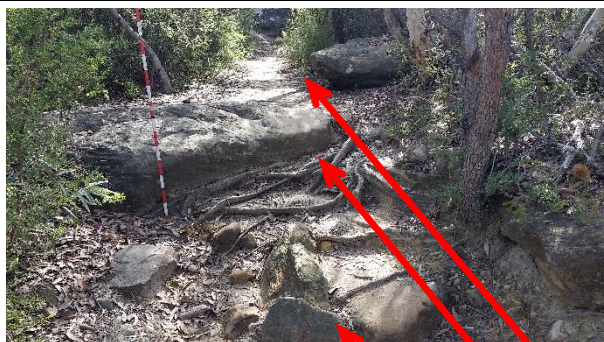
**Site ID: PCT(E) – 15J**

*Location:* 337787 6261837 Rock outcrop/ledge with 600mm face, exposed/protruding roots beside and below, protruding/embedded and loose rock on slope below eroded to 400mm below NSL on upper section with drainage down, curve with compacted sand and loose/embedded rock, to sewer lid with concrete base 100mm above track level. 9m overall, 6° gradient, 1,200-1,800mm wide.

Embed/fix stone armouring at angle on protruding (trackside) edge of sewer access lid to reduce trip hazard.

**(Medium - for both passability/safety issues and sustainability/impact issues)**

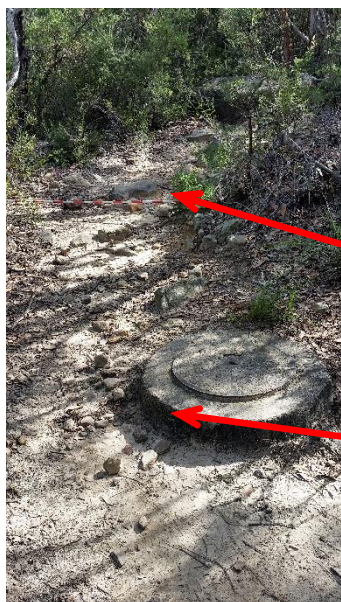
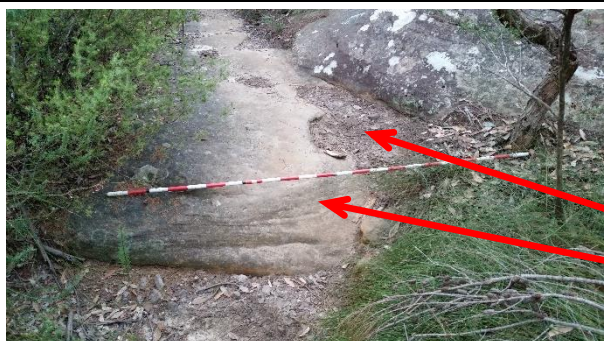
**Site ID: PCT(E) – 15K**

*Location:* 337778 6261848

Cut step and level tread into sloped rock face below.

**(low)**

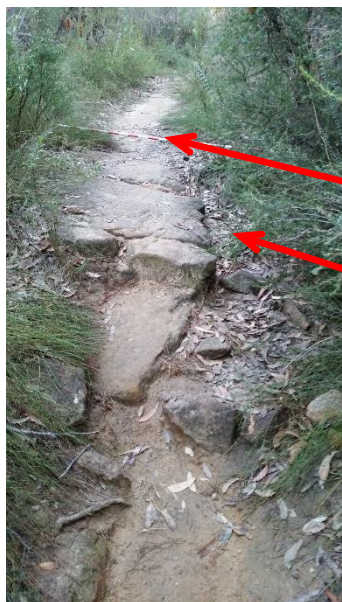
**Site ID:** PCT(E) – 16A

**Location:** 337746 6261860 Squared rock outcrops with “natural “ steps, and drainage down gutter along downslope side of outcrops.

Stone flagging/fill in gutter - flat and level with adjacent rock outcrops.

**(low)**

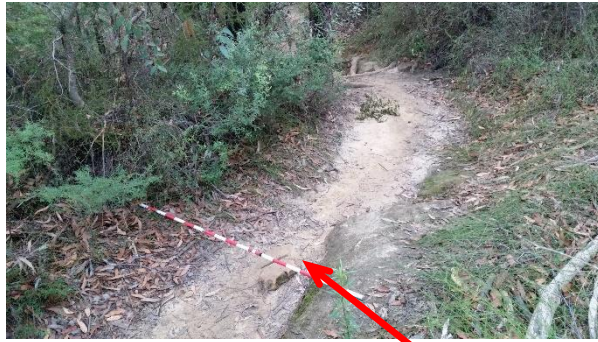
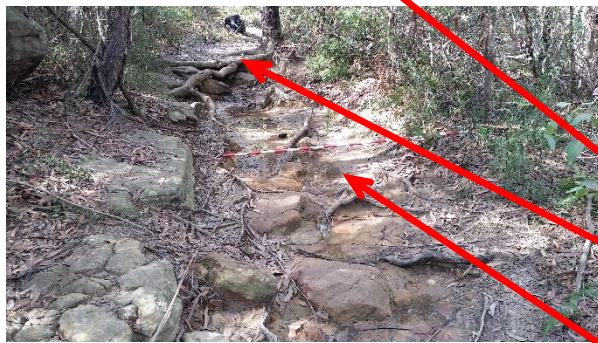
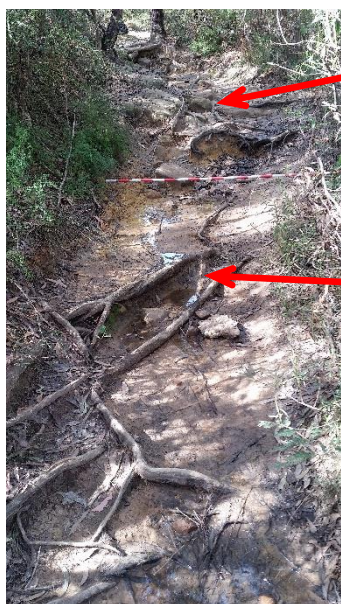
**Site ID: PCT(E) – 16B**

**Location:** 337728 6261861 Bend with erosion scarp over large roots, drop of 500mm with drainage capture, embedded rocks and protruding roots below with water ponding. Track downslope 1,200-1,400 wide, eroded d to 300 below NSWL with protruding roots, and embedded rocks on upper section dropping to protruding roots on lower section. 10m long (approx.) and 5° gradient with drainage down entire site. 6m section upslope of tree/bend, compacted sand and rock outcrop.

Pull-in track width and provide edge definition/containment as required.

**(Medium)**

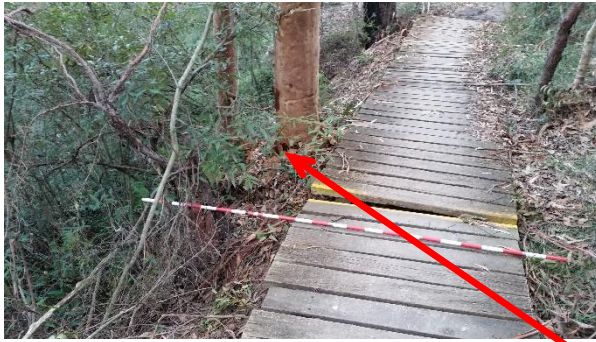
**Site ID: PCT(E) – 16C**

*Location:* 337698 6261857 On-ground timber boardwalk 12m long (approx.) and 1,200mm wide, +2m drop along much of boardwalk's length with only a narrow leaf-litter covered slope above – potential hazard. Jutting board approx. halfway (painted "hazard" yellow). Full /failed timber waterbar off E end of boardwalk.

Monitor boardwalk deck for repair and hazard management requirements.

**(HIGH – safety issue, and monitor)**

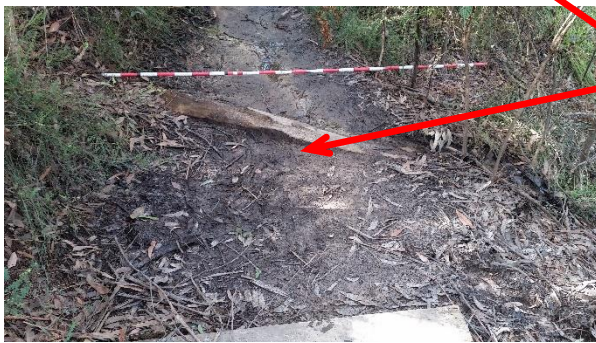
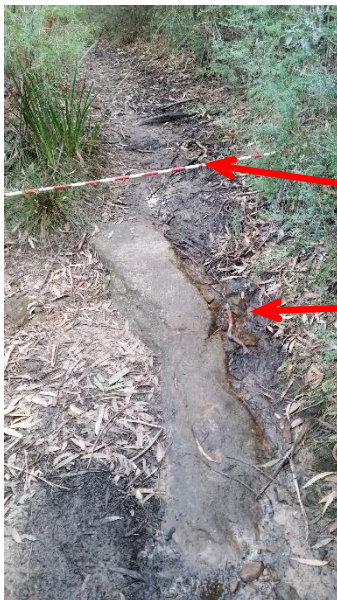
**Site ID: PCT(E) – 16D**

*Location:* 337686 6261855 Elongated narrow rock bar/outcrop directing flows and seepage onto timber boardwalk to E.

Infill and level (rock armour preferably) gutter on high side of rock bar to level track.

**(low)**

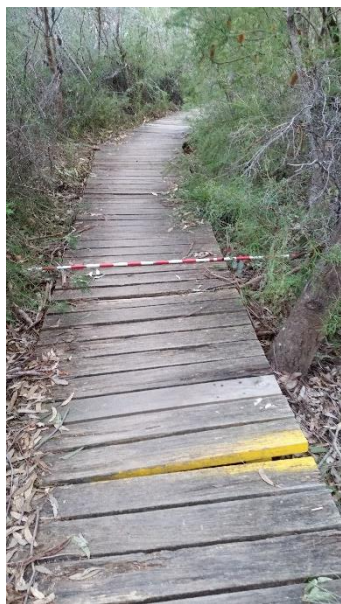
**Site ID: PCT(E) – 16E**

*Location:* 337659 6261849 On-ground timber boardwalk, curved 19.5 m long (approx.) and 1,200mm wide, fair condition only - with jutting board (painted “hazard” yellow) and some decaying boards.

Monitor for repair and hazard management requirements.

**(monitor)**

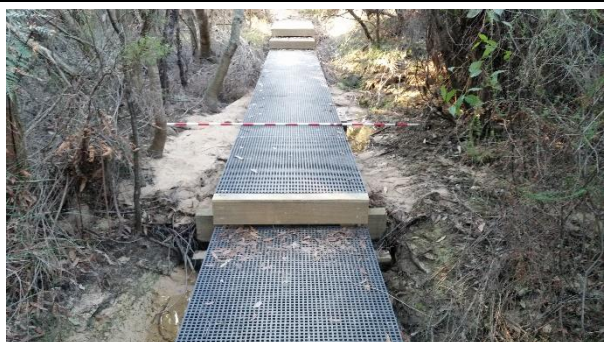
**Site ID: PCT(E) – 16F**

*Location:* 337585 6261892 Sediment deposition under fibreglass reinforced plastic boardwalk and over/covering on-ground timber boardwalk, and sediment fan in bushland downslope – from spoon drain discharge off Perimeter Fire Trail upslope (just E of entry to Park Circuit Track)

Large stone lined gutter under W end of on-ground timber boardwalk to carry flows (from spoon drain) under boardwalk (alternatively drain/gutter under S end of fibreglass reinforced plastic boardwalk to catch and divert flows away from on-pound boardwalk).

**(Medium - sustainability/impact issues)**

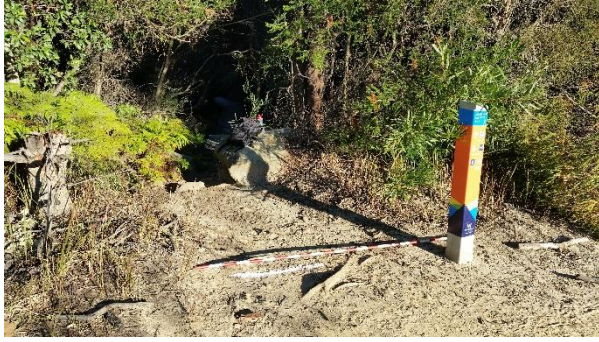
**Site ID: PCT(E) – 16G**

*Location:* 337579 6261908 Junction of Park Circuit Track and Perimeter FireTrail / Shared Path. New signage/directional totem. Drainage from fire trail onto start of Park Circuit Track.

**(low)**

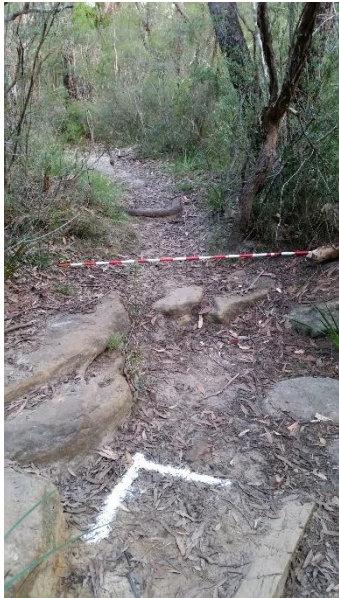
#### **Site ID: DSB – 1(A) (junction with Park Circuit Track (East) – 9/10)**

*Location:* 338124 6261598 Track junction (DSB-1 to S, PCT(E)-9 to E and PCT(E)-10 to W) with stone pavement/outcrops as “natural” steps above, and scored sleeper steps below with compacted sandy loam treads and end rocks. Log waterbar/step angled to NW off stone pavement/outcrops, and extended with scored sleeper waterbar. Small log post with two metal directional arrows (indicating PCT(E), DSB not signposted), taller timber post/stake behind log post but no signage. Drainage flows down/through junction, but little scour. Start of DWB to S is compacted sand/loam with occasional embedded rocks and large root (as step), 900-1,100mm wide, slightly dished to 100-150mm deep.

Upgrade signage as per Manly Dam Sign Location Plan.

**(Medium)**

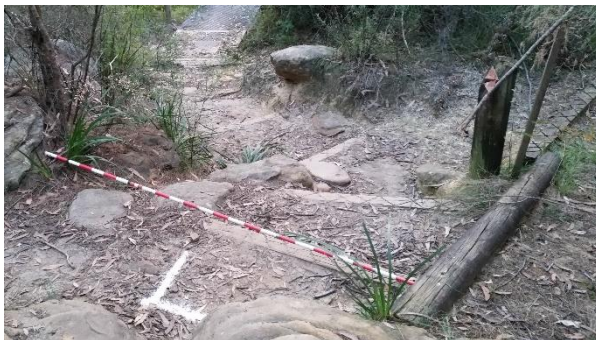
**Site ID: DSB – 1(B)**

**Location:** 338123 6261579 (midpoint)  
Compacted sand and some sandy/clay track, 900-1,200mm wide, 3-5° gradient (gentler at top, steeper gradient is in S on slope to dam/boardwalk), dished to deeply dished in places up to 300mm below NSL with drainage down, occasional protruding roots, embedded rock/outcrops (ironstone) at lower/S end (downslope of last/lowest waterbar). 4 log waterbars or waterbars/steps over 20m approx. total distance – 2 middle log waterbars failed with wash around lower ends, and 350mm step-off last/lowest waterbar/step to uneven embedded rock. Short cut track from PCT(E)-9 joins at upper part of site.

Extend (or replace) 2 middle waterbars, to prevent wash around.

**(low)**

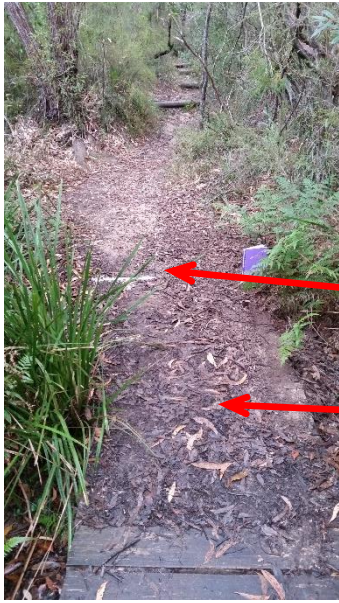
**Site ID: DSB – 1(C)**

*Location:* 338112 6261564 Compacted and deposited sand track, 900-1,200mm wide. Gentle gradient, but drainage down from upslope, with loose/deposited sand and leaf litter over first 1.5m of timber boardwalk (potential for rotting/decay).

**(low, and monitor)**

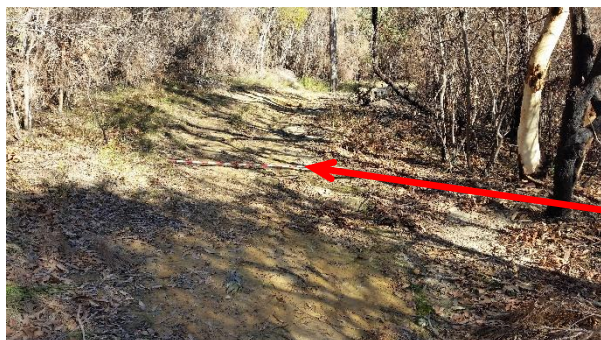
**Site ID:** MRE – 1(A)

**Location:** 338277 6261811 Wide shallow gutter on N side of sweeping downslope “S” bend fire trail, 3° gradient.

Rollover drain upslope.

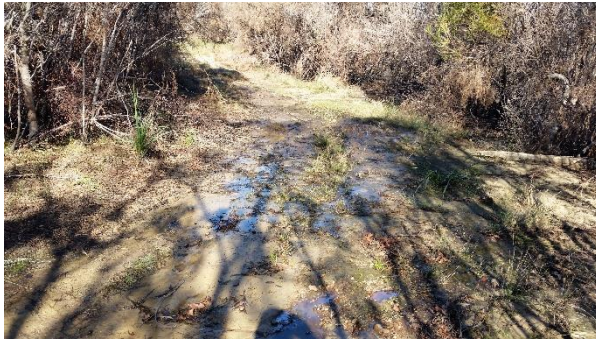
**Site ID: MRE – 2(B)**

*Location:* 338227 6261745 Seepage ponding on low point/kink on fire trail.

Open windrow along downslope edge of trail, excavate broad shallow invert along downslope edge of trail if problem recurs.

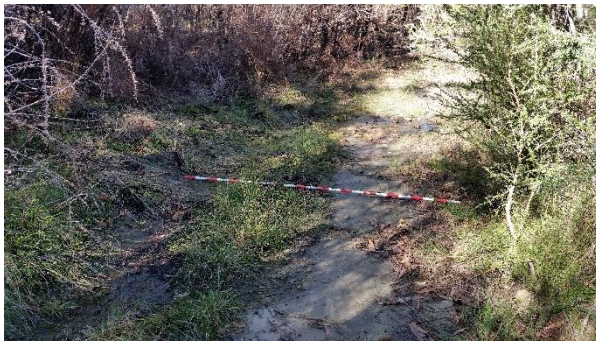
**Site ID: MRE – 2(C)**

*Location:* 338261 6261628 Concentrated overland flow across /along fire trail.

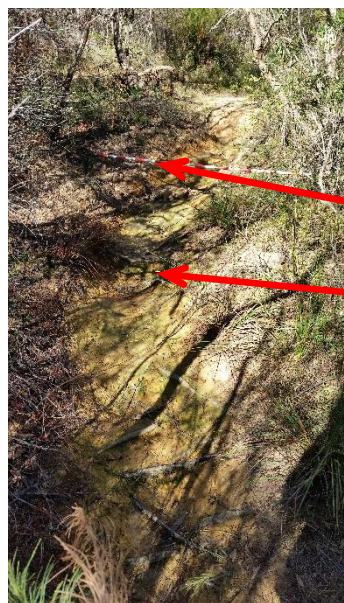
#### Site ID: MRE – 2(A)

**Location:** 338277 6261603 Guttered track to 400mm below NSL over rock outcrops and embedded rocks, compacted sandy/clay and roots, 600-800mm wide.

Install 5-6 step-and-runs (steps may be needed in upper section) with filled and compacted treads (fill could be delivered via nearby fire/service trail), extend a suitable tread midway down series to include waterbar.
