# MANLY DAM WALKING TRACKS AUDIT

for  
**Northern Beaches Council**  
May, 2017

CONTROLLED DOCUMENT  
**“Manly Dam Walking Tracks Audit”**

**FINAL ISSUE**

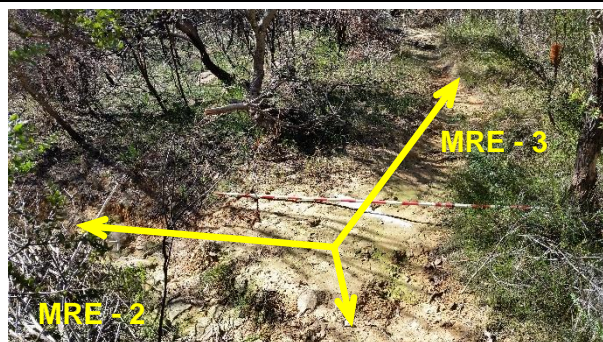
#### Site ID: MRE – 2/3 (junction)

**Location:** 338279 6261591 Junction with segment MRE – 3, from upslope. No wayfinding.

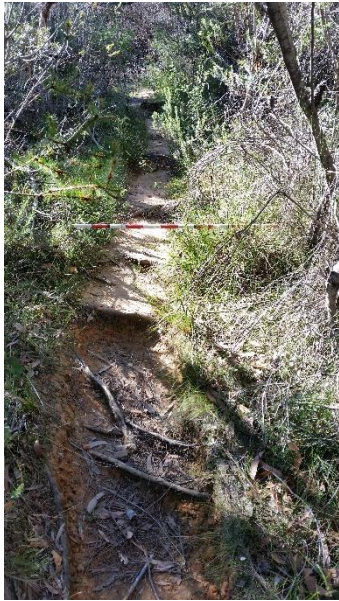
**Site ID: MRE – 2(B)**

Guttered track 50-150mm below NSL in compacted sandy clay, drainage down track from junction upslope, failed/rotted waterbar with wash/tracking around end, roots retaining track surface, 2.5 ° to 4° gradient.

Replace upper waterbar.

New waterbar/step in lower section.

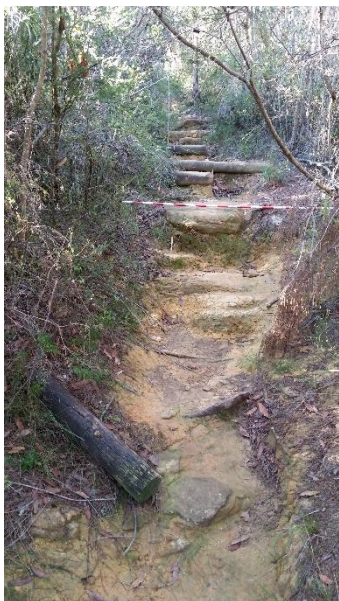
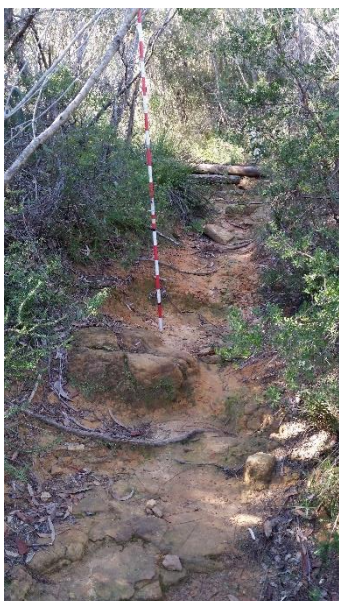
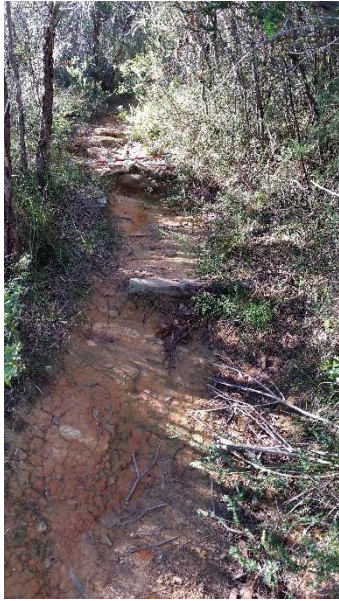
**Site ID: MRE – 2(C)**

Extended run of entrenched track 600-1,100mm wide up/down moderate slope (11° to 15°) with total elevation change of 11-12m, guttered 100-400mm below NSL with drainage capture and flows down, compacted clay/sand with embedded rock and roots with some rock outcrops/ledges on lower section, areas of gravel and loose/deposited sand, 12 existing log steps and 4 log waterbars (all full/failed, several with wash/erosion around end).

- waterbars (timber) – new waterbar at top, replace/reinstate 2 existing waterbars, 6 new waterbars (2 built onto/off in-situ rock), retain and clean-out 2 existing waterbars;
- steps (timber) – replace/reinstate 8 existing steps, 11 new steps, retain 1 existing step;
- 7 new rock steps, built onto/off in-situ rocks; and
- 5 new rock steps – infill/extend and level in-situ rock outcrops to create rock step.

Extend all new or reinstated steps well into adjacent natural ground.

**(Note:** Alternative approach would be to close and rehabilitate this entire section of track (running straight up/down slope) and establish a new track, to NW, contoured into

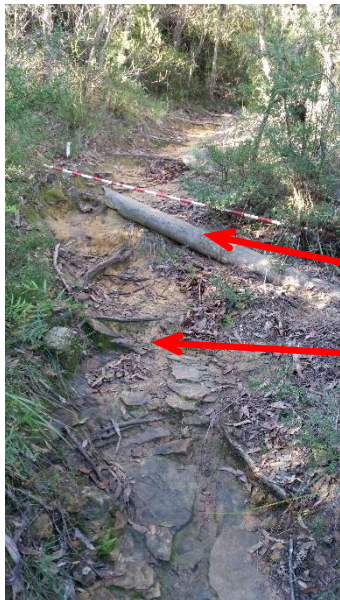
<p><b>Site ID: MRE – 2(E)</b></p> <p><i>Location:</i> 338223 6261533 Failed log waterbar on 13° gradient, benched/guttered track to 150mm deep and 600-800mm wide, compacted sandy clay, embedded rocks (some sloping) and roots, drainage capture/flows down.</p> <p><i>Works:</i></p> <ul style="list-style-type: none"> <li>Replace and extend waterbar.</li> <li>2 new boxed step-and-runs below, with filled/compacted tread.</li> </ul> <p><b>(Medium - for passability and safety)</b></p>

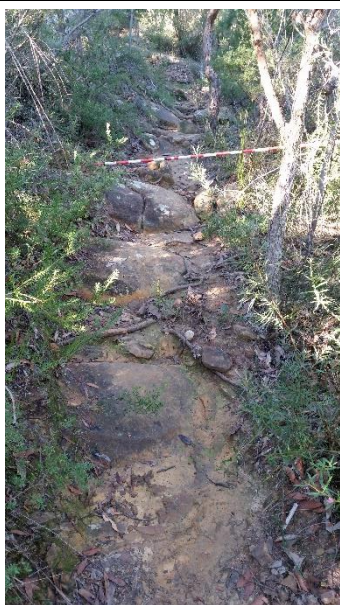
<p><b>Site ID: MRE – 2(F)</b></p> <p><i>Location:</i> 338216 6261532 slope of embedded and protruding rocks in compacted sand/clay, 600-800mm wide, 10° gradient with drainage capture/flows down.</p> <p><i>Works:</i></p> <p>5 rock steps or step-and-runs variously cut into or built onto in-situ rocks, box/retain lower side as required, and extend a suitable tread midway down series to include stone-lined invert.</p> <p><b>(Medium - for both passability issues and sustainability/impact issues)</b></p>

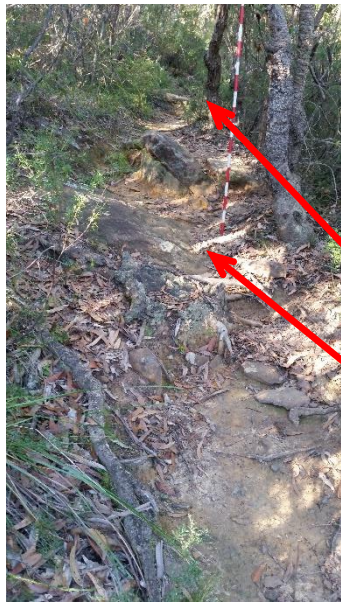
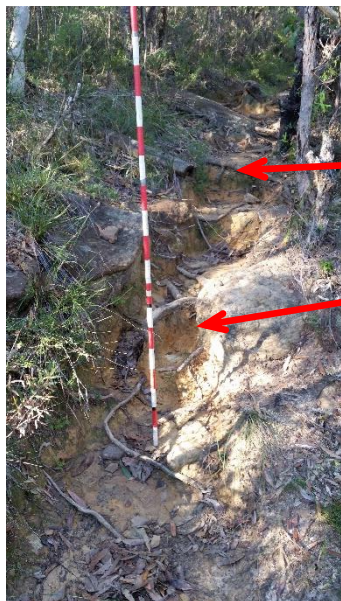
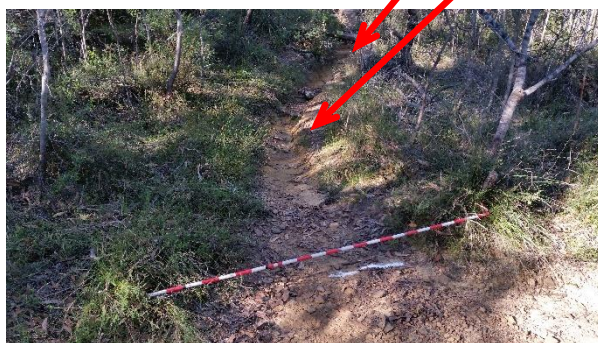
**Site ID: MRE – 2(G)**

Eroded (28m) section of entrenched track up/down and angled across slope, 12° gradient overall, some steeper sections on upper part and gentler on lower part (above junction with PCT( E) – 8), compacted clay/sand guttered 100-500mm below NSL and 300-400mm wide and drainage capture/flows down, sloped embedded rocks and rock outcrops, stumps and protruding roots, failed log waterbars.

Replace failed water bar at top.

Replace failed waterbar and build 2 boxed steps, or 1 step and 1 step-and-run, with filled/compacted tread below.

Reinstate/replace waterbar with 2 steps or step-and-runs, with filled/compacted tread, below.

1 step-and-run, with filled/compacted tread, on extended gutter at lower end.

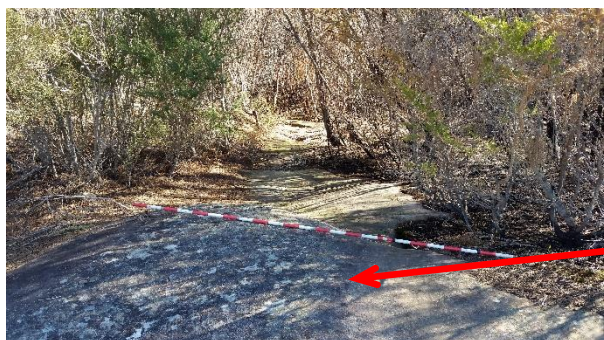
**Site ID: MRE – 3(A)**

**Location:** 338322 6261618 Lower NW edge of large rock bench/pavement (track crosses NW corner of bench) with flows concentrated off pavement down track.

Cut broad shallow invert/spoon drain across drainage path over bench, discharging N away from track below (discharge area may need reinforcing with waterbar, or cut outlet drain, to ensure outflow is well clear of track below). Caution required in cutting invert across bench to avoid trip hazard and detracting from appearance of site.

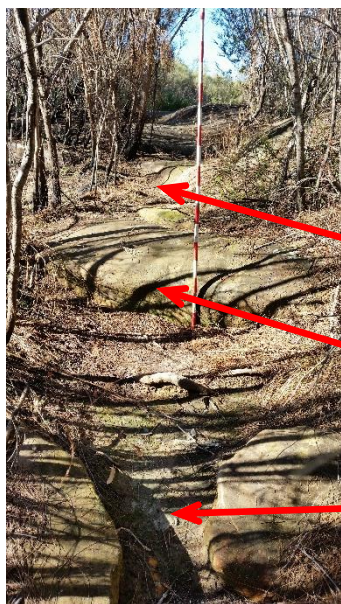
**Site ID: MRE – 3(B)**

*Location:* 338314 6261619 Series of rock ledges/outcrops and “natural steps” up to 500mm high over 13m section, some rounded/angled and slippery, 600-1,100mm wide compacted clay/sand, 13° gradient with drainage capture/flows down.

Total rebuild of upper section with steps and step-and-runs with infilling and compaction of treads (approx. 12-14 steps/risers needed overall), waterbar at top and at least 5 waterbars or stone-lined inverts on elongated treads midslope where practical (fill could be delivered via Perimeter Fire Trail upslope). Alternative treatment would be fibreglass reinforced plastic steps and landings, with existing gutter rubble filled and drainage inverts cut or blocked/walled underneath mesh at top and at least 2 points downslope).

Waterbar (rock) on central flatter section).

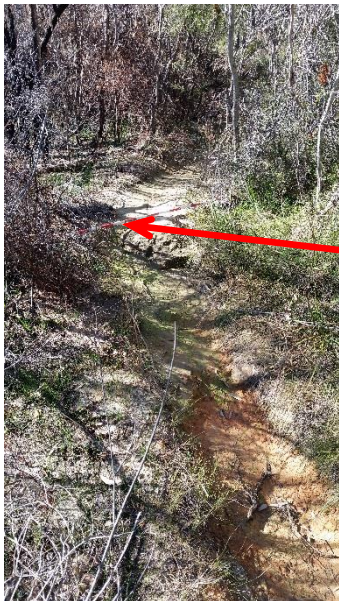
**Site ID: MRE – 3(D)**

*Location:* 338284 6261593 Dished track eroded 50-100mm below NSL, 400-600mm wide in compacted sandy clay with low embedded/outcropping rock, 4.5° gradient.

Rock waterbar built onto in-situ embedded/outcropping rock.

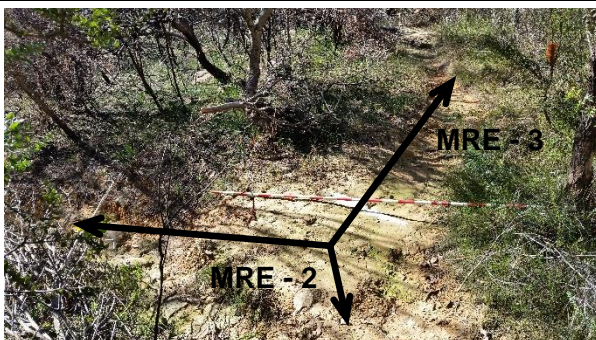
**Site ID: MRE – 3/2 (junction)**

*Location:* 338279 6261591 Junction with segment MRE – 2, joins at 80° bend. No wayfinding.

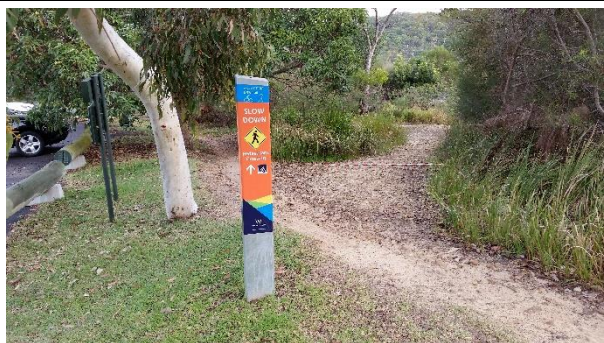
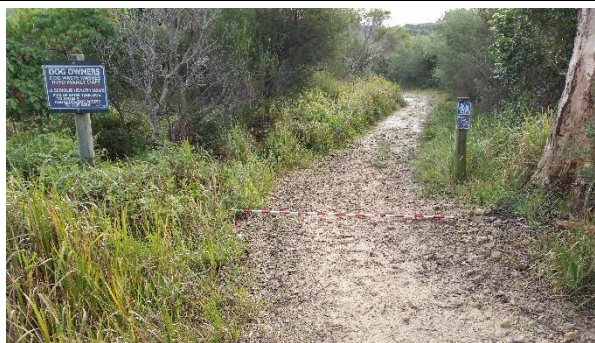
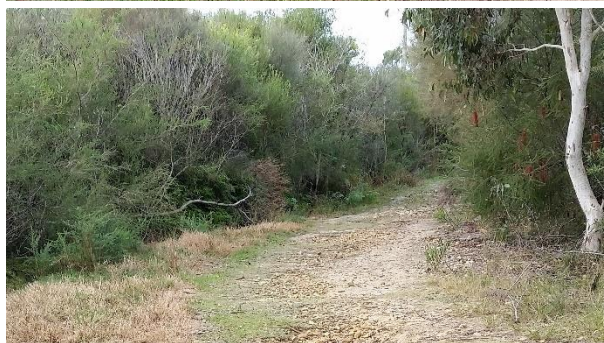
**Key Issues:** Drainage capture and fire trail maintenance. Signposting at junction with Park Circuit Track (East) – 5.

- Routine fire trail maintenance.
- Upgrade signage (at W end) as per Manly Dam sign Location Plan.

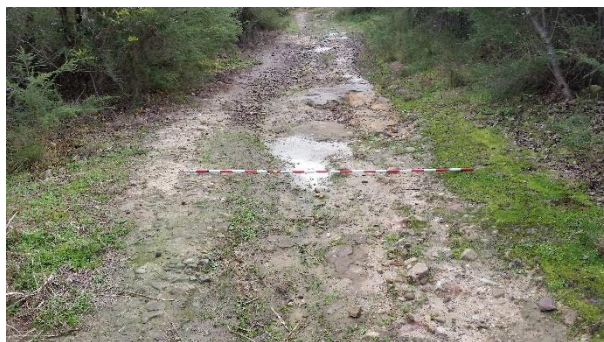
##### **Site ID: NRFT – 1A**

**Location:** 338377 6261220 Erosion to 150mm below NSL over and around flat/rounded rock outcrop.

**(low)**

Rollover drain upslope.

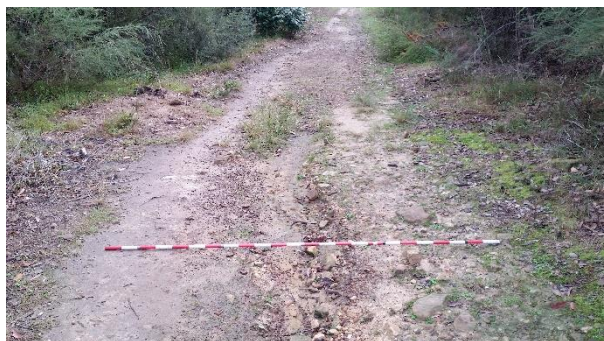
##### **Site ID: NRFT – 1B**

**Location:** 338349 6261229 Erosion guttering over knick points, with downslope loose sand and stone deposition. Drainage capture down track

**(low)**

Rollover drain upslope of erosion (downslope of power line service access gate).

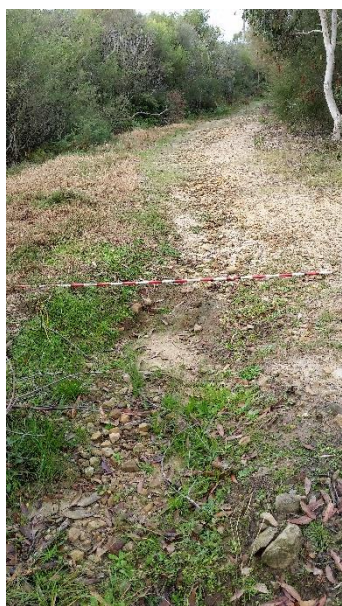
**Site ID: NRFT – 1C**

*Location:* 338275 6261256 Erosion gutter 5m long and 50-250mm below NSL, running from centre of track to N side on bend, with loose rounded rocks. Drainage capture down trail.

**(Medium - sustainability/impact issues  
(sediment deposition))**

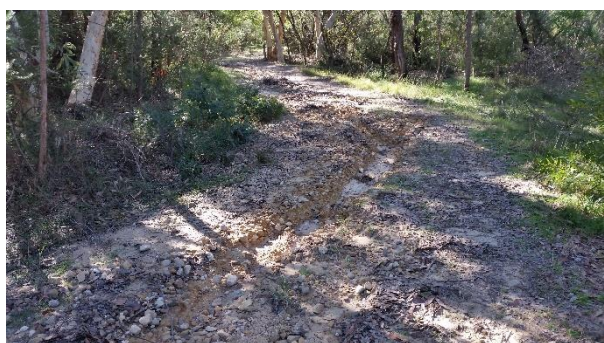
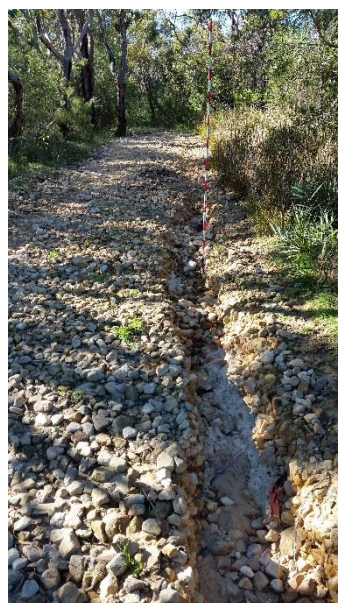
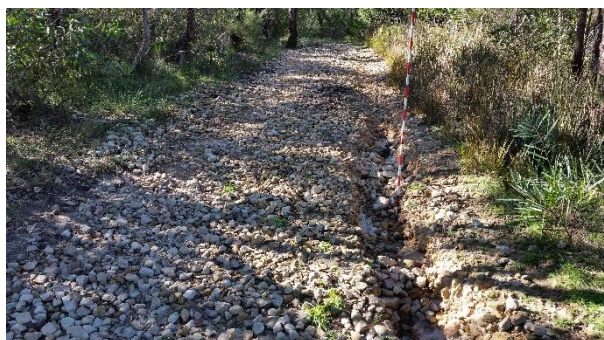
*Key Issues:* Loose rounded surface rocks and slip/fall hazard. Drainage capture and fire trail maintenance. Signposting at W end at junction with Park Circuit Track (East) – 4, and at E end at junction with Park Circuit Track (East) – 5.

- Repair deeply guttered/eroded section (whole segment) and address exacerbated loose/rounded rock hazard (on lower section) after storm event (below right and left). **(HIGH – passability/safety issues, and sustainability/impact issues)**
- Upgrade signage/wayfinding as per Manly Dam Sign Location Plan.

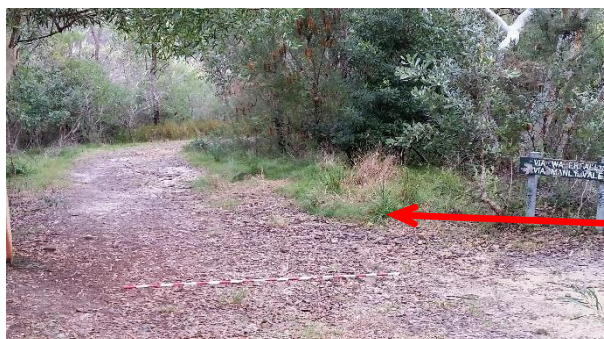
**Site ID: NRFT – 2A**

**Location:** 338251 6261236 N side gutter spills out over Fire Trail and flows down trail with minor below junction with Park Circuit Track (East) -5.

**(low)**

Enlarge N side gutter and outflow, reinforce (with trailside mound) to prevent backflow onto Fire Trail.

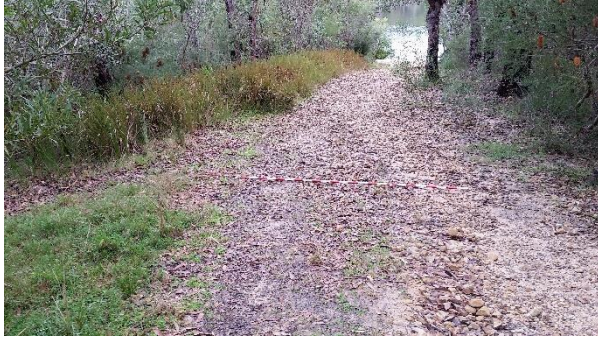
**Site ID: NRFT – 2B**

**Location:** 338239 6261212 Top of 5° gradient directly downslope to dam, with existing scour and sheet erosion with loose rounded rocks. (Deeply guttered/eroded by later major rainfall event of 4-6 June 2016.)

**(Medium - passability/safety issues)**

Rolllover drain on upper section of slope to divert flows and reduce further erosion.

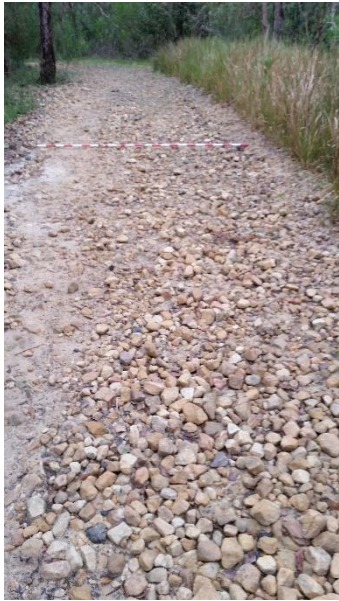
**Site ID: NRFT – 2C**

**Location:** 338225 6261205 Extended slope at gentle/moderate 5° gradient with considerable loose rounded rock (tennis ball size), slip/fall hazard, 38m overall (lower 28m in poor/hazardous condition, upper 10m in fair condition). (Deeply guttered/eroded, and loose rounded rock hazard exacerbated, by major rainfall event of 4-6 June 2016.)

**(HIGH – safety issue, for passability/safety)**

Remove and/or stabilise and compact loose rounded rocks.

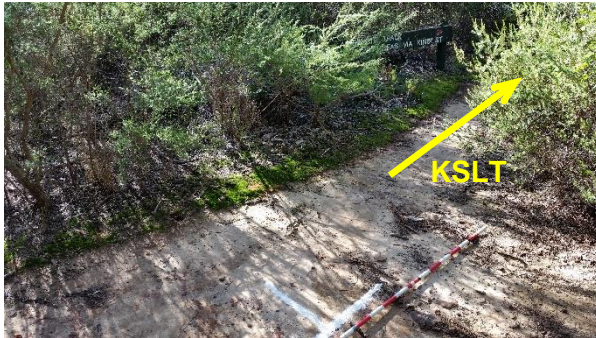
**Site ID: KSLT(W), junction with Park Circuit Track (East)**

*Location:* 338440 6260929 Track junction, “King St Link” track to APZ head NE at sharp/90° bend in Park Circuit Track (East). Two routed timber signs (1 - “ALTERNATE TRACK TO PICNIC AREAS VIA KING STREET” and 2 - “PICNIC AREA VIA DAM WALL” upper line “PARK CIRCUIT TRACK TO PICNIC AREAS VIA WATERFALL ”LOWER LINE”) – fair condition.

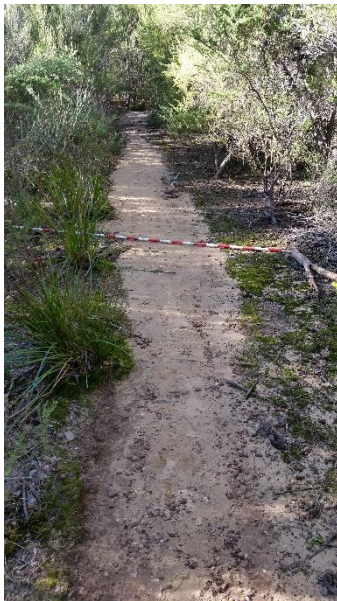
**Site ID: KSLT – 1**

*Location:* 338450 6260941 Loose/deposited sand from junction with Park Circuit Track upslope (site PCT(E) – 2D).

**(low)**

Waterbar, with extended discharge/outlet well off track.

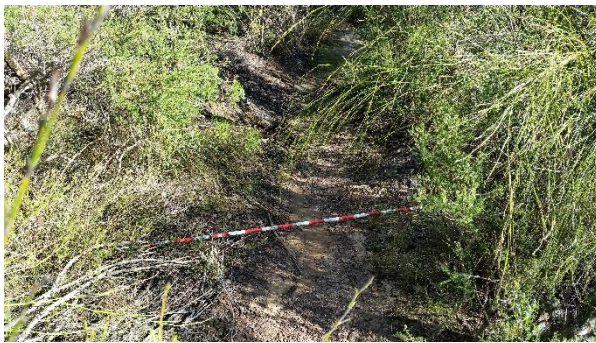
**Site ID: KSLT – 2**

*Location:* 338462 6260954 3 spaced rock outcrops, sloped with compacted sand and laterite gravel between, 4-5° gradient with drainage down track.

**(low)**

Stone infill and level gap/dip in lower rock outcrop.

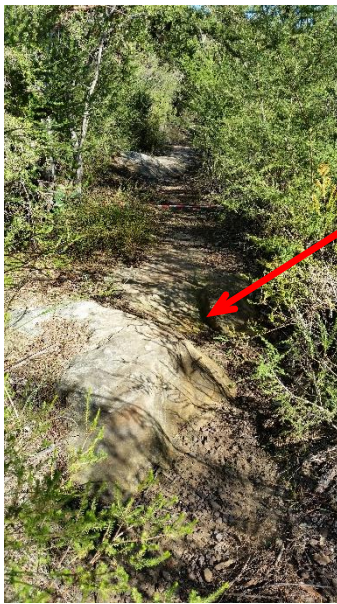
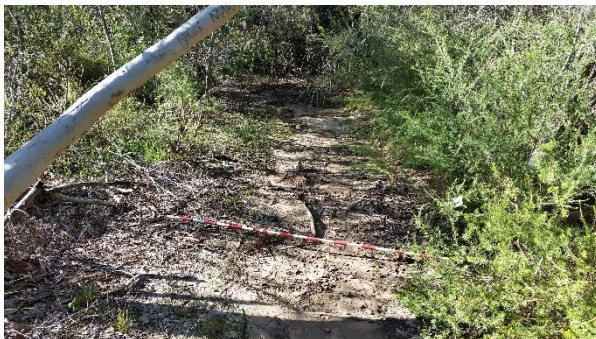
**Site ID: KSLT - 3**

*Location:* 338473 6260974 Upslope of flat/uneven rock outcrops and small ledge/"natural" step on bend, exposed roots, 2.5 ° gradient.

**(low)**

Waterbar, to divert flows before rock outcrops.

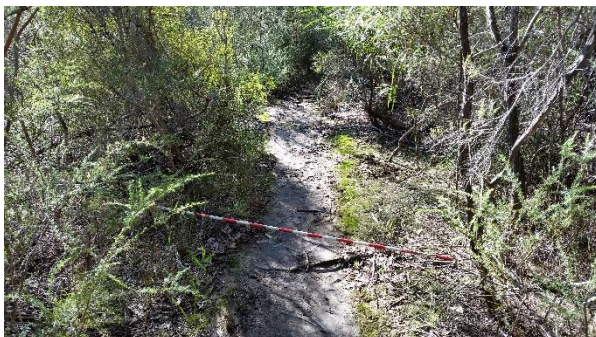
**Site ID: KSLT - 4**

*Location:* 338479 6261001 Upslope of flat/uneven rock outcrops, with ledge/small "natural" step, 2.5 ° gradient.

**(low)**

Waterbar, to divert flows before rock outcrops.

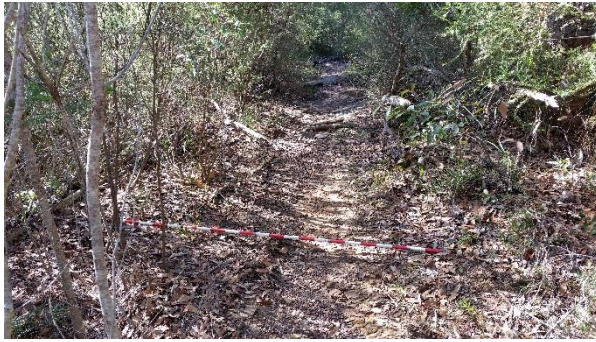
**Site ID: KSLT – 5**

*Location:* 338480 6261042 Upslope of angled flat rock outcrops with drainage capture, 4 ° gradient

**(low)**

Waterbar, to divert flows before rock outcrops.

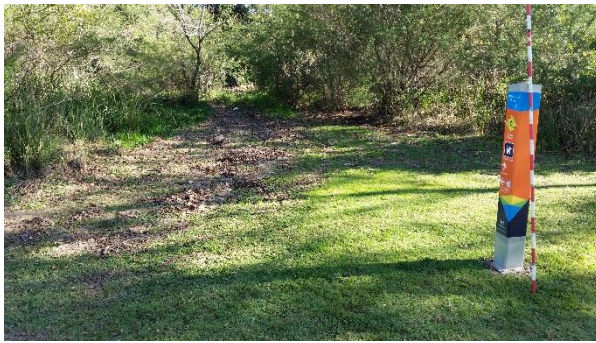
**Site ID: KSLT(E), east end of King Street Link Track, at APZ**

*Location:* 338480 6261042 New signage/directional totem at APZ.
