# ARBORICULTURAL IMPACT ASSESSMENT REPORT

relating to the proposed inclinor at

**106 PRINCE ALFRED PARADE  
NEWPORT NSW 2106**

22 November 2023  
Revision A

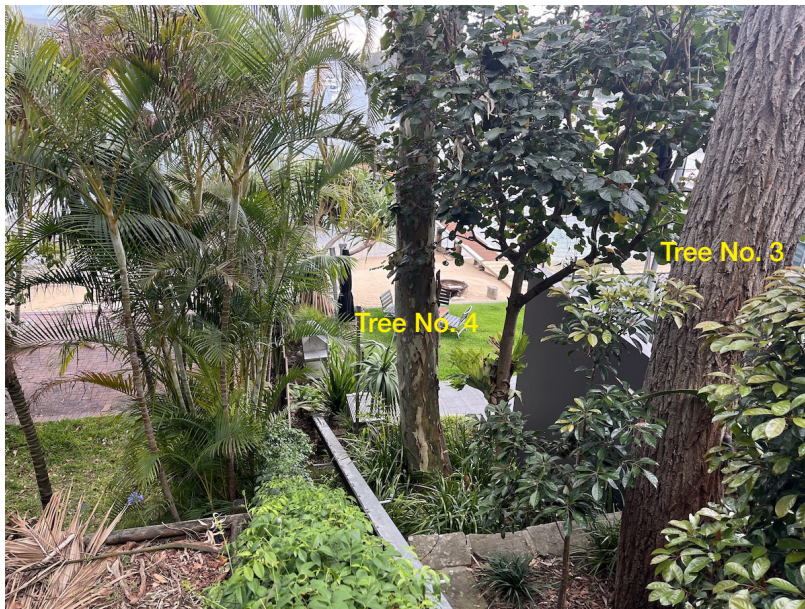
Figure 7 (left): Photograph viewing north along the eastern side boundary with the neighbouring trees visible. (Photo: J Willis)

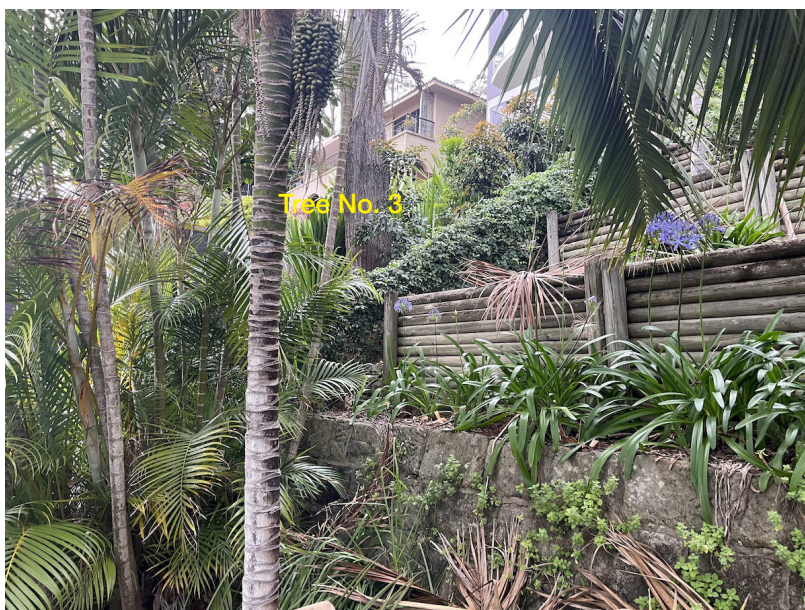
Figure 8 (left): Photograph viewing southwest to the existing retaining walls in the rear yard. Tree No. 3 is visible in the background. (Photo: J Willis)

**(ii) Excavation Works:** Excavation for foundations, piers and all footings must be hand dug with extreme care when located in the TPZ of the assessed trees. Additionally, adjustments to retaining wall and terraced garden level (RL 7.15) in TPZ of Tree No. 3 must be undertaken by non-mechanical methods. Under no circumstances should excavation occur via mechanical methods unless rock is encountered. The final location of all foundations, piers and footings must ensure there is no cutting of any woody roots greater than 40mm diameter. Where woody roots greater than 40mm diameter are encountered and the foundation cannot be relocated, further advice must be sought from a qualified Arborist prior to root severance. Any roots less than 40mm in diameter shall be cut cleanly with sharp pruning implement.
