## **ARBORIST REPORT**

### **Arboricultural Hazard Assessment**

114 Lady Davidson Circuit  
Forestville  
NSW 2087

Sydney Arborist  
Paul Shearer 8<sup>th</sup> of February 2014  
Ph: 0423 568 159  
Email: [antony@sydneyarborist.com](mailto:antony@sydneyarborist.com)  
Version 01. Revision 00.

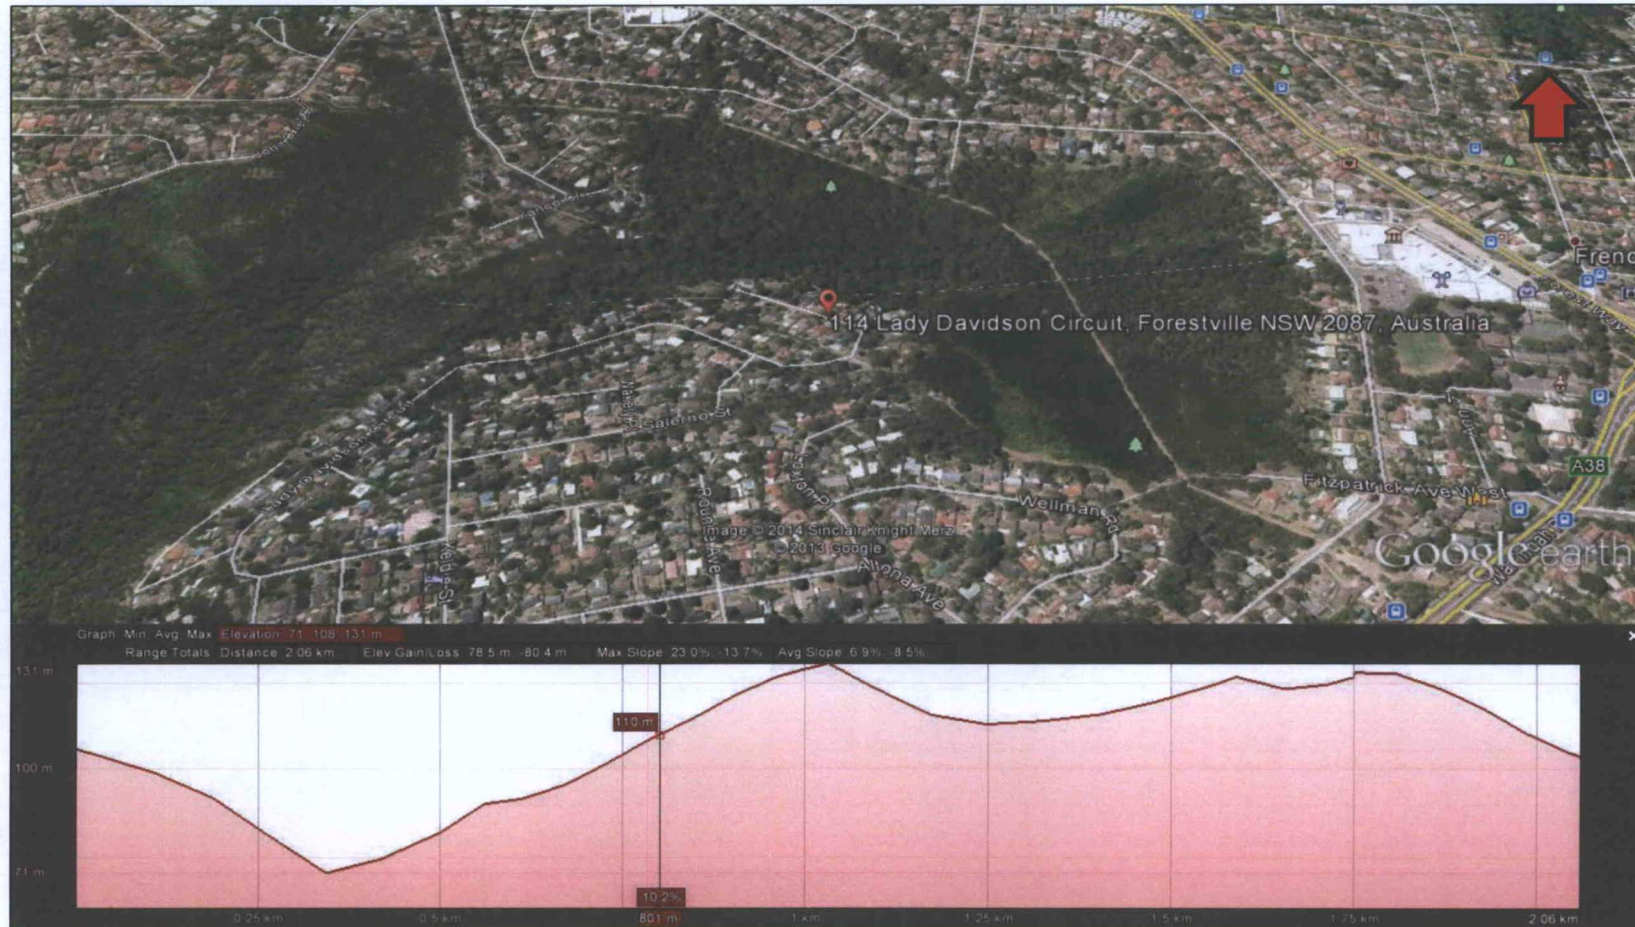
**PHOTOGRAPH 2 & DIAGRAM 1. Site Elevation Profile. The elevation on-site is 109 metres. North point estimated. (Google Earth 2014)**

- 2.2 The site elevation profile (photograph 2 and diagram 2) has been provided as mean wind speed and gale frequency increases with elevation. Site exposure to strong winds due to aspect, topography and elevation are all factors which contribute to tree failure. (*Harris Clarke & Matheny 2004*)
