GEOTECHNICAL INVESTIGATION:

Alterations and Additions at **1 James Wheeler Place, Wheeler Heights**

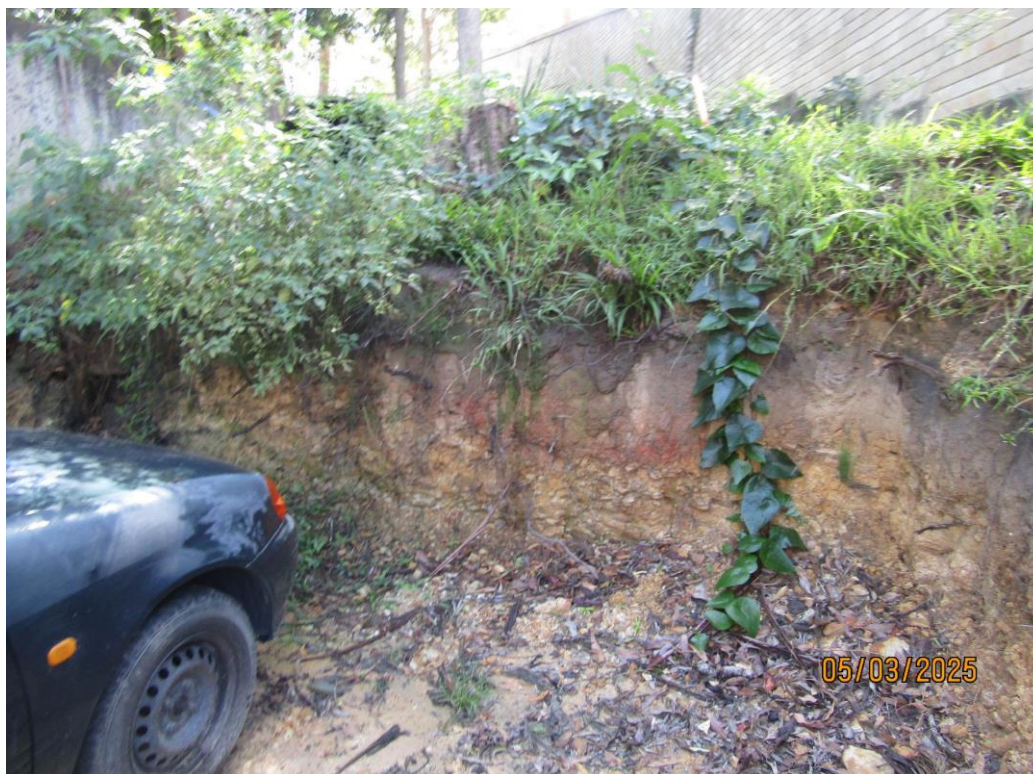
Photo 12

A pool that shows no significant signs of movement is located at the SW side of the house (Photo 8). Stable sandstone block and rendered masonry retaining walls up to ~3.5m high support fills for lawn, garden and paved areas across the property, and for a cut and fill for a tennis court in the NW corner of the property (Photos 9 to 12). The S side of the property is accessed via a gravel driveway with level parking area (Photo 12). An unsupported excavation up to ~1.5m high for the parking area has been taken through topsoil, clay and weathered rock (Photo 13). The excavation comes close to flush with a rendered masonry retaining wall supporting fill above (Photos 12 & 14). It is recommended the excavation be supported by a retaining wall as soon as possible.
