## **40 Bassett Street, Mona Vale**

### Geotechnical Comments for Section 4.55.

## **GEOTECHNICAL INVESTIGATION:**

### **New House and Pool at 40 Bassett Street, Mona Vale**

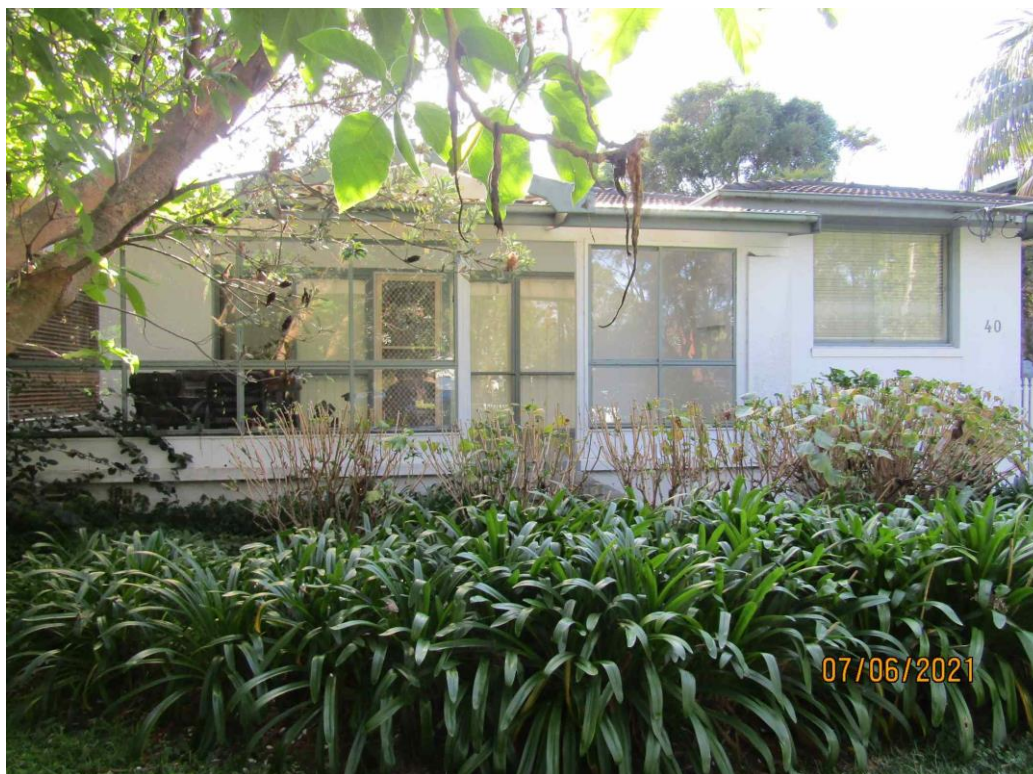
Photo 2

- 2.3** At the road frontage, a gravel and concrete driveway runs along the E side of the house to a rendered masonry garage on the uphill side of the house (Photos 1 & 2). Between the road frontage and the house is a near level lawn area (Photo 1). The single storey rendered brick house is supported by brick walls and brick piers (Photos 3 & 4). The supporting walls and piers stand vertical and show no significant signs of movement (Photo 5). A gently sloping lawn extends from the uphill side of the house and garage to the uphill property boundary (Photo 6).
