# ALL ARBOR SOLUTIONS

## Arboricultural Impact Assessment

**Site Address:** 61 Loombah Street  
Bilgola Plateau  
NSW  
2107

**Date:** 2 November 2022

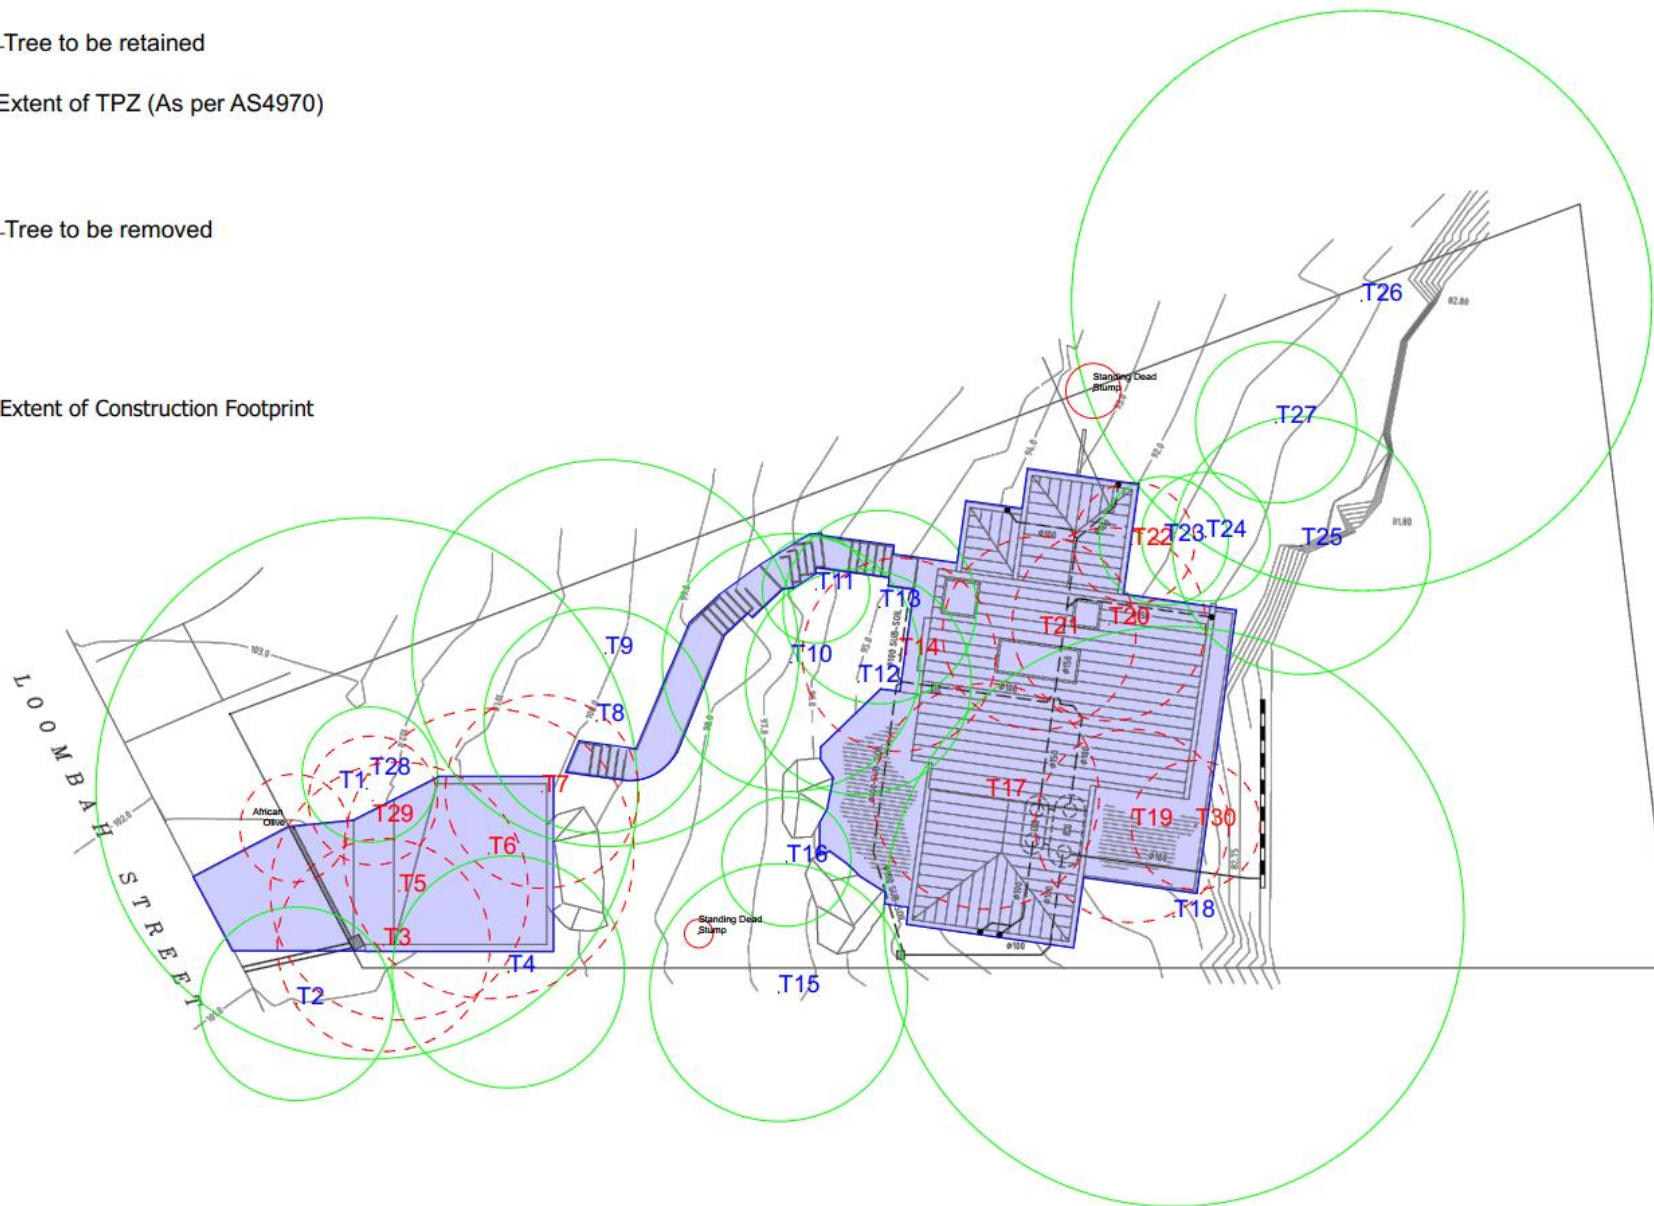
**Appendix 4: Tree Retention & Removal Plan**

Extract from Stormwater Management Plan showing trees to be retained and trees to be removed.

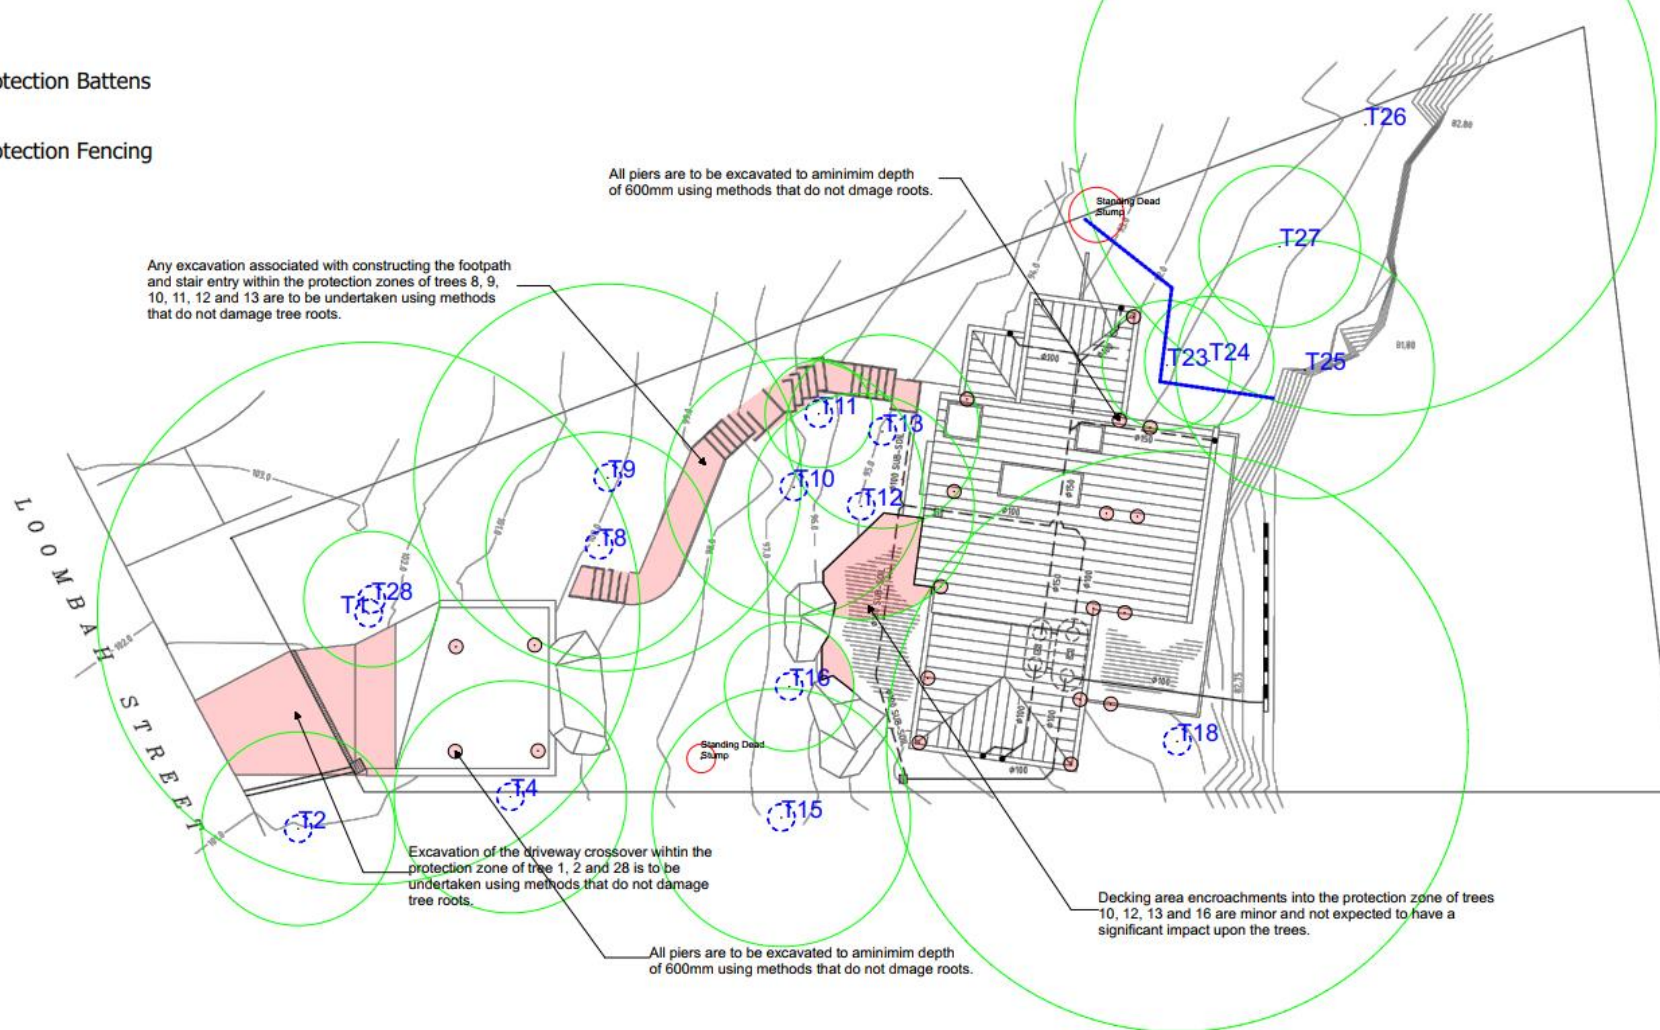
Extract from stormwater Management Plan showing TPZ encroachment areas and protection methods for individual trees. Tree protection is to be implemented under the guidance of the project arborist.
