J0830. 6th June, 2016. Page 1.

GEOTECHNICAL INVESTIGATION:

Alterations & Additions at 2 Herbert Avenue, Newport

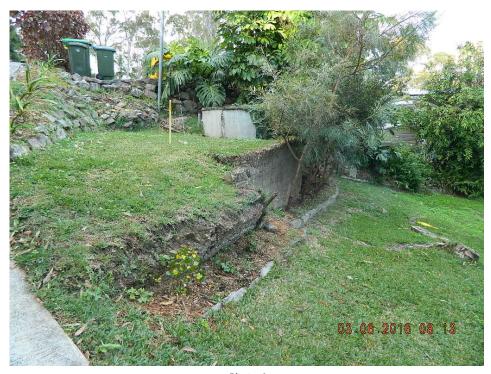
Photo 3

- 2.3 At the road frontage a concrete driveway runs to a concrete paved car parking area under the house (Photo 1 & 2). The fill batter for the driveway is supported by an old stack rock retaining wall that is inclined upslope and shows no significant signs of movement (Photo 3). The area beside the driveway has been terraced with an old formed concrete retaining wall that has failed on its N side (Photo 4). The plans indicate the N side of the wall will be demolished as part of the proposed works. The S side of the wall that will remain currently appears stable (Photo 5). The single storey steel, brick and timber framed house is in good condition for its age. Its supporting steel posts stand vertical. The concrete slab for the parking area under the house displays cracking and minor settlement in areas however it poses no risk to life or property (Photo 6 & 7). A low elevation, mortared rock retaining wall supports a fill for the downhill side of the car parking area (Photo 8). It displays minor cracking but is currently considered stable. The land surface surrounding the house, driveway and parking area is mostly lawn covered.
