Report Title: Geotechnical Report 5 Northview Road, Palm Beach  
Report Date: 23/12/20

## **GEOTECHNICAL INVESTIGATION:**

### **Alterations and Additions at 5 Northview Road, Palm Beach**

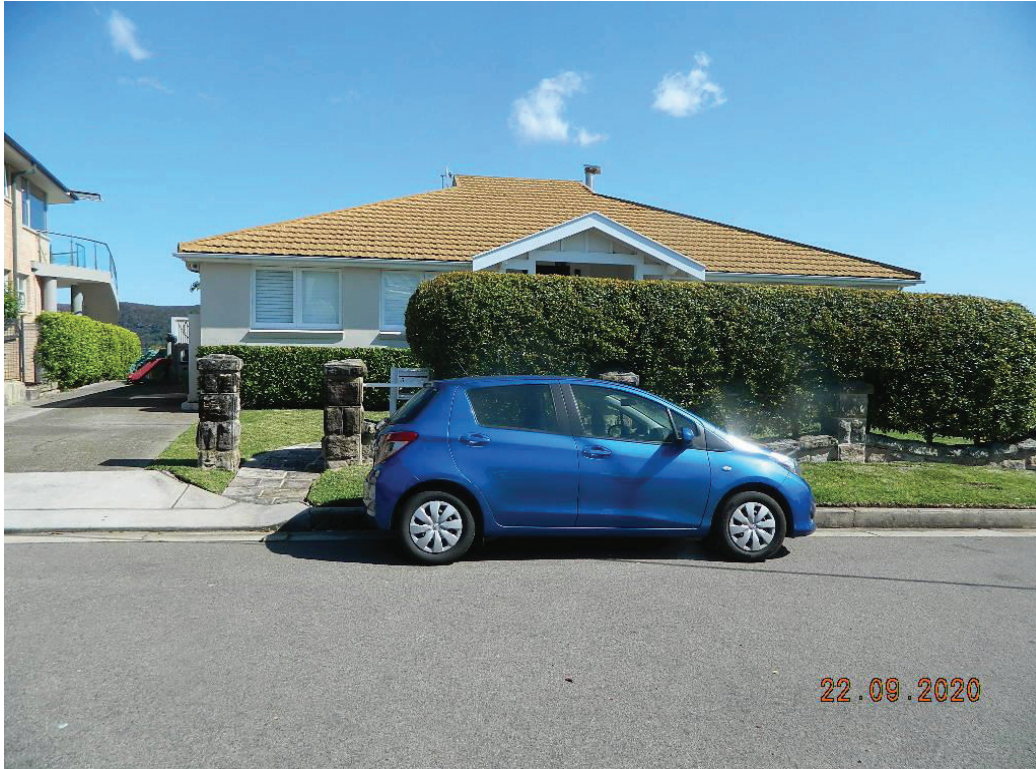
Photo 1

- 2.1** The site was inspected on the 22<sup>nd</sup> of September, 2020.
- 2.2** This residential property is on the low side of the road and has a NW aspect. It is located on the moderate to steeply graded upper reaches of a hillslope. The natural slope falls from the uphill boundary to the downhill side of the house at an angle of ~11° before increasing in grade to an angle of ~26°. The slope below the property continues at similar steep angles for some 30m before gradually easing. The slope above the property eases to near level angles on the crest of the hillslope.
- 2.3** At the road frontage, a concrete driveway runs to a parking area on the S side of the house (Photos 1 to 2). The two storey rendered masonry and sandstone block

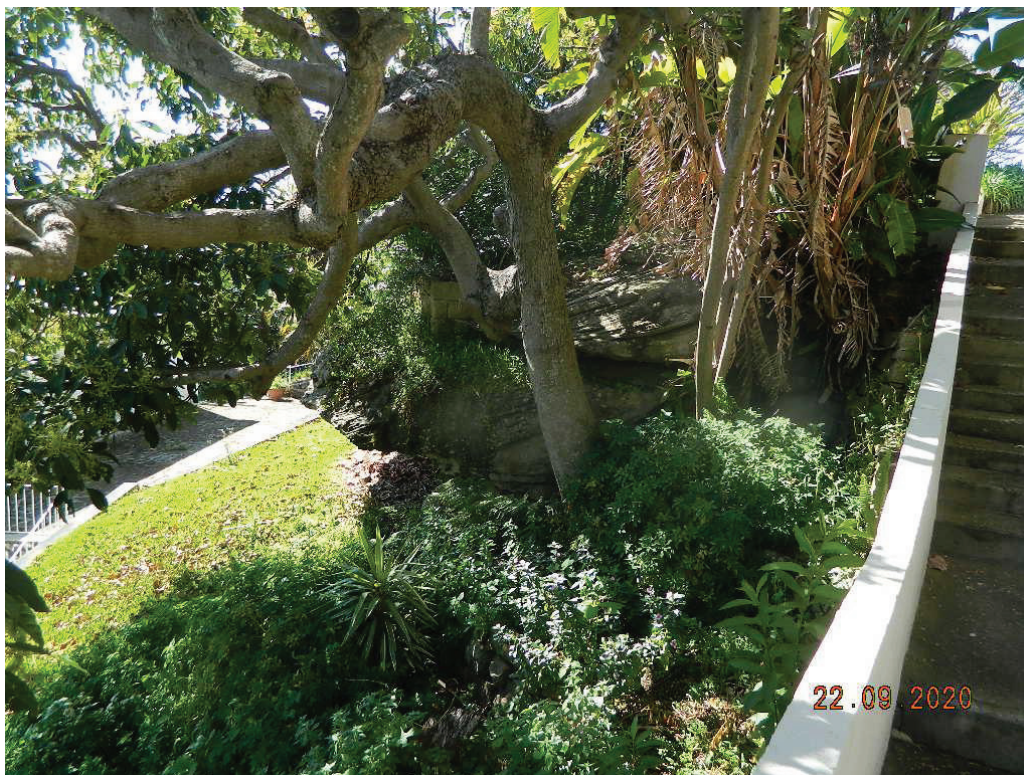
Photo 6

house is supported by rendered masonry walls, sandstone block walls and brick walls (Photos 3 & 4). One of the supporting sandstone block walls displays cracking through the mortar but is considered to be stable (Photo 5). Sandstone bedrock outcrops on the N and downhill sides of the house (Photos 6 & 7). A sandstone block retaining wall ~1.5m supports fill near the SW corner of the house (Photo 7). The wall displays two thick stepped and vertical cracks through the mortar. See 'Section 14 Ongoing Maintenance'. Fill provides a near level lawn area on the downhill side of the house. The fill is supported by timber crib and stack rock retaining walls up to ~2.5m high (Photos 8 & 9). The timber crib retaining wall is in a dilapidated state. See 'Section 14 Ongoing Maintenance'. Sandstone bedrock is outcropping on the steep slope below the lawn area (Photo 10). No signs of slope instability were observed on the property that could have occurred since the property was developed. The adjoining neighbouring properties were observed to be in good order as seen from the street and subject property.
