## **2A Beatty Street, Balgowlah Heights**

## **GEOTECHNICAL INVESTIGATION:**

### **New Inclined Lift at 2A Beatty Street, Balgowlah Heights**

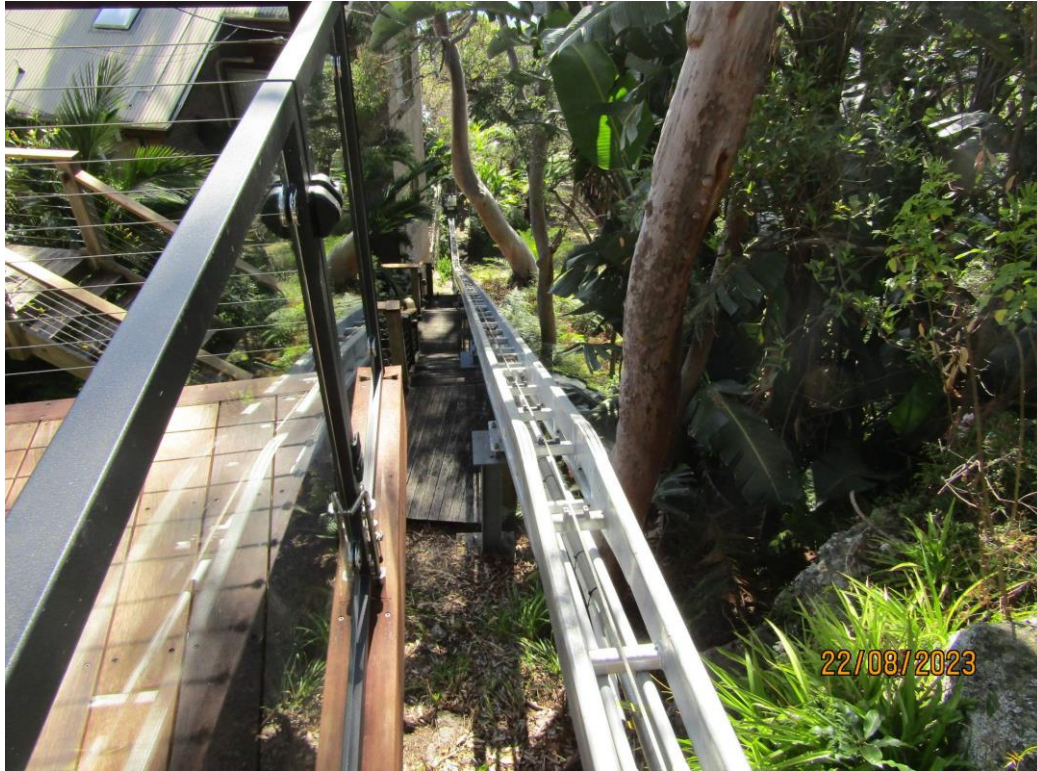
Photo 2

- 2.3** At the road frontage, a concrete Right of Carriageway (ROW) runs down the slope to a suspended carport (Photos 1 & 2). The concrete piers that support the carport stand vertical. An inclined lift runs through a narrow strip of land to the SE of 2 Beatty St from beside the carport to beside the subject house (Photo 3). Medium Strength Sandstone bedrock outcrops and steps down the slope between the carport and the house (Photos 4 & 5). Sprayed concrete has been installed onto part of the rock face upslope of the subject house and below the uphill neighbouring house (Photo 6). This is expected to have remediated a defect in the rock face. The visible portion of the rock face appears to be stable. The two-storey tile and sandstone dressed house and single-storey secondary dwelling show no significant signs of

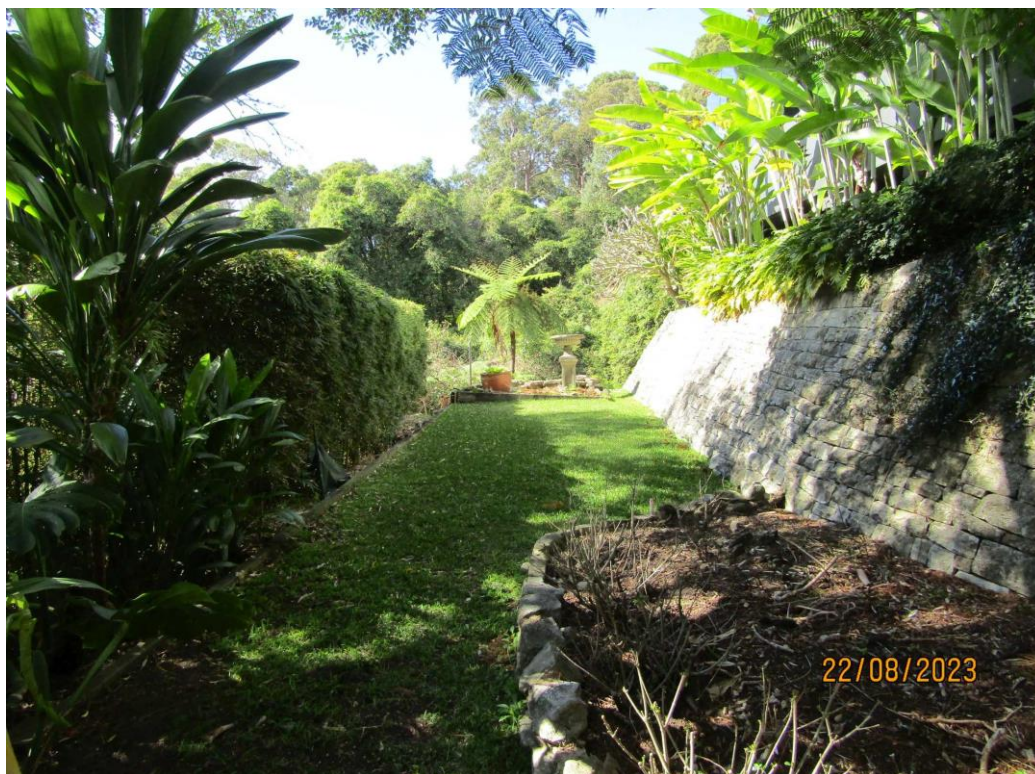
Photo 10

Fill provides level platforms for paved, lawn and garden areas between the house and the downhill property boundary. Sandstone block, stack rock and timber retaining walls up to ~2.5m high support the fills (Photos 10 to 12). Most of the retaining walls appear to be stable or are sufficiently low in height that they do not pose a significant threat to life or property. A stack rock retaining wall up to ~2.0m high to the NE of a timber clad boatshed near the downhill property (Photo 12) displays minor bulging, but will be partially demolished and rebuilt as part of the proposed works. Medium Strength Sandstone bedrock outcrops at the waterfront (Photo 13). An intermittent watercourse runs down the slope on the council reserve to the SE of the property (Photo 14). The adjoining neighbouring properties were observed to be in good order as seen from the street and subject property.
