Arboricultural Impact Assessment

Tree Protection Plan

Site: 918 Barrenjoey Road Palm Beach 2108

Date of review: 24 March 2022

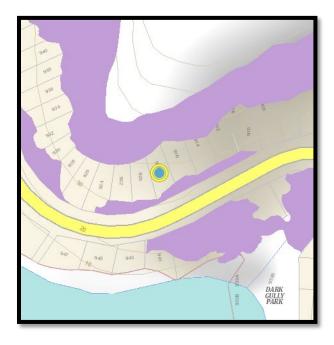
Figure 2 - Aerial image of the site indicating threatened communities in purple

The site has been identified on the Biodiversity Values Map and Threshold Tool as a parcel containing sensitive vegetation. Threatened species or communities (Pittwater Spotted Gum Forest, Littoral Rainforest) with potential for serious and irreversible impacts (figure 2).

The site has been identified on the Biodiversity Values Map and Threshold Tool as a parcel containing sensitive vegetation, threatened species or communities with potential for serious and irreversible impacts (figure 2). Tree protection measures to protect these areas identified within biodiversity mapping tool are required.
