# **Arboricultural Impact Assessment**

**8 Alan Avenue Seaforth**

**December 2020**

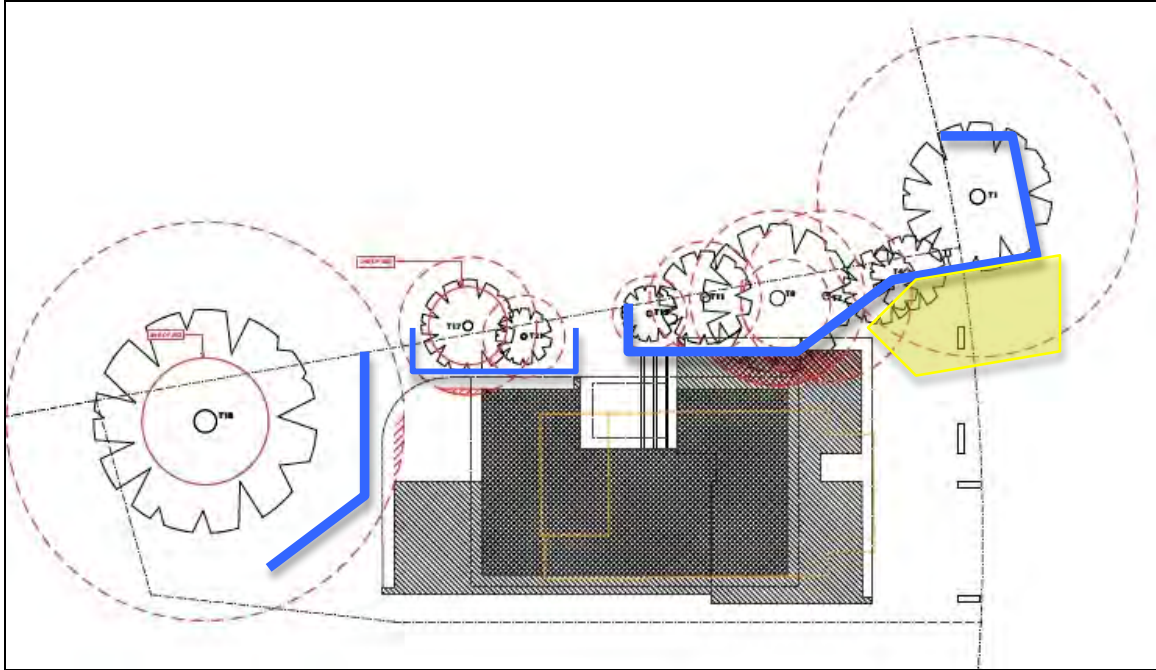
**Figure 30:** Install ground protection in the current site access which is through the TPZ of Tree 1 indicated by the yellow polygon. Install TPZ fencing at location of blue lines. (Source Tree Protection Plan by JR Residential Design, dated 11/12/2020)

Ground protection matts or rumble boards of suitable thickness to prevent ground compaction and root damage are to be installed in the access route through the TPZ of Tree 1.
