## 75 Victor Road, Dee Why

Arbor Impact Assessment  
Version 1.0

Client: Mr & Mrs Bloch  
c/- Niwa Designs

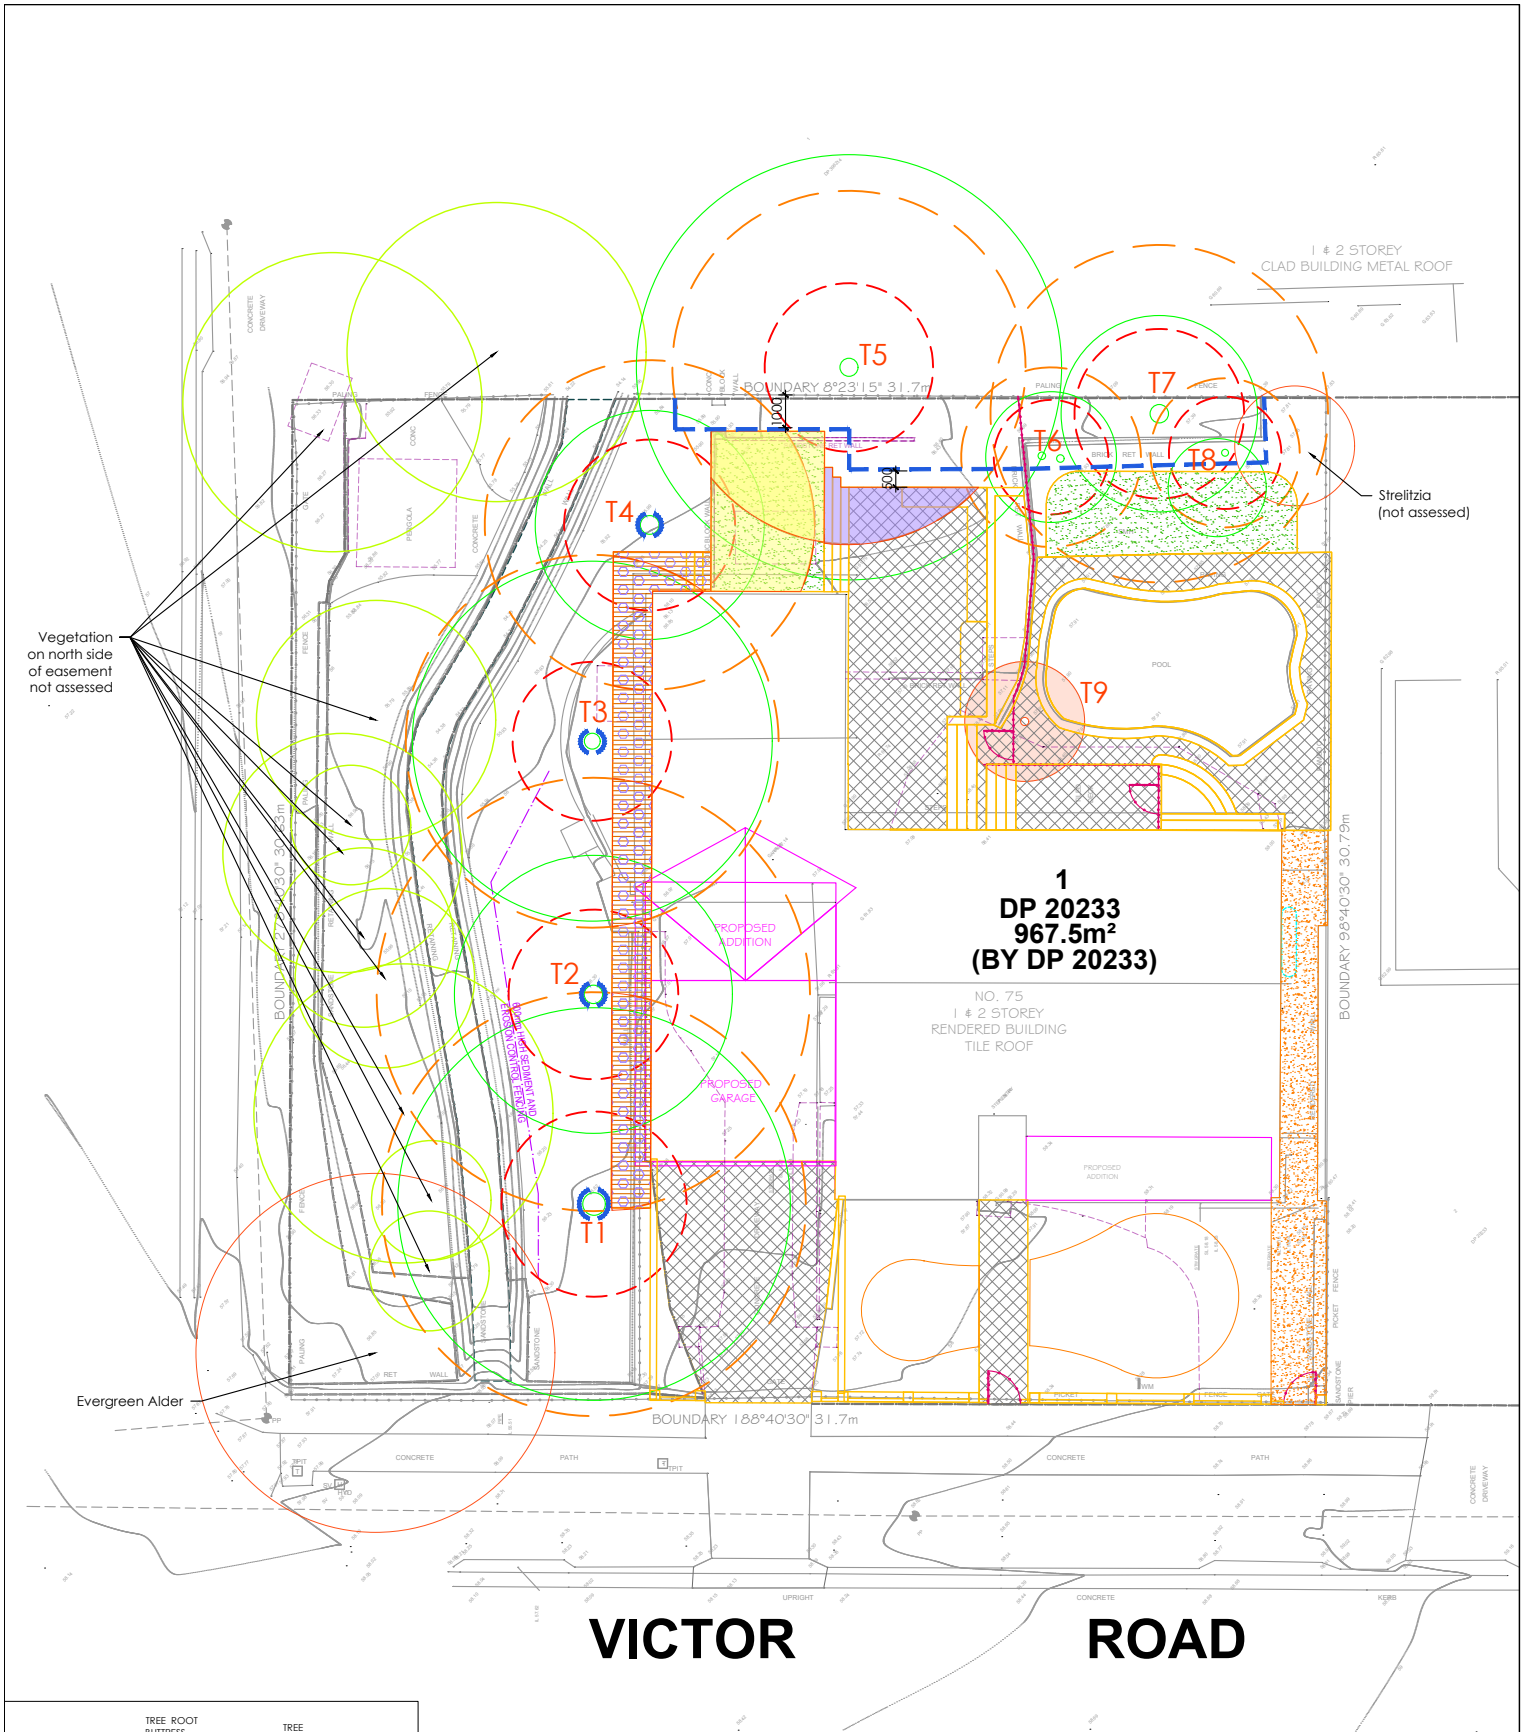
| REV | ISS | BY | DATE | DESCRIPTION | PROJECT | ADDITIONS & ALTERATIONS | DATE |
|---|---|---|---|---|---|---|---|
| A | | LS | 20.06.24 | TREE LOCATION & IMPACT PLAN | 75 VICTOR ROAD, DEE WHY | TREE LOCATION & IMPACT PLAN | |

- A fenced exclusion zone must be implemented that extends around as much of the TPZ of Tree No.'s 6 & 8, while providing a reasonable offset from soft landscape works within the pool complex to allow clear access for construction activities (as indicated on the **TREE LOCATION & IMPACT PLAN**, page 20). This exclusion zone must be installed as per **10.2- TREE PROTECTION FENCING**, page 21 of this report.

- Tree No.'s 1, 2, 3 & 4 must have protective battening installed on the lower trunk (as per **10.3 – OTHER TREE PROTECTION MEASURES**, page 22) that shall consist of internal cushioning and battens strapped together consistent with the Australian Standard for the Protection of Trees on Development Sites (AS 4970 - 2009), Section 4 and paragraph 4.5.2 and Figure 4. The battens shall consist of 2.5m lengths on Tree 1, 3m lengths on Tree 2, and 2m lengths on Tree No.'s 3 & 4 that are 35 x 70mm (or similar to accommodate tree structure) structural timber secured side by side, spaced 50-100mm apart with galvanised steel banding for the full circumference of the trunk and fixed by straps without driving nails or screws into the trunk or branches. These battens should be installed prior to site establishment and removed after completion of the development.
