Development Application for Jennifer Hempton  
Name of Applicant  
Address of site 89 Marine Parade, Avalon Beach, NSW

**REPORT ON GEOTECHNICAL SITE INVESTIGATION  
AND RISK ASSESSMENT  
FOR PROPOSED NEW DWELLING**

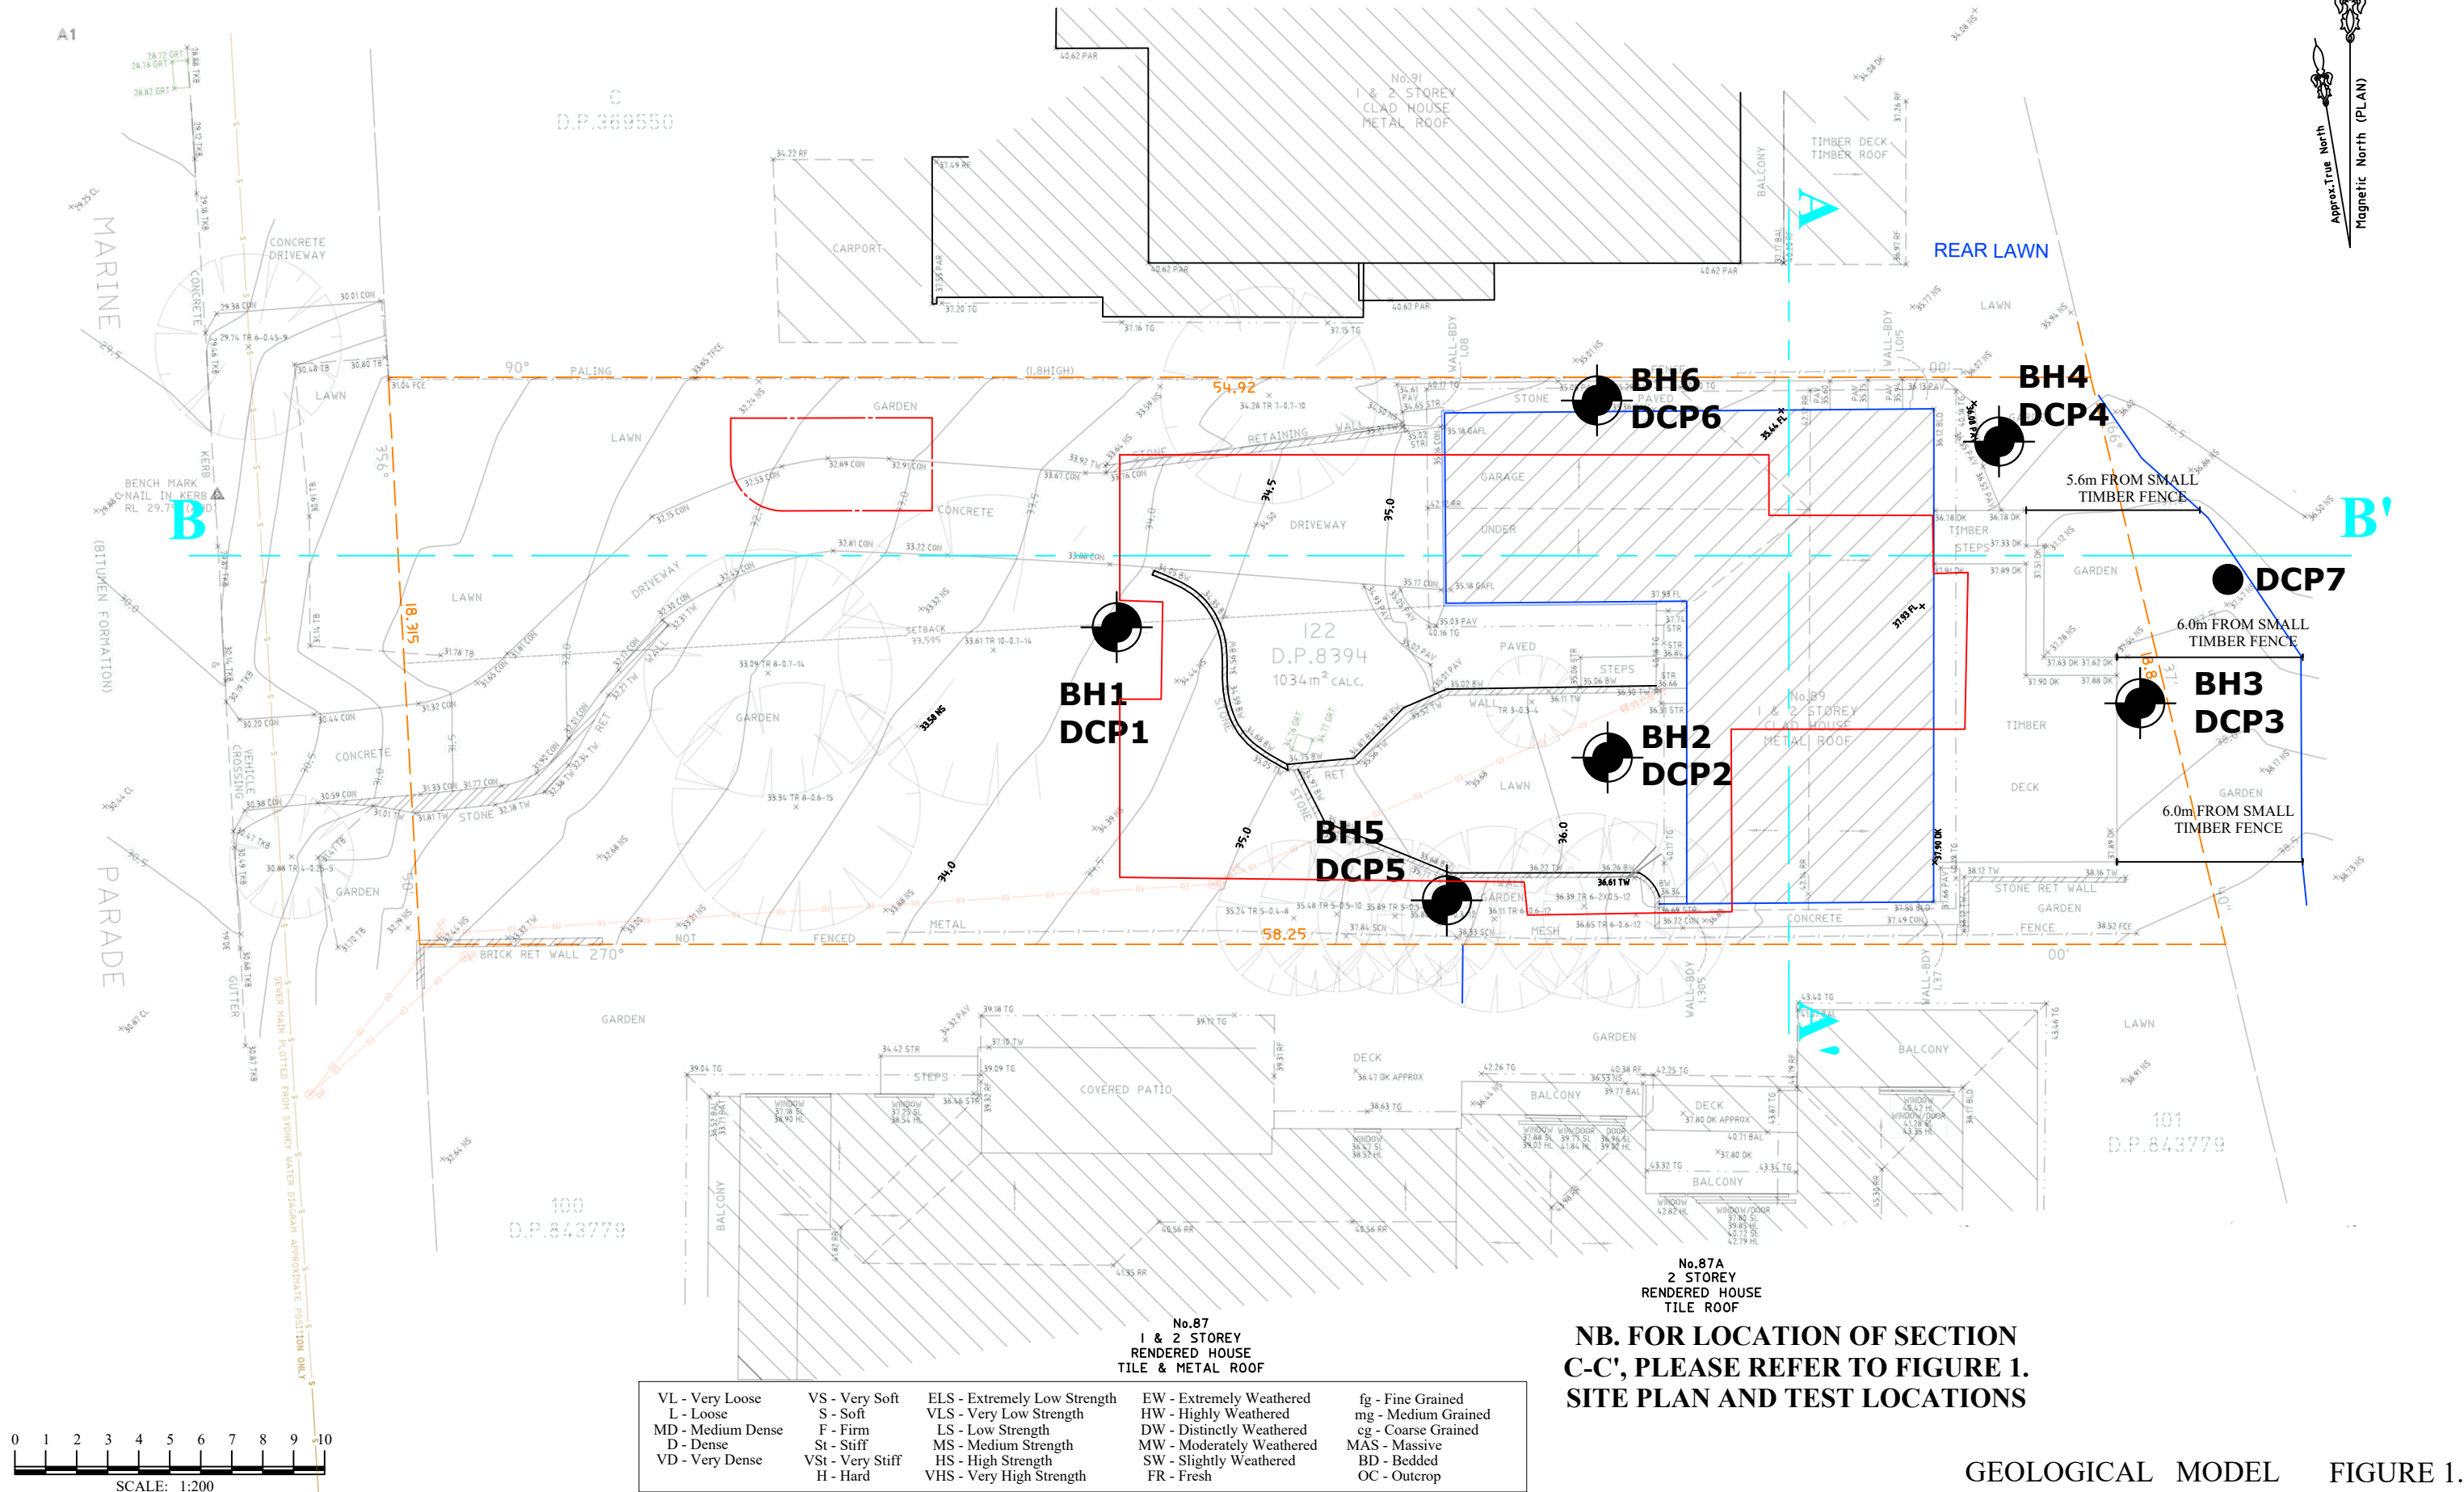
**GEOLOGICAL MODEL FIGURE 1.**

**NB. FOR LOCATION OF SECTION C-C', PLEASE REFER TO FIGURE 1. SITE PLAN AND TEST LOCATIONS**

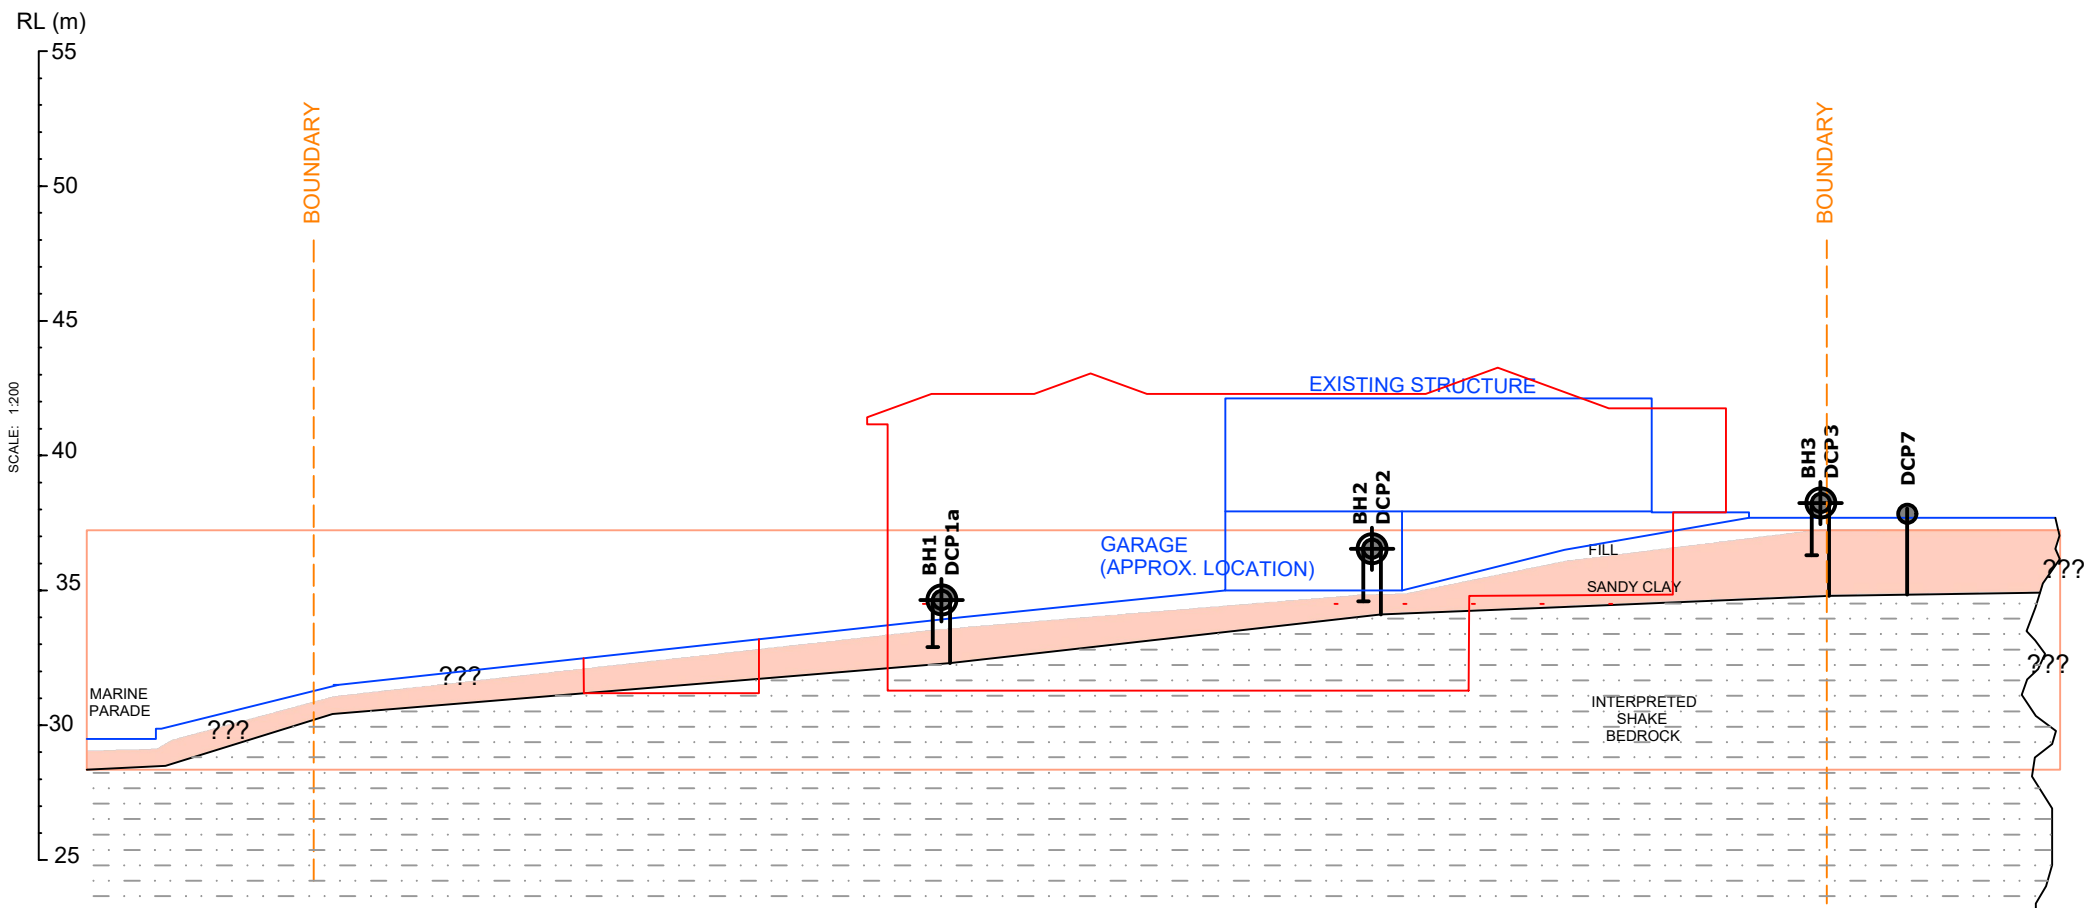
**GEOLOGICAL MODEL** **FIGURE 3.**

**NB. FOR LOCATION OF SECTION A-A', PLEASE REFER TO FIGURE 1. SITE PLAN AND TEST LOCATIONS**

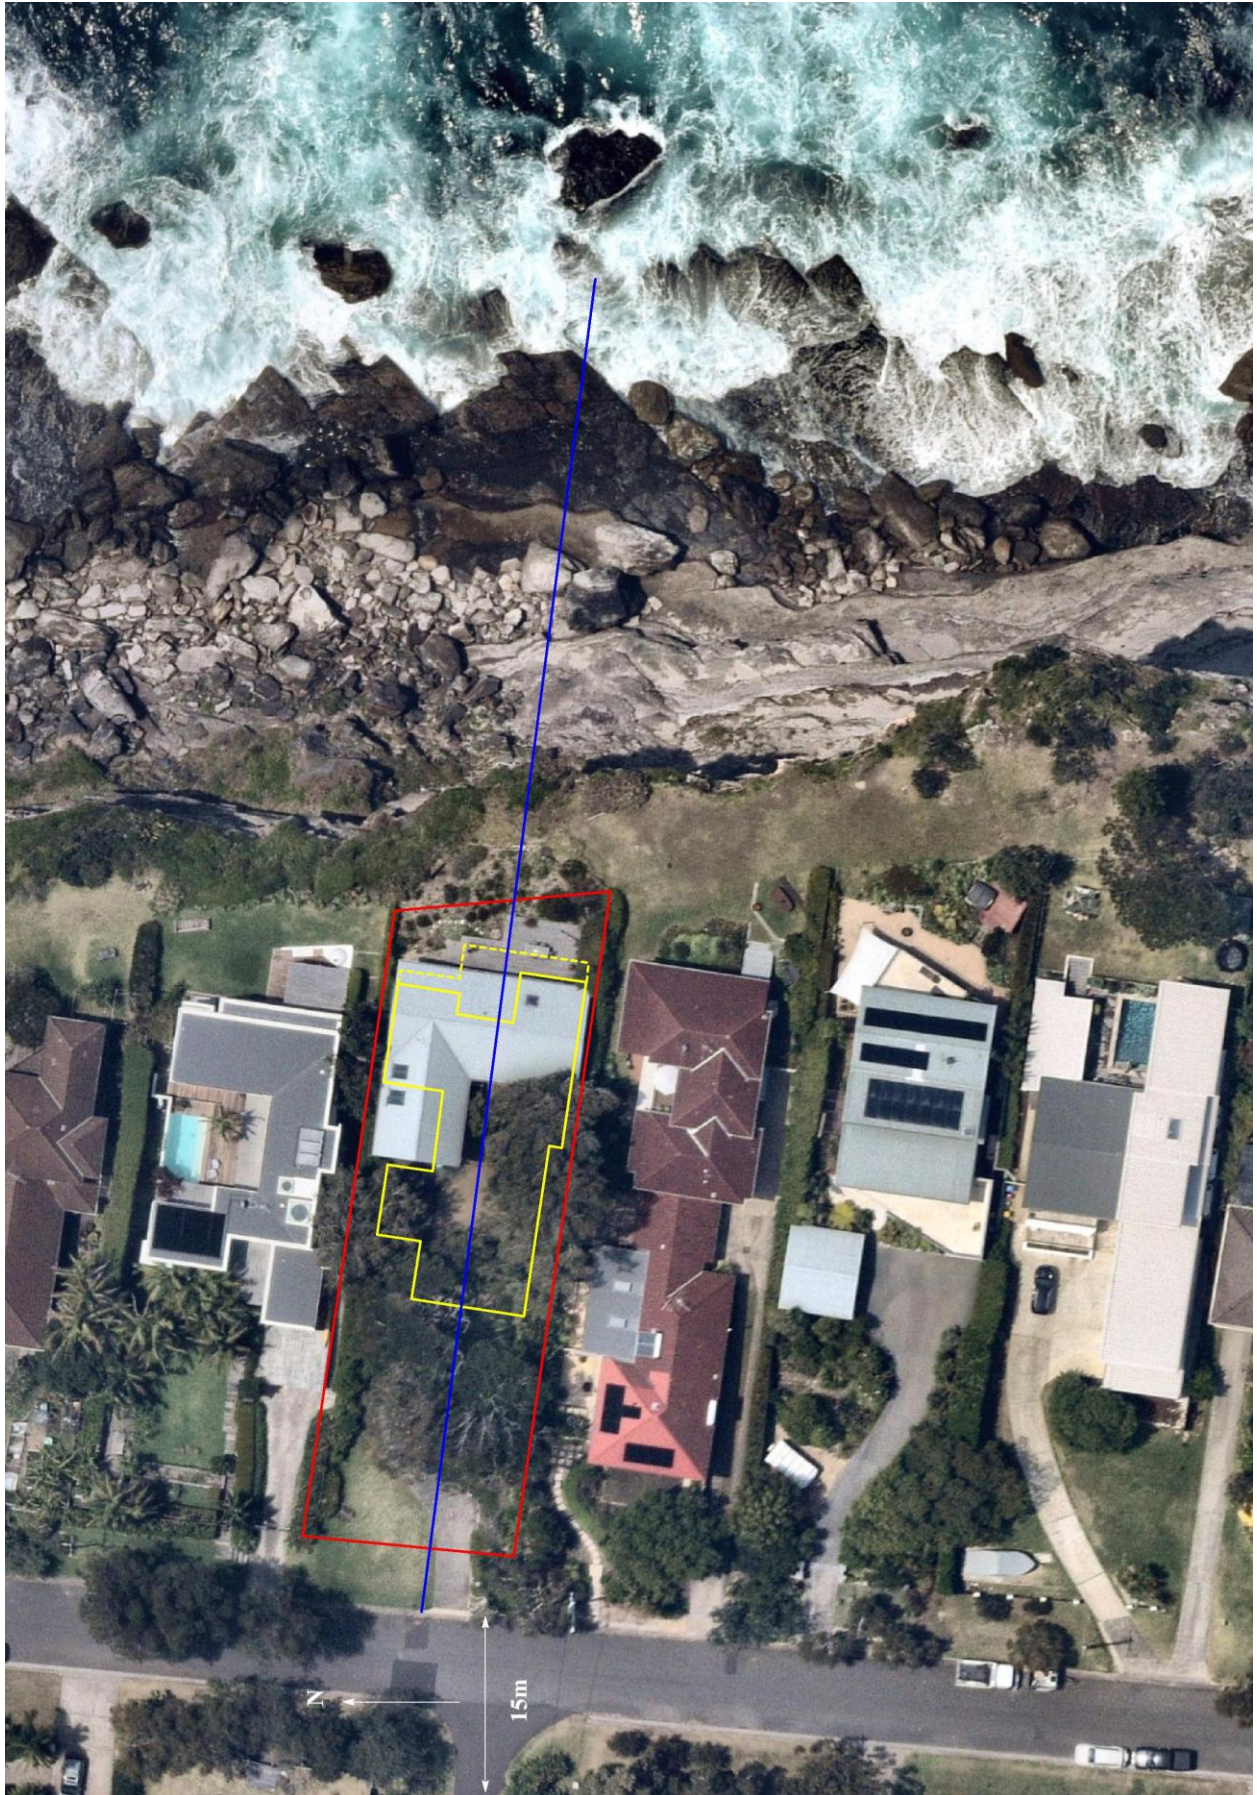
**Figure 2: Zoomed aerial view of site (approximate red outline) on 21 October 2023, with Section A location in blue and outline of proposed upper ground floor in solid yellow (with deck dashed)**

It is proposed to demolish and rebuild the dwelling at the site, with the new dwelling having three levels. The lowest level (basement) is to have a finished floor level of 31.6m AHD, with the lower ground floor at 35.1m AHD, and upper ground floor at 38.3m AHD. The upper ground floor is the ground level on the seaward side of the site. The location of the proposed development (upper ground floor) was depicted in Figure 2.

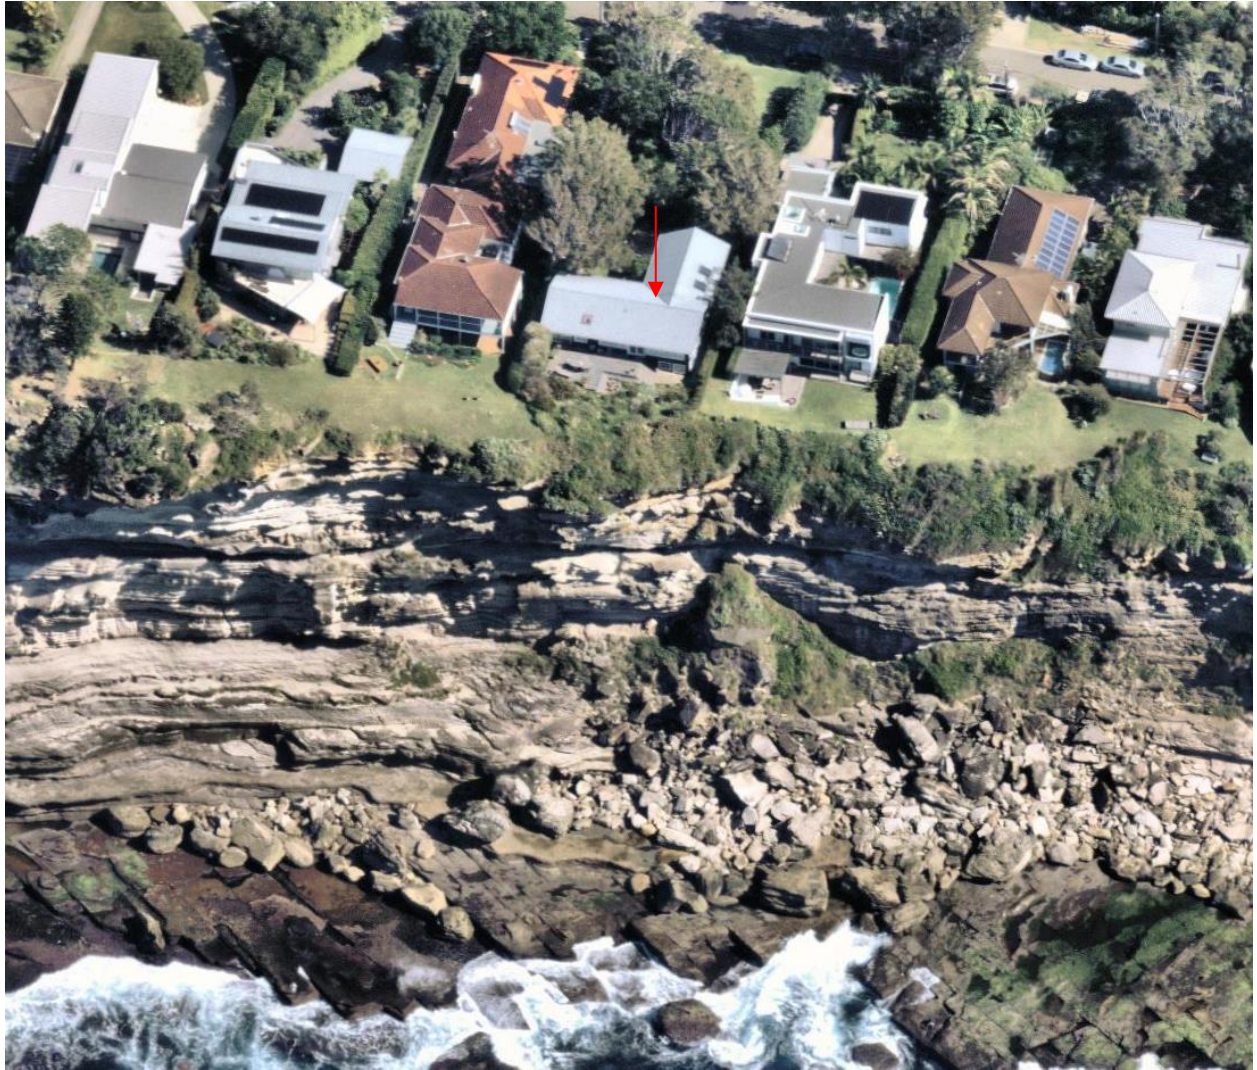
**Figure 3: Oblique aerial view of site (at arrow) on 1 May 2023, facing west**

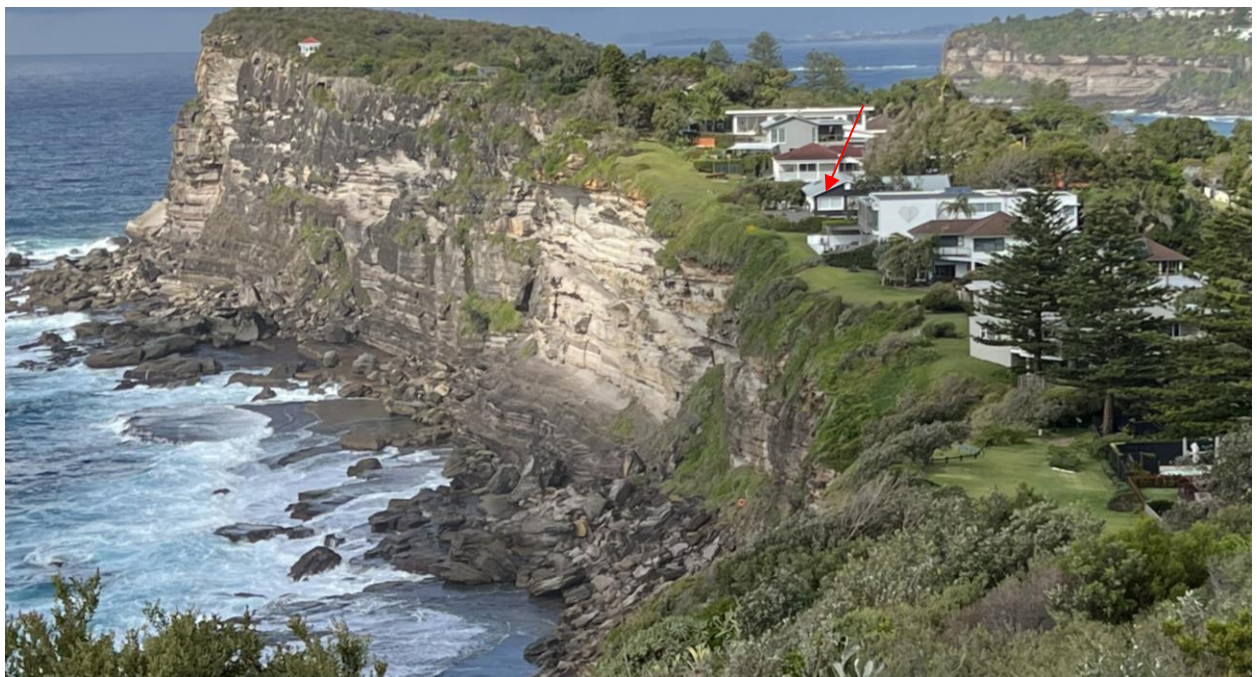
**Figure 4: View of site (at arrow) from cliff to north on 14 April 2023, facing SSW**

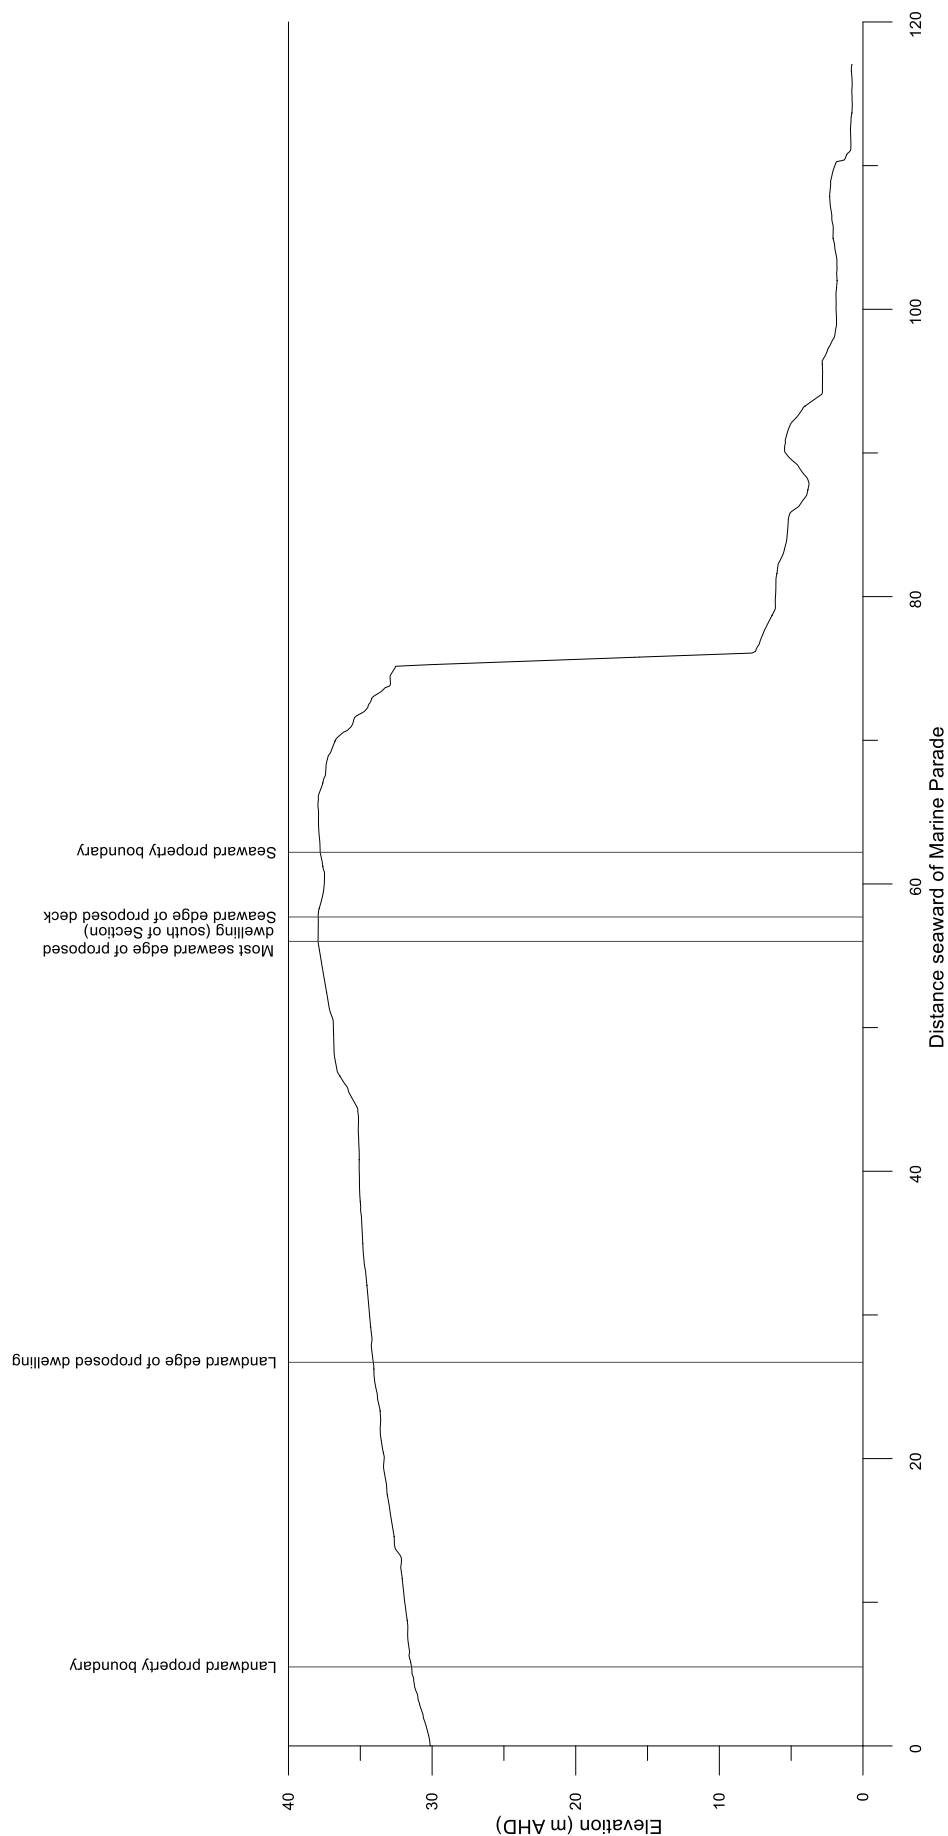
Figure 5: Section A through site and adjacent cliff and rock platform

There is no evidence of any recent significant cliff failures having occurred near the site. Coffey & Partners (1987) noted that the cliff profiles in the vicinity of the site (from Avalon Beach to Careel Head) were composed of massive sandstone and interbedded siltstone/sandstone beds with slope angles of about 80°. Undercutting in the sandstone units was found to have produced local overhangs and slope angles as low as 45° in the interbedded units. Cliff formation was seen to be primarily controlled by jointing, with undercutting in the less resistant interlaminated beds and toppling of large blocks of sandstone which line the cliff base.

Based on the ALS data depicted in Figure 5, ground elevations along Section A at and adjacent to the site approximately vary as follows:
