## **GEOTECHNICAL INVESTIGATION:**

Alterations & Additions at **37 Hilltop Road, Avalon**

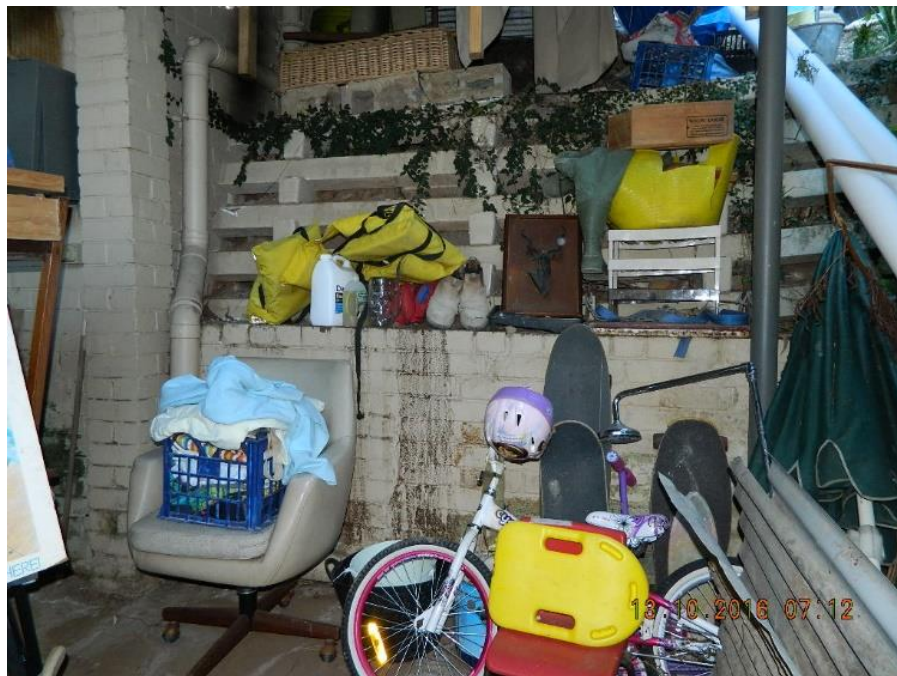
Photo 1

- 2.3** At the road frontage a concrete driveway runs up the slope to a parking area and shed under the house (Photo 1). This area has been cut into the slope. The upper S portion of the cut is supported by stepped brick, concrete crib and concrete block retaining walls (Photo 2 & 3). The upper concrete crib and concrete block walls display movement but will be demolished as part of the proposed works. The lower brick retaining wall is in good condition. A supporting brick wall of the house is located to the N of the stepped retaining walls (Photo 4). Below the wall a cut has been made into the slope to widen the existing parking area and to install a shed. The uphill side of the cut has undercut the supporting brick wall of the house (Photo 5). The excavation is either supported by the walls of the shed or a door with sandstone blocks holding it in place (Photo 5 & 6). The undercut footing and the unsupported cut below does not meet current engineering standards and our recommendations are outlined in **Section 17**. The shed will be demolished as part of the proposed works. Some loose soil has been scattered over the slope, under the N side of the house (Photo 7). We were informed by the owner that it will be removed
