Report Title: Geotechnical Report 316 Hudson Parade, Clareville

Report Date: 28/8/24

## **GEOTECHNICAL INVESTIGATION:**

New Pool at **316 Hudson Parade, Clareville**

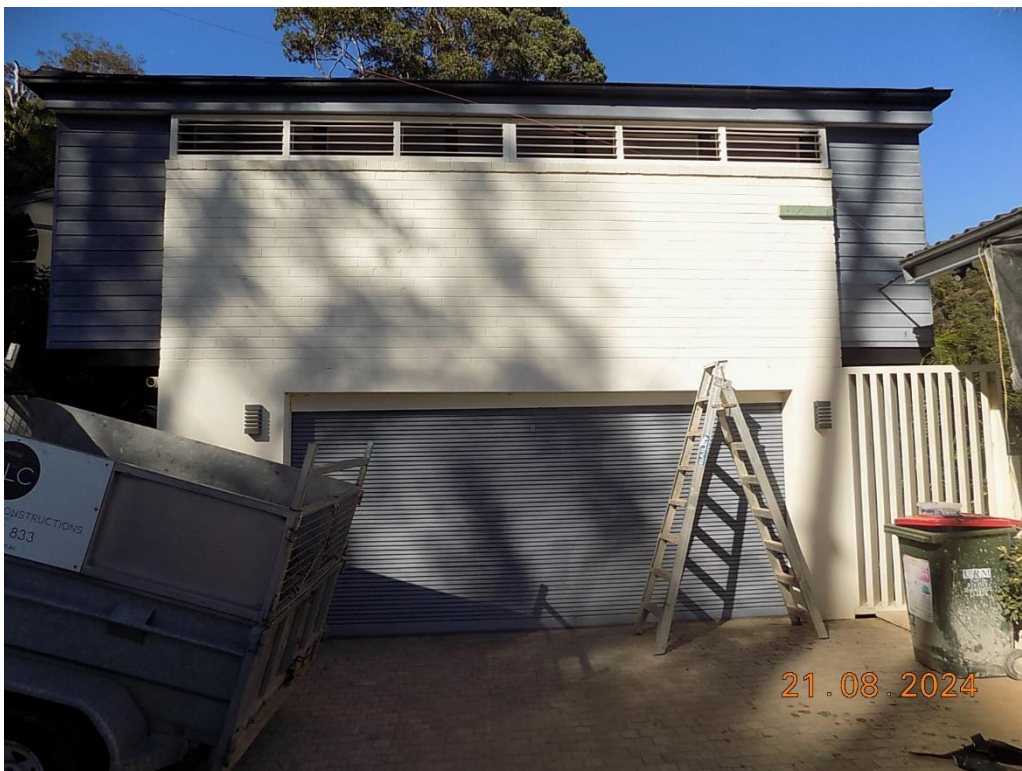
Photo 1

- 2.3** At the road frontage, a steeply graded slope falls to the uphill side of the subject house (Photos 1). Vehicular access to the property is provided by a shared driveway from the S that cuts across the slope and runs to the existing house and a detached brick garage/studio beside the house (Photos 2 & 3). The detached garage and uphill side of the property is currently undergoing demolition/construction works approved as part of a separate DA.

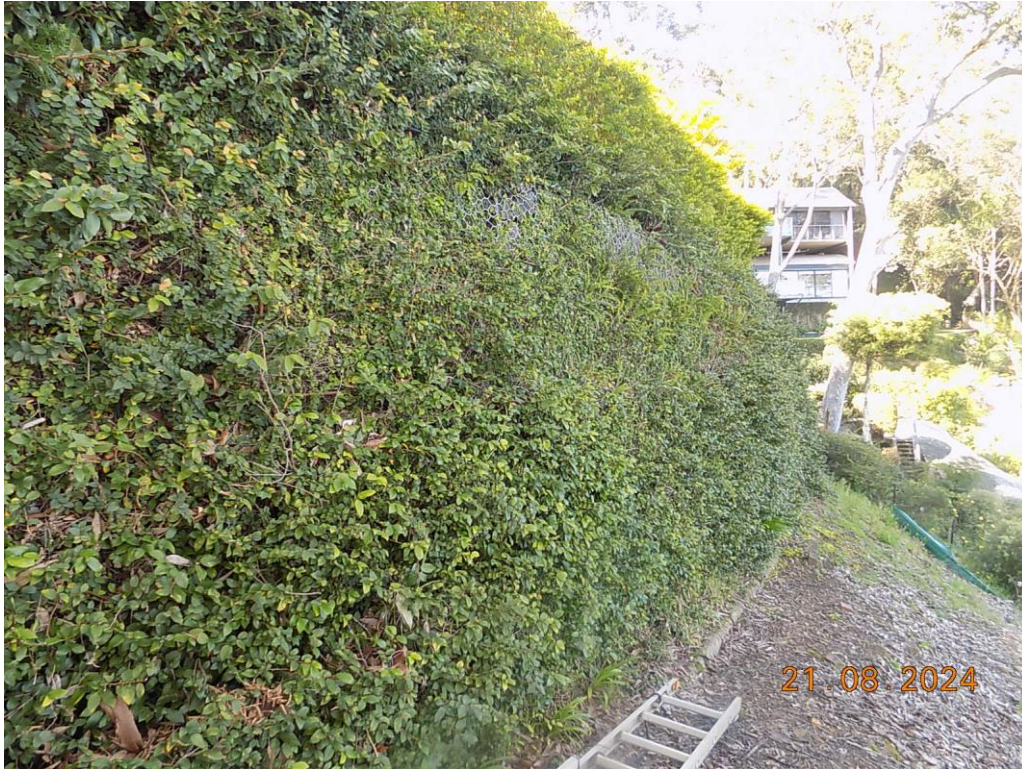
Photo 4

The two-storey brick house displays no significant movement in the external supporting walls that could be associated with slope instability. A concrete pool is located below the N side of the house (Photo 4). The pool shell displays no visible signs of movement. This is to be demolished as part of the proposed works. The area below the house and beside the pool has been filled for a level lawn area. From visual observations on site, the fill reaches a maximum height of ~5.0m on the S side and reduces to ~1.4m on the N end. The S side of the fill is supported by a gabion basket retaining wall (Photos 5 & 6). Where the wall lines the S common boundary, the baskets are slightly bulging. To ensure the ongoing stability of the wall into the future, the recommendations in **Section 16** are to be followed. The remaining areas of the wall show no obvious bulging. The N side of the fill is supported by a concrete crib retaining wall that is obscured by thick vegetation (Photo 7). From what could be seen of the wall, it appears stable.
