# Geotechnical Assessment

**Project:** Alterations & Additions  
16 Worcester Street, Collaroy NSW

## Geotechnical Assessment

**16 Worcester Street, Collaroy NSW**

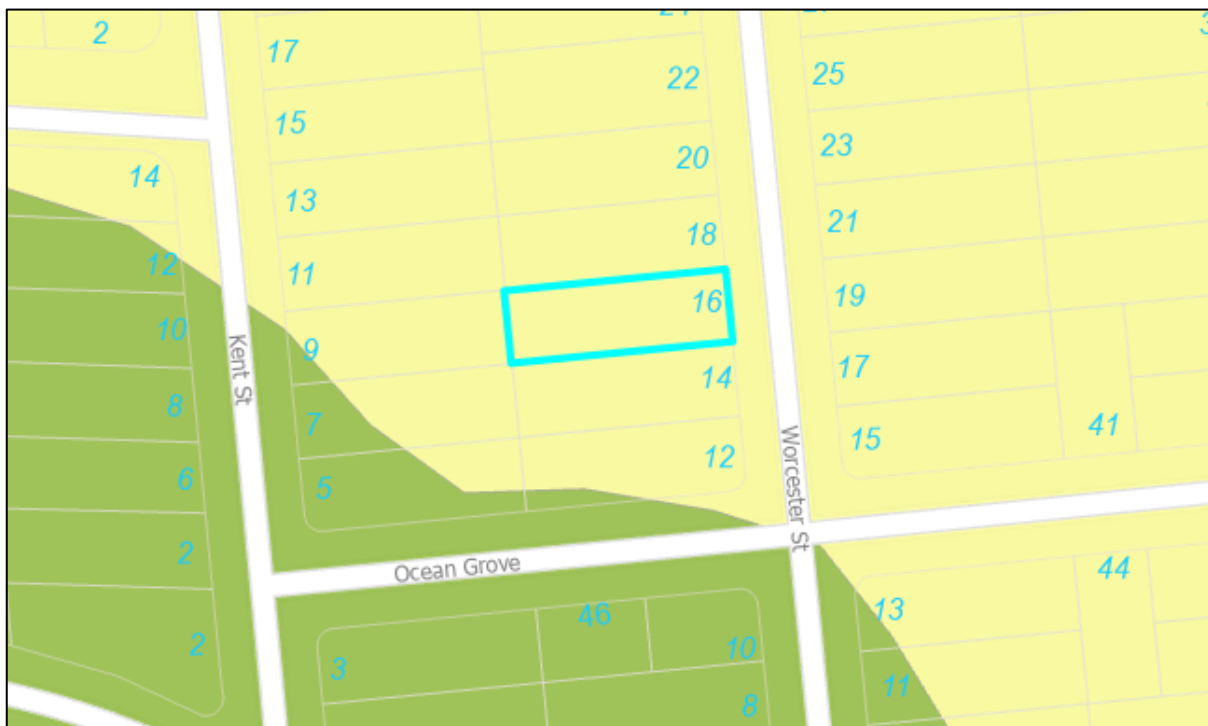
**Figure 2.** Warringah Landslip Risk Map:  
16 Worcester Street, Collaroy NSW (© NBC Maps)

- No evidence of significant soil creep, tension cracks or landslip instability were identified across the site or on adjacent properties as viewed from the subject site at the time of our inspection.
- The property is classified as **Area A** with reference to Northern Beaches Council WLEP – Warringah Landslip Risk Map (**Image 2**).

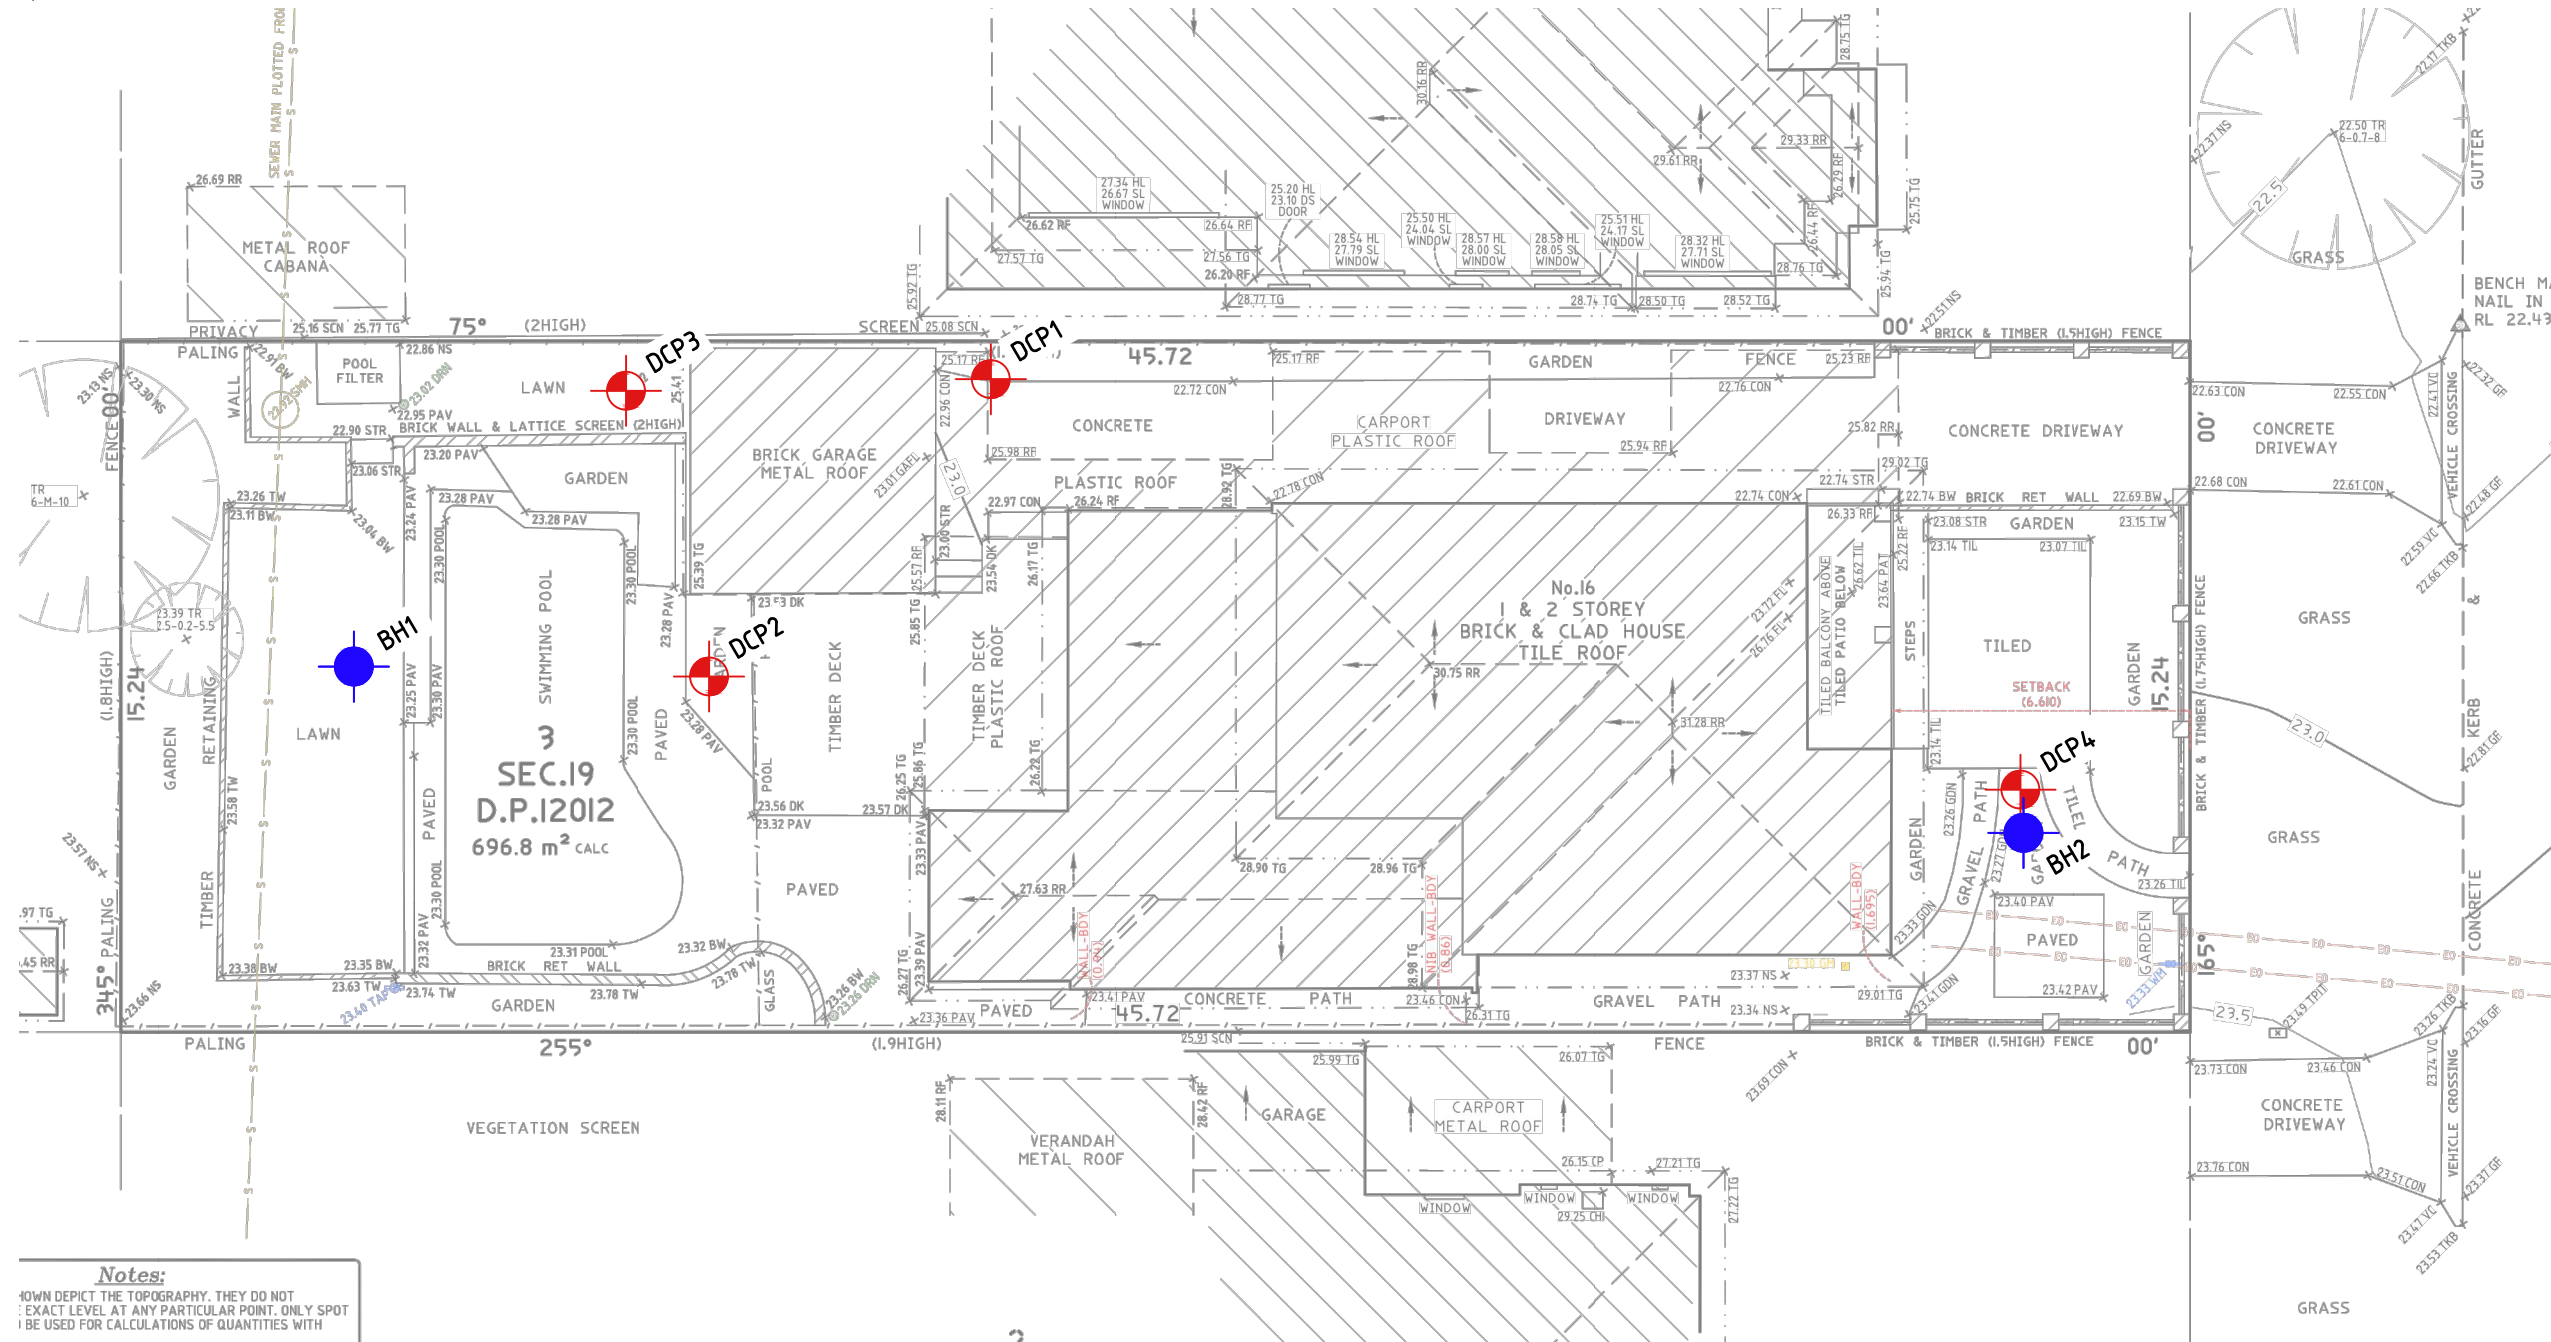
**SITE PLAN/GROUND TEST LOCATIONS**  
SCALE NTS

BOREHOLE LOCATIONS
