J0877. 24th June, 2016. Page 1.

GEOTECHNICAL INVESTIGATION:

Secondary Dwelling at 6 Bushrangers Hill, Newport.

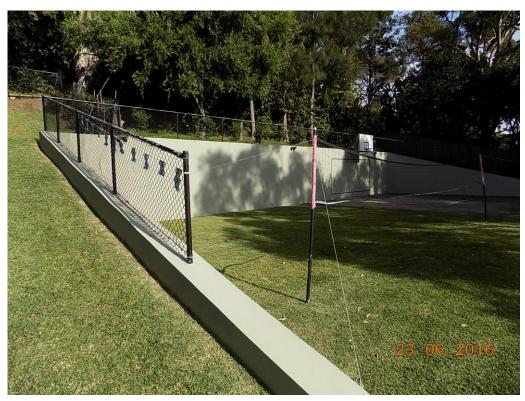
Photo 1

- 2.3 At the Bushrangers Hill road frontage two concrete driveways runs up the slope to a concrete parking area and rendered brick garage. A large sloping lawn that has been terraced encompasses the entire W half of the site (Photo 1). The fills are supported by stable rendered concrete block and stacked boulder retaining walls. A large cut has been made into the slope for a level lawn and concrete-paved area which is supported by a ~2.7m high concrete block retaining wall (Photo 2). The wall displays minor hairline cracking but no signs of movement. The lawn beside to the E and above the cut extends to a chain-link fence lining the upper third of the site.

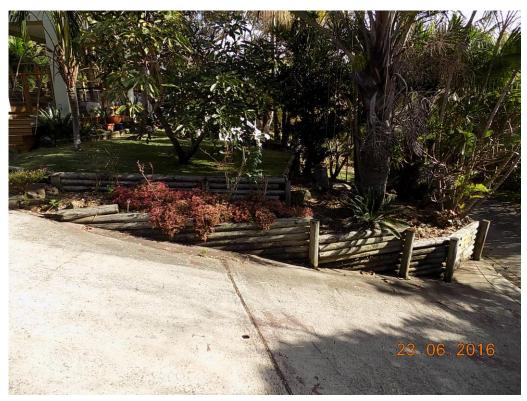
Photo 3

The E driveway is flanked on both sides by low terraces supported by low retaining walls (Photo 3). The W flank terraces are supported by two low timber retaining walls. The lower wall is ~0.7m high and tilting at angles of ~7°. The wall will eventually need replacing but is not considered a threat to life or property. The upper wall is up to ~1.0m high and considered stable (Photo 4). The E flank terraces are supported by 2 mortared sandstone block walls ~0.6m high. The walls display cracking through the blocks and the upper wall has settled away from the concrete of the
