Report Title: Geotechnical Report 51 Alleyne Avenue, North Narrabeen

Report Date: 24/7/25

GEOTECHNICAL INVESTIGATION:

New Granny Flat at **51 Alleyne Avenue, North Narrabeen**

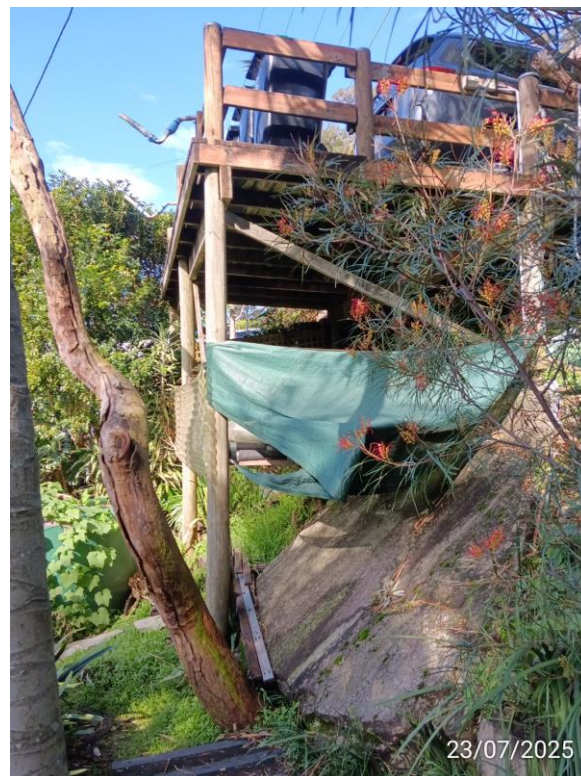
Photo 2

- 2.3** Low to Medium Strength Sandstone bedrock outcrops at the uphill side of the road (Photo 1). A suspended timber parking platform is located at the road frontage. The timber posts that support the parking platform stand vertical (Photo 2). Beneath the parking platform, a large boulder is partially embedded in the slope (Photo 2). It is considered stable provided the drainage regime on the slope is not altered (i.e. so water flows are not directed to the uphill side of the boulder). Cuts and fills provide level platforms for lawn, garden and paved areas between the parking platform and
