Development Application for D & J Suttie  
Name of Applicant

Address of site 67 Florence Terrace, Scotland Island

Report Title: RISK ANALYSIS & MANAGEMENT FOR PROPOSED BOAT SHED AND SKID RAMP AT 67 FLORENCE TERRACE, SCOTLAND ISLAND- PX 00007

**RISK ANALYSIS & MANAGEMENT  
FOR  
PROPOSED BOAT SHED AND SKID RAMP  
AT  
67 FLORENCE TERRACE, SCOTLAND ISLAND**

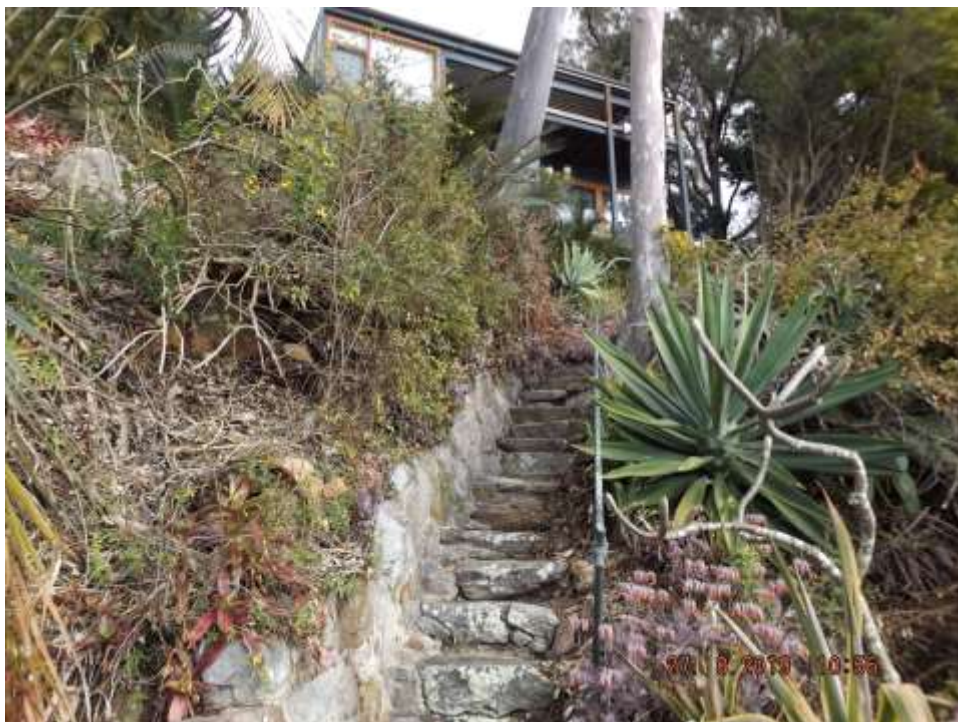
**Photo 1**

**3.3** The site is accessed from Florence Terrace or the water front. From the water front a stairway leads up to the residence, Photo 1. At the top of the sea wall there is a level lawn area. A block retaining wall is at the toe of the vegetated slope rises up to the residence from the level area. An 'S' shaped stone stairway leads up to the residence from the waterfront, Photo 2. At the top of the stairs a path with a railing runs across the eastern side of the house and around the corner to the main entrance to the existing residence. Along the south eastern side of the residence is a paved path with steps that leads to the rear of the property, Photo 3. The rear of the property is accessed up some wooden stairs that leads to garden area at the south western end of the block. The slope continues to rise up to and beyond Florence Terrace, Photo 4. Florence Terrace can be accessed via path with handrail. There are two tanks in the north western corner of the property, Photo 5.

**5.1** Based on visual observation the site is considered consistent with adjacent local sites previously inspected and reported and accordingly physical subsurface investigation has not been conducted at this stage on this proposed development. The rock shelf is visible some 1.5 metres below the level lawn area as seen in Photo 1.
