## **REPORT ON GEOTECHNICAL SITE INVESTIGATION**

### **PROPOSED NEW RESIDENTIAL HOUSE**

**1168 BARRENJOEY ROAD, PALM BEACH, NSW**

**Project No.: 2022-210**

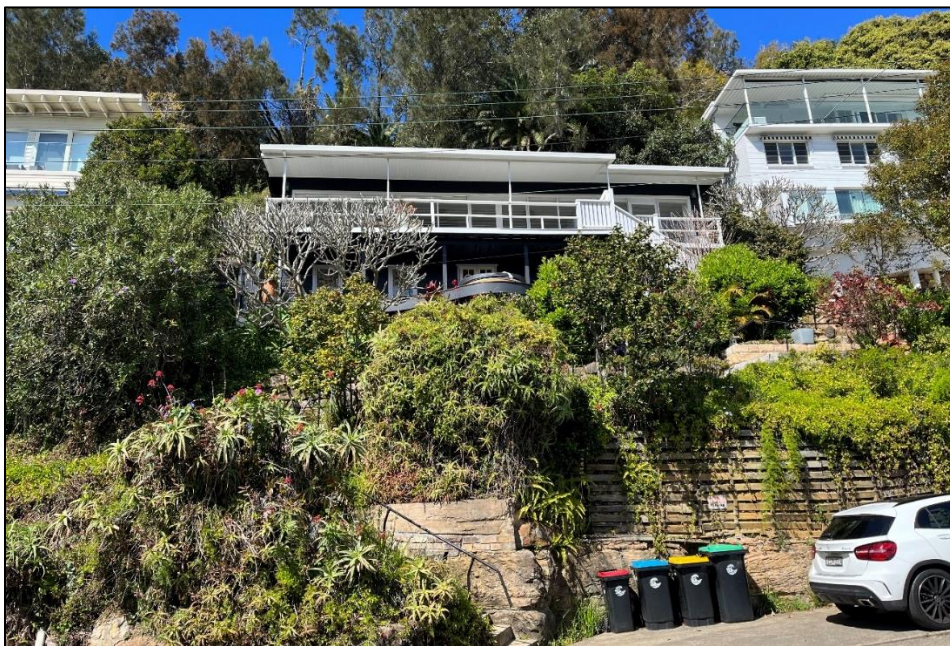
The front garden and pathway are partially supported by a low (<1.0m high) sandstone block retaining wall. Access to the rear of the property is via concrete paths to the east and west of the existing residence. A general view of the site is provided in Photograph 2.

*Photograph 2: View of the site looking south from Barrenjoey Road*

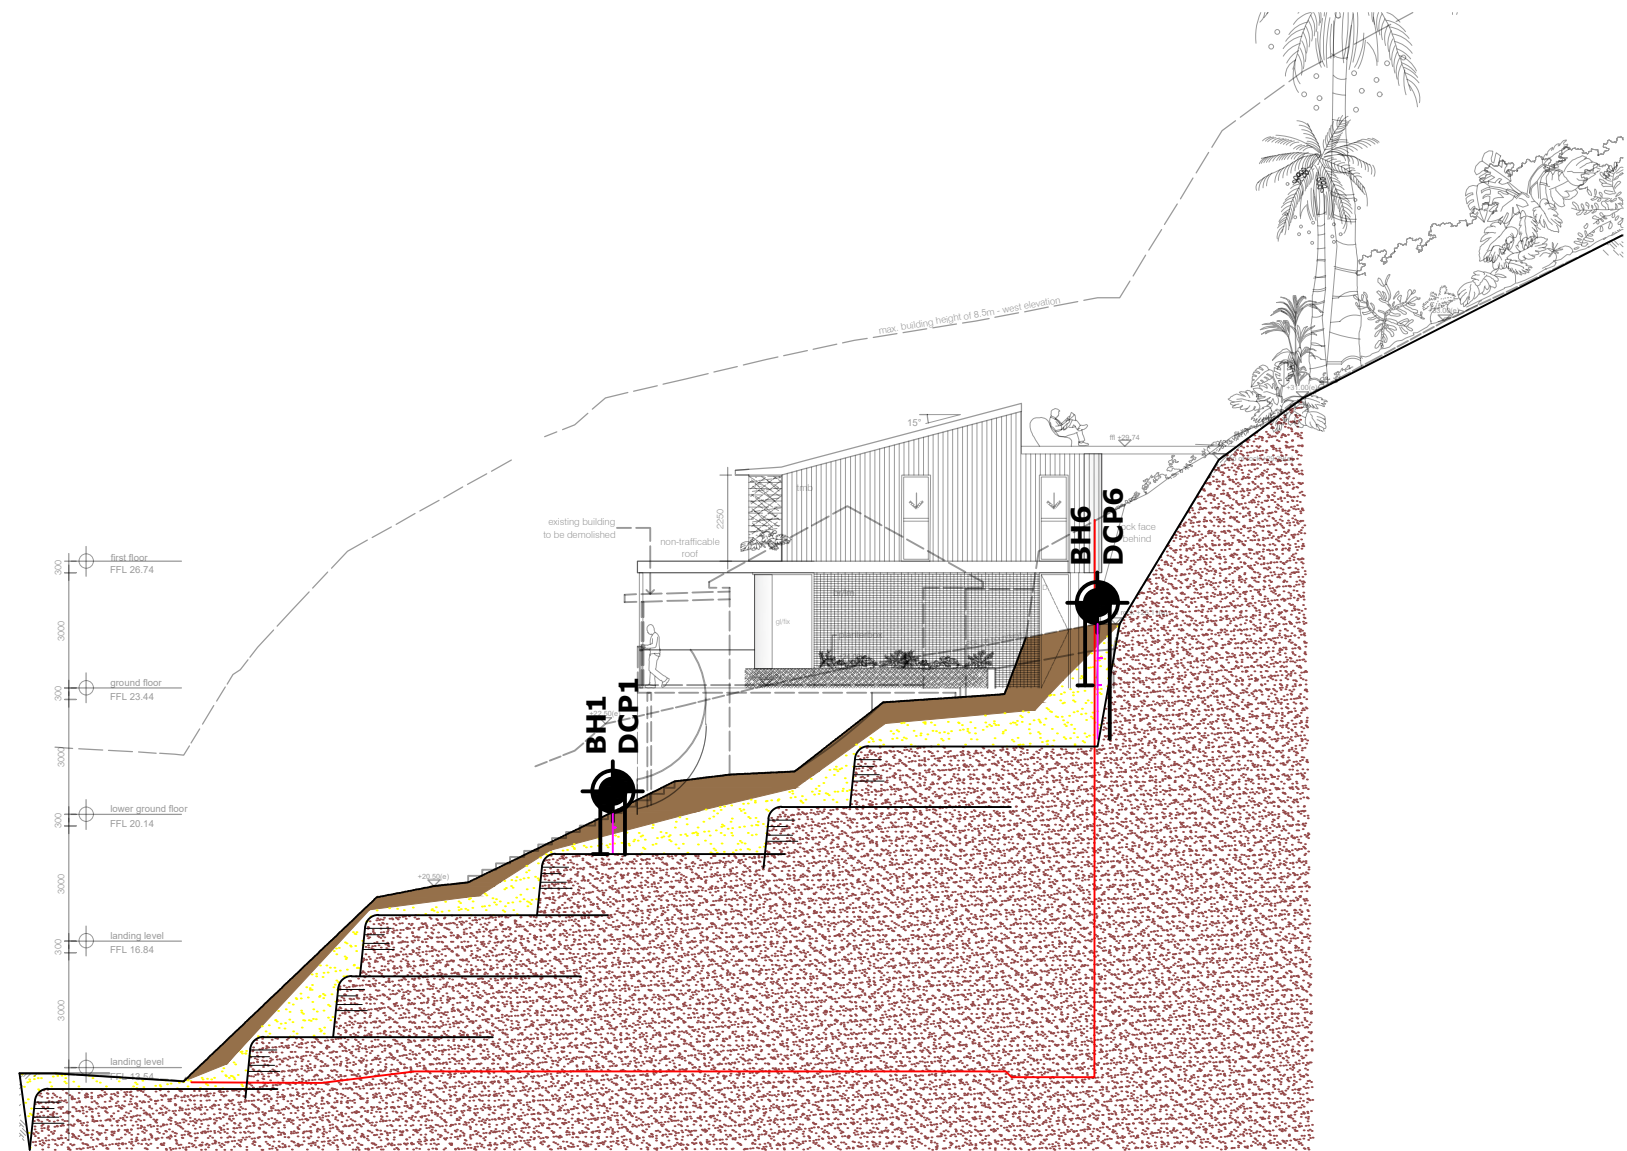
SITE SECTION FIGURE 2.

the bedrock surface. It is anticipated the bedrock may contain defects, possibly trending north-south and northwest-southeast. A groundwater table is not anticipated within the proposed excavation however seepage at bedrock/soil interface and within bedrock defects could be expected.
