# Arboricultural Impact Assessment

1 Highview Avenue, Queenscliff  
NSW, 2100  
B/-/DP330244  
DA2024/0629 – PAN-436241  
20/06/2024

**Temporal Tree Management Pty Ltd.**

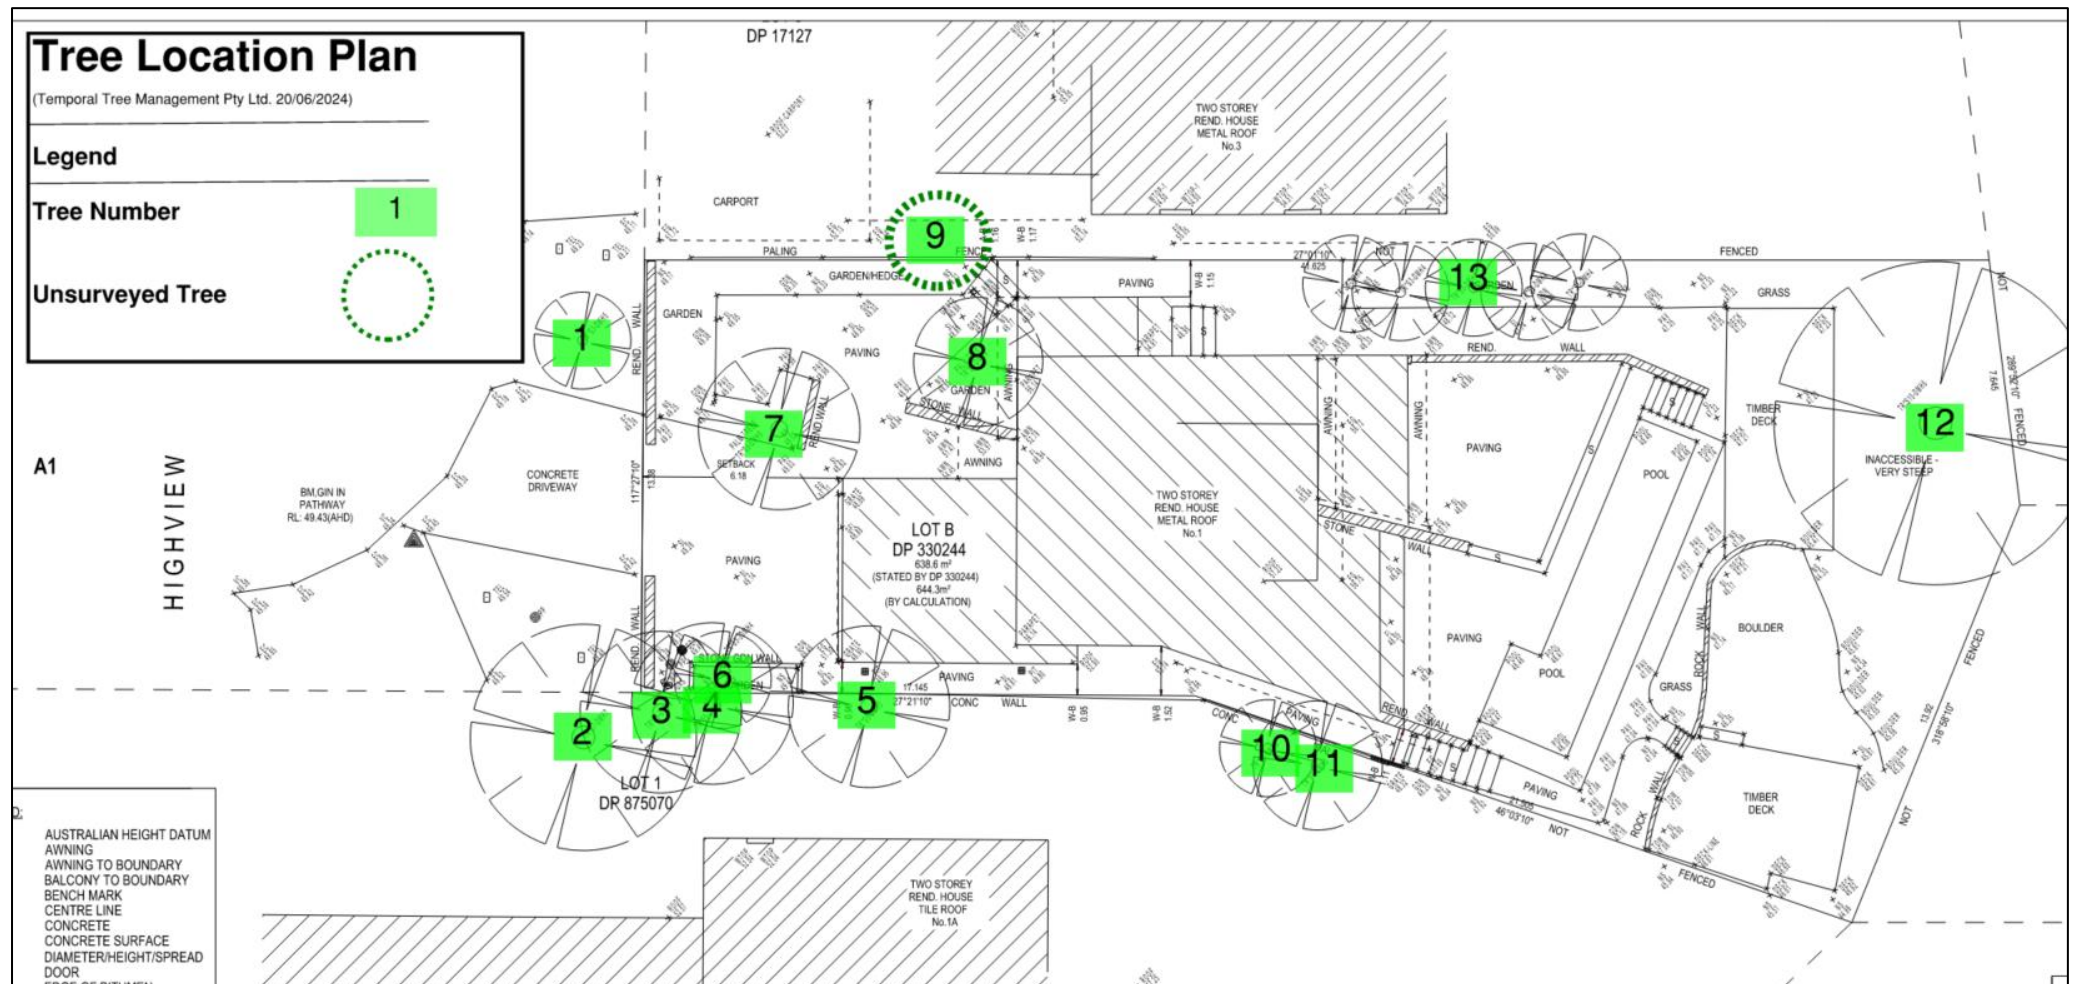
Figure 1. Location of thirteen assessed trees in relation to existing dwelling and structures. Site Plan prepared by *Rapid Plans* (Project Number: RP0523NES, Drawing No: DA1002, Issue: -, drawn 15/04/2024).

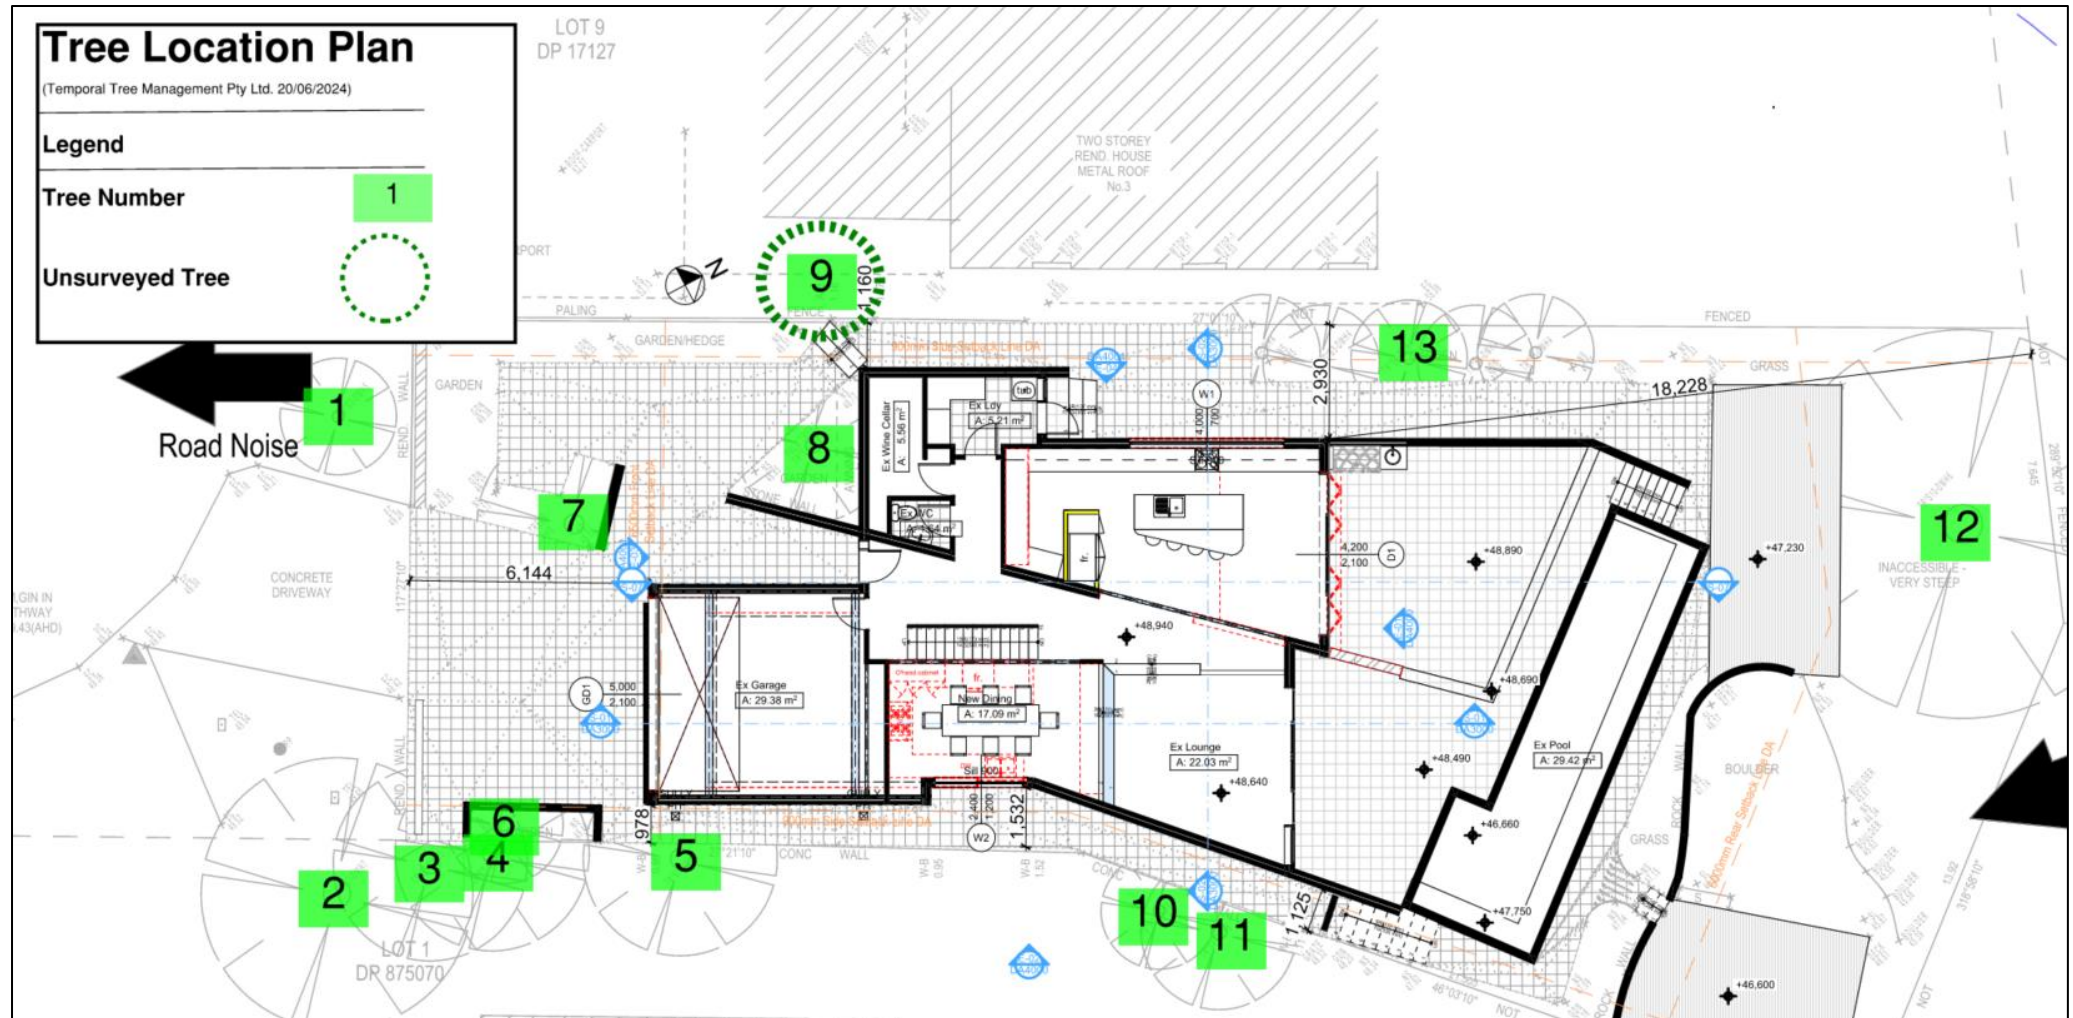
Minor alterations and additions are proposed within the subject site (Figure 2). The footprint of the existing dwelling and ancillary structure will remain unchanged. Internal demolition and renovation of the dwelling is proposed. Existing structural walls, retained garden beds and paved areas surrounding the dwelling will be retained. The retention of the existing dwelling and ancillary structure within the southern boundary will significantly mitigate the potential impact on the assessed trees.

Figure 2. Location of thirteen assessed trees in relation to proposed development. Site Plan prepared by *Rapid Plans* (Project Number: RP0523NES, Drawing No: DA1002, Issue: -, drawn 15/04/2024)

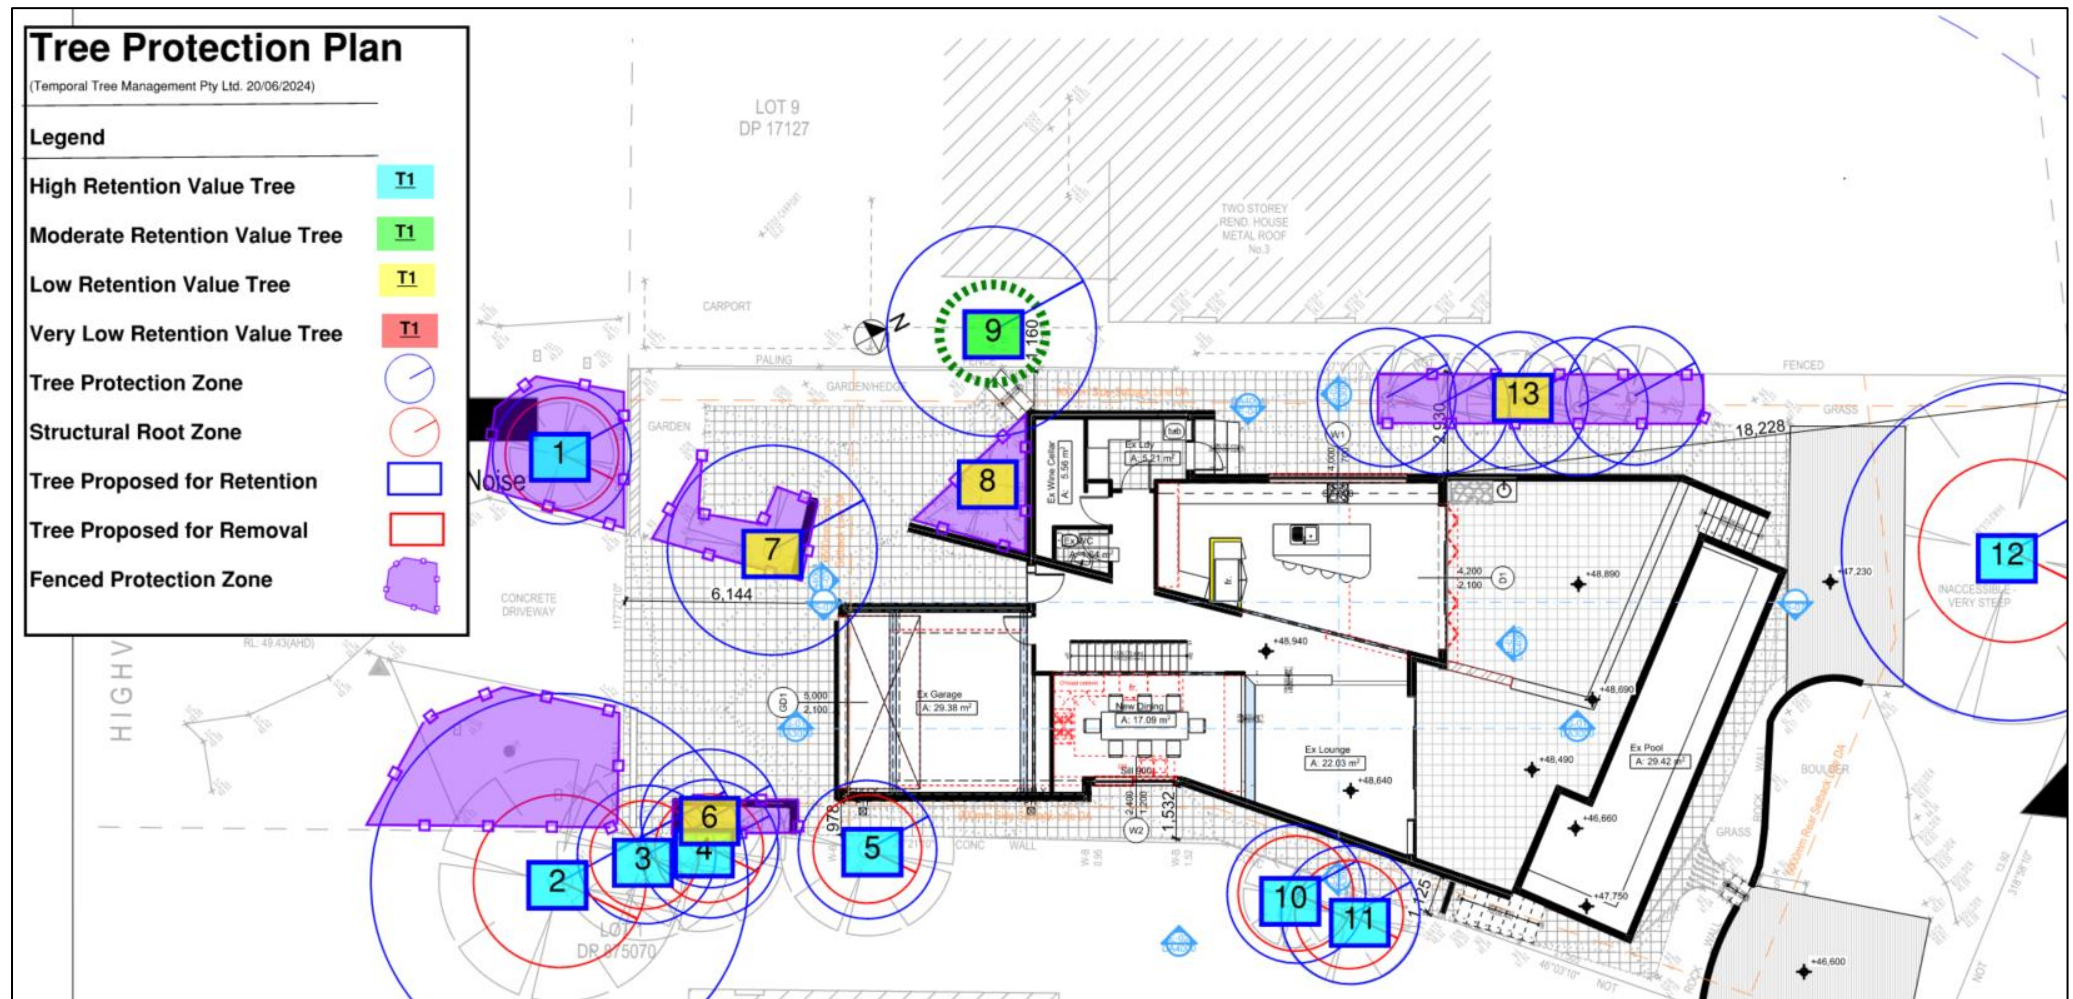
Figure 9. Tree Protection / Removal Plan for proposed development. Site Plan prepared by *Rapid Plans* (Project Number: RP0523NES, Drawing No: DA1002, Issue: -, drawn 15/04/2024).

- Three fenced protection zones compliant with the specifications outlined in Section 4.3 of *AS4970 (2009)* must be installed around Tree 1, Tree 2, Tree 6, Tree 7, Tree 8 and Tree 13 (Figure 5 and Figure 8).

- Installation of Tree Protection Measures – Inspection and certification by the Project Arborist of the three fenced protection zones as specified in the Tree Protection Plan (Section 7.3 of this report) (Figure 9). This hold point must be complete prior to the commencement of any practical works.
- Monitoring of Retained Trees– Regular inspection and certification by the Project Arborist of tree protection measures and condition of retained trees. Any required maintenance of the tree protection measures or retained trees must be undertaken by the Project Arborist at this time.
- Final Project Arborist Inspection– Final inspection by Project Arborist and certification of compliance with the Tree Protection Plan as specified in Section 7.3 of this report. All specified protection measures outlined in Section 7.3. must remain in place until this final inspection.
