7 Laura Street, Seaforth

Geotechnical Comments for Section 96.

GEOTECHNICAL INVESTIGATION:

Alterations & Additions at 7 Laura Street, Seaforth

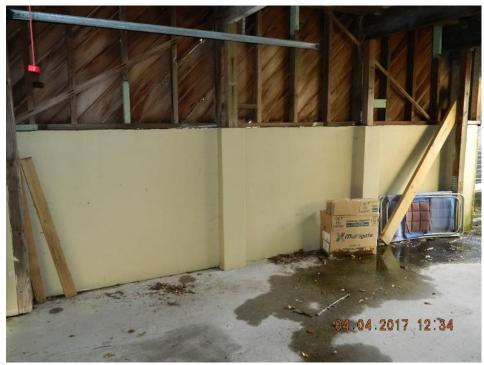
Photo 2

- 2.3 At the road frontage a concrete driveway runs to a garage and parking area on the uphill side of the house (Photo 1). A cut has been made into the slope to create a level platform for the garage. It is supported by a rendered brick retaining wall that appears stable (Photo 2). The downhill supporting brick wall of the garage is tilting and bulging due to the presence of a tree growing immediately beside it. The garage is being demolished and the tree removed as part of the proposed works (Photos 3 & 4). The part three storey brick and dimensioned sandstone block house steps down the slope. The external supporting walls of the house display no significant signs of movement that could be related to slope stability. Competent, medium strength sandstone is
