GEOTECHNICAL INVESTIGATION:

New Pool, Cabana & Garage at **15 Chisholm Avenue, Avalon Beach**

1. Proposed Development

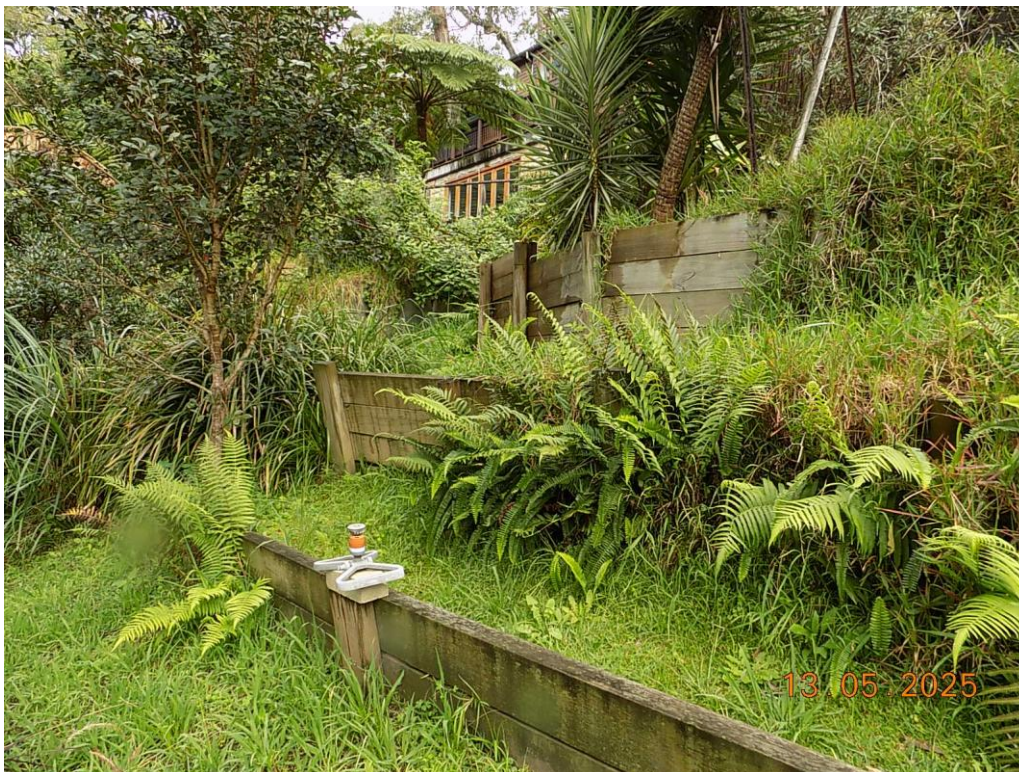
Photo 8

Timber retaining walls reaching ~1.3m which terrace the slope in this location are proposed to be demolished in order to landscape the property and construct the cabana (Photos 7 & 8). The walls are to be demolished from the top down in an orderly manner with the fill behind the walls being systematically lowered at the same time. The soil batter slope is not to exceed 1.0 Vertical to 1.7 Horizontal (30°) as the walls are demolished.
