REPORT

316 Hudson Parade, Clareville Upgraded Boatshed Works Coastal and Marine Damages Assessment

Reference: PA1959MARP1901310938

Date: 31 January 2019

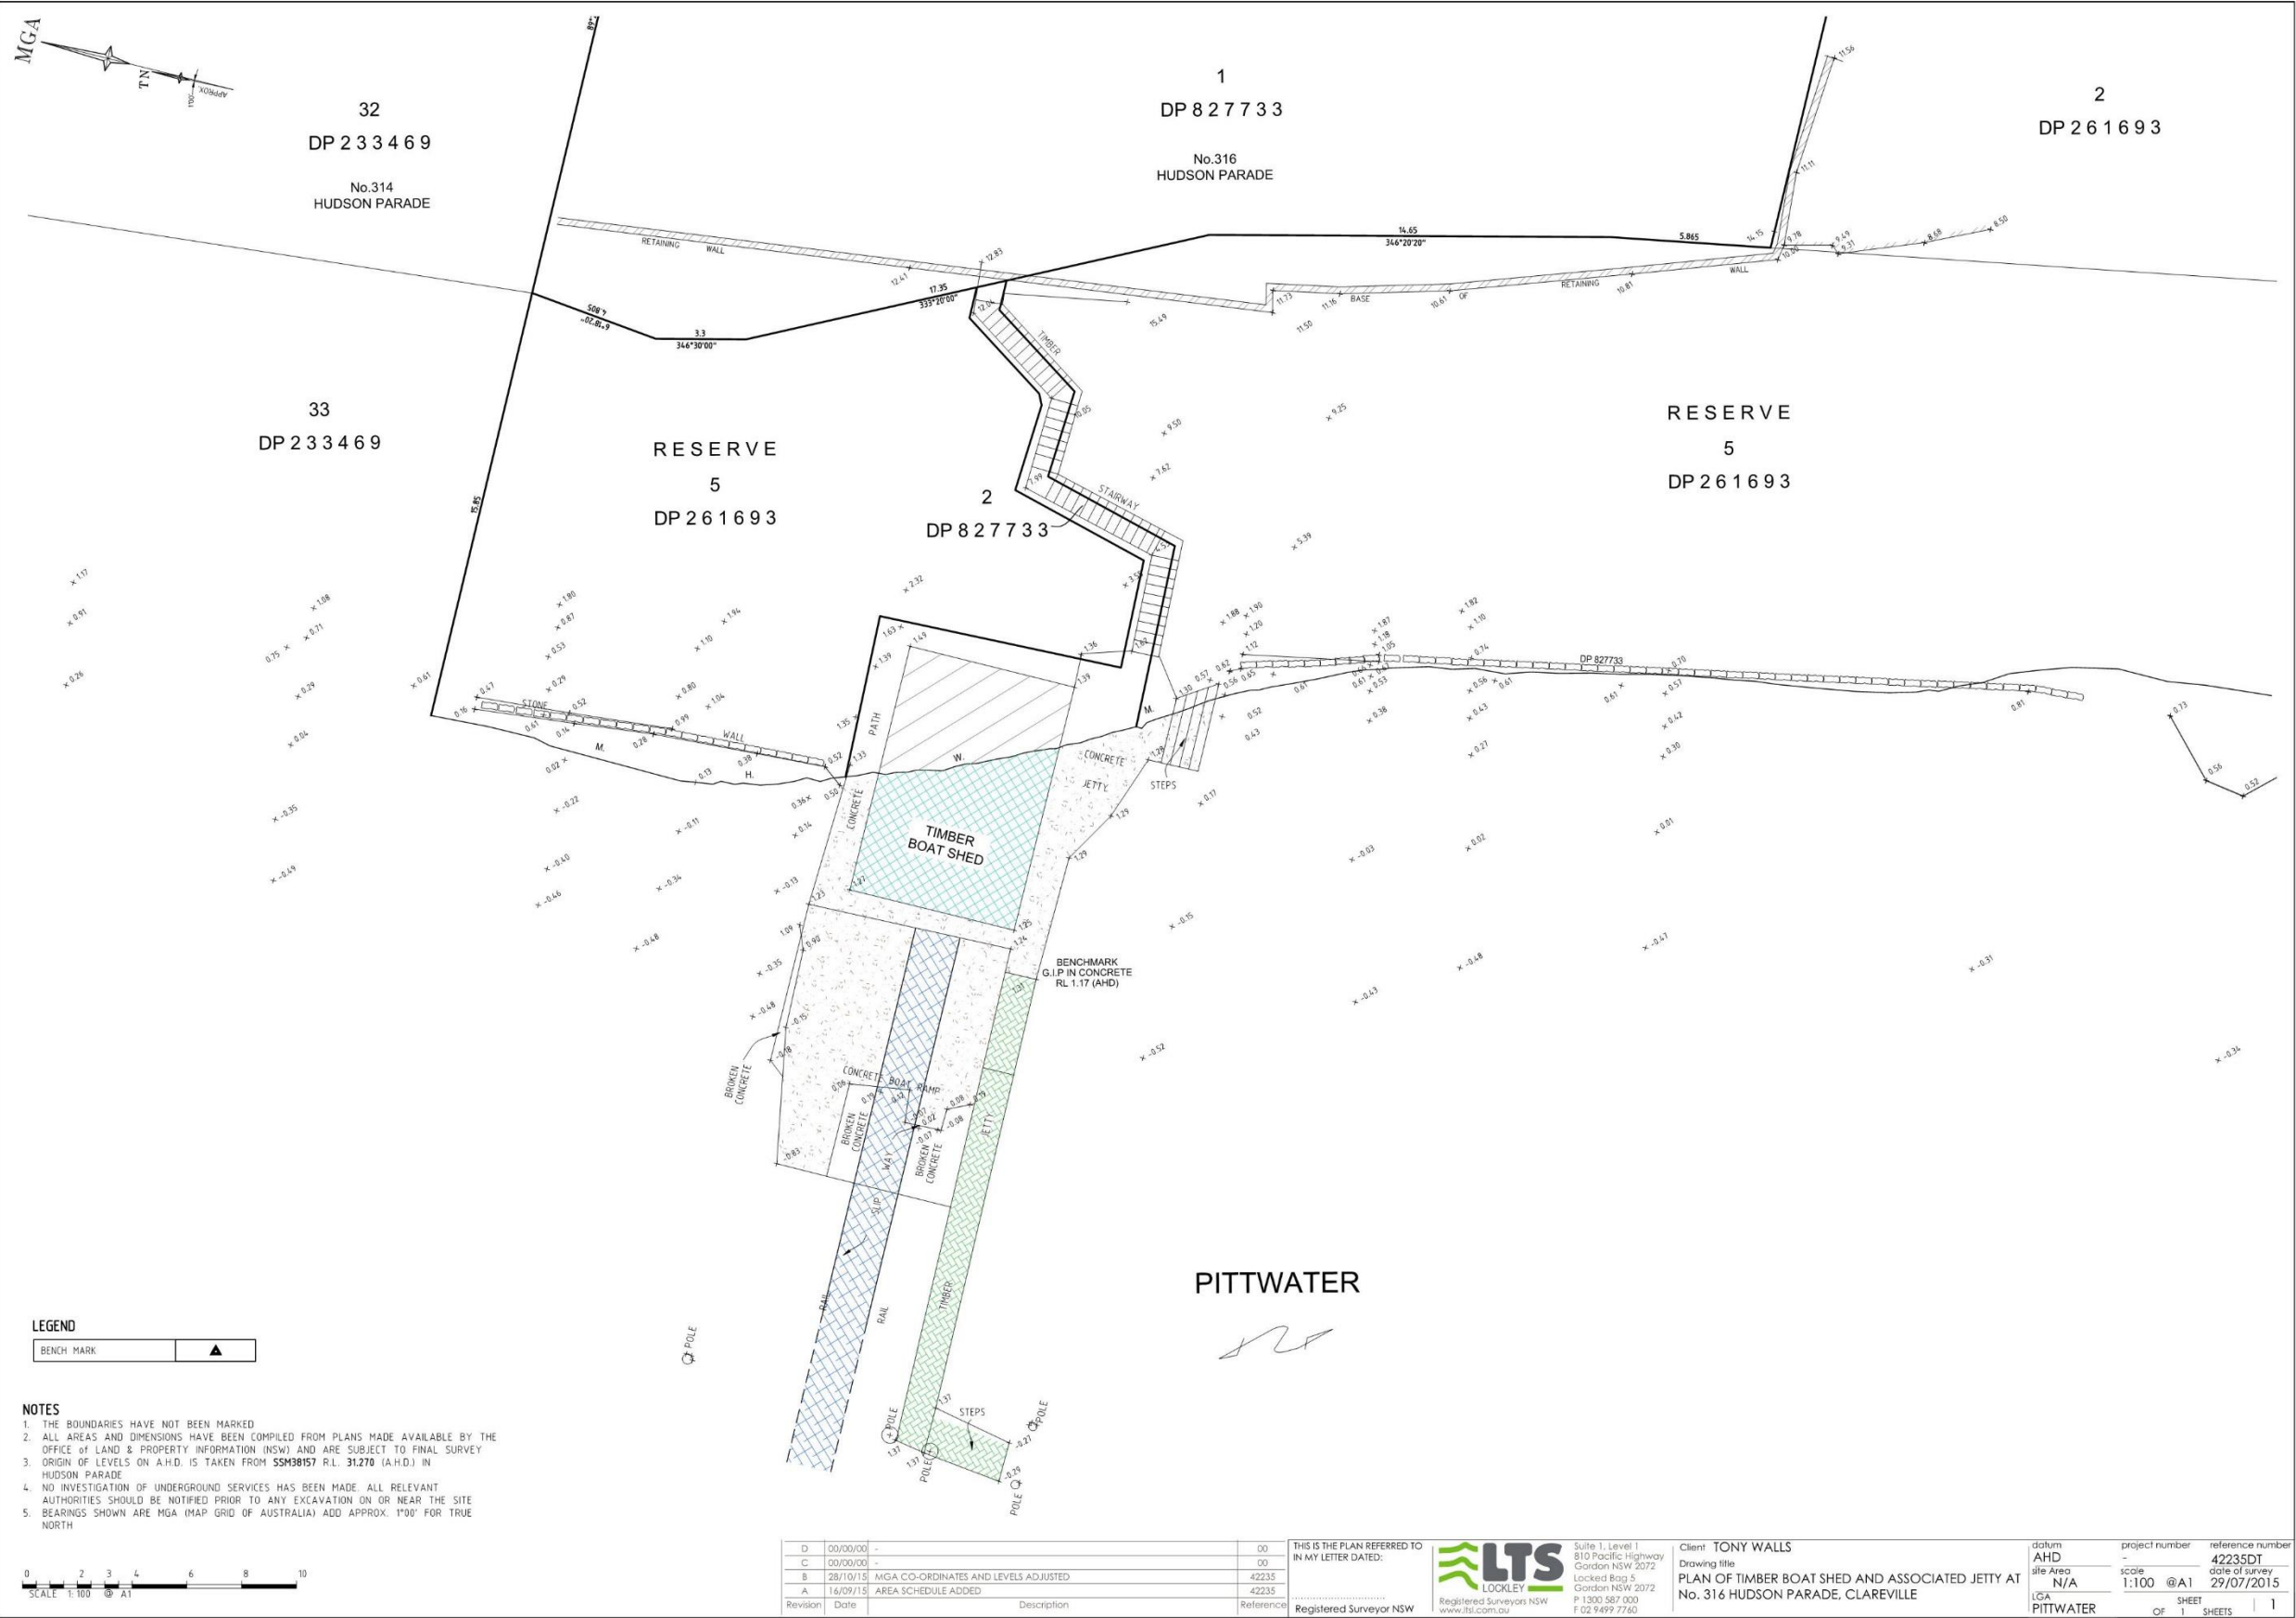
Figure 1 Survey showing former marine structures at 316 Hudson Parade, Clareville

In November 2016 a Complying Development Certificate (CDC) was issued by Anthony Protas Consulting Pty Ltd for “Repairs and restoration of existing marine structures” at 316 Hudson Parade, Clareville. The works relate to the reconstruction of a boatshed, concrete jetty, ramp, slipway, timber jetty, piles and timber steps. DPI Crown Lands had previously provided Land Owners Consent to make the CDC. A modified CDC was subsequently issued to cover a varied roof form at the boatshed. Works have recently commenced on the site including demolition of former marine structures, and construction of foundation walls surrounding the former boatshed. A survey by LTS Lockley Registered Surveyors dated 29/7/15 showing the former marine structures is presented in **Figure 1**, the approved CDC dated 24/5/17 is shown in **Figure 2**.

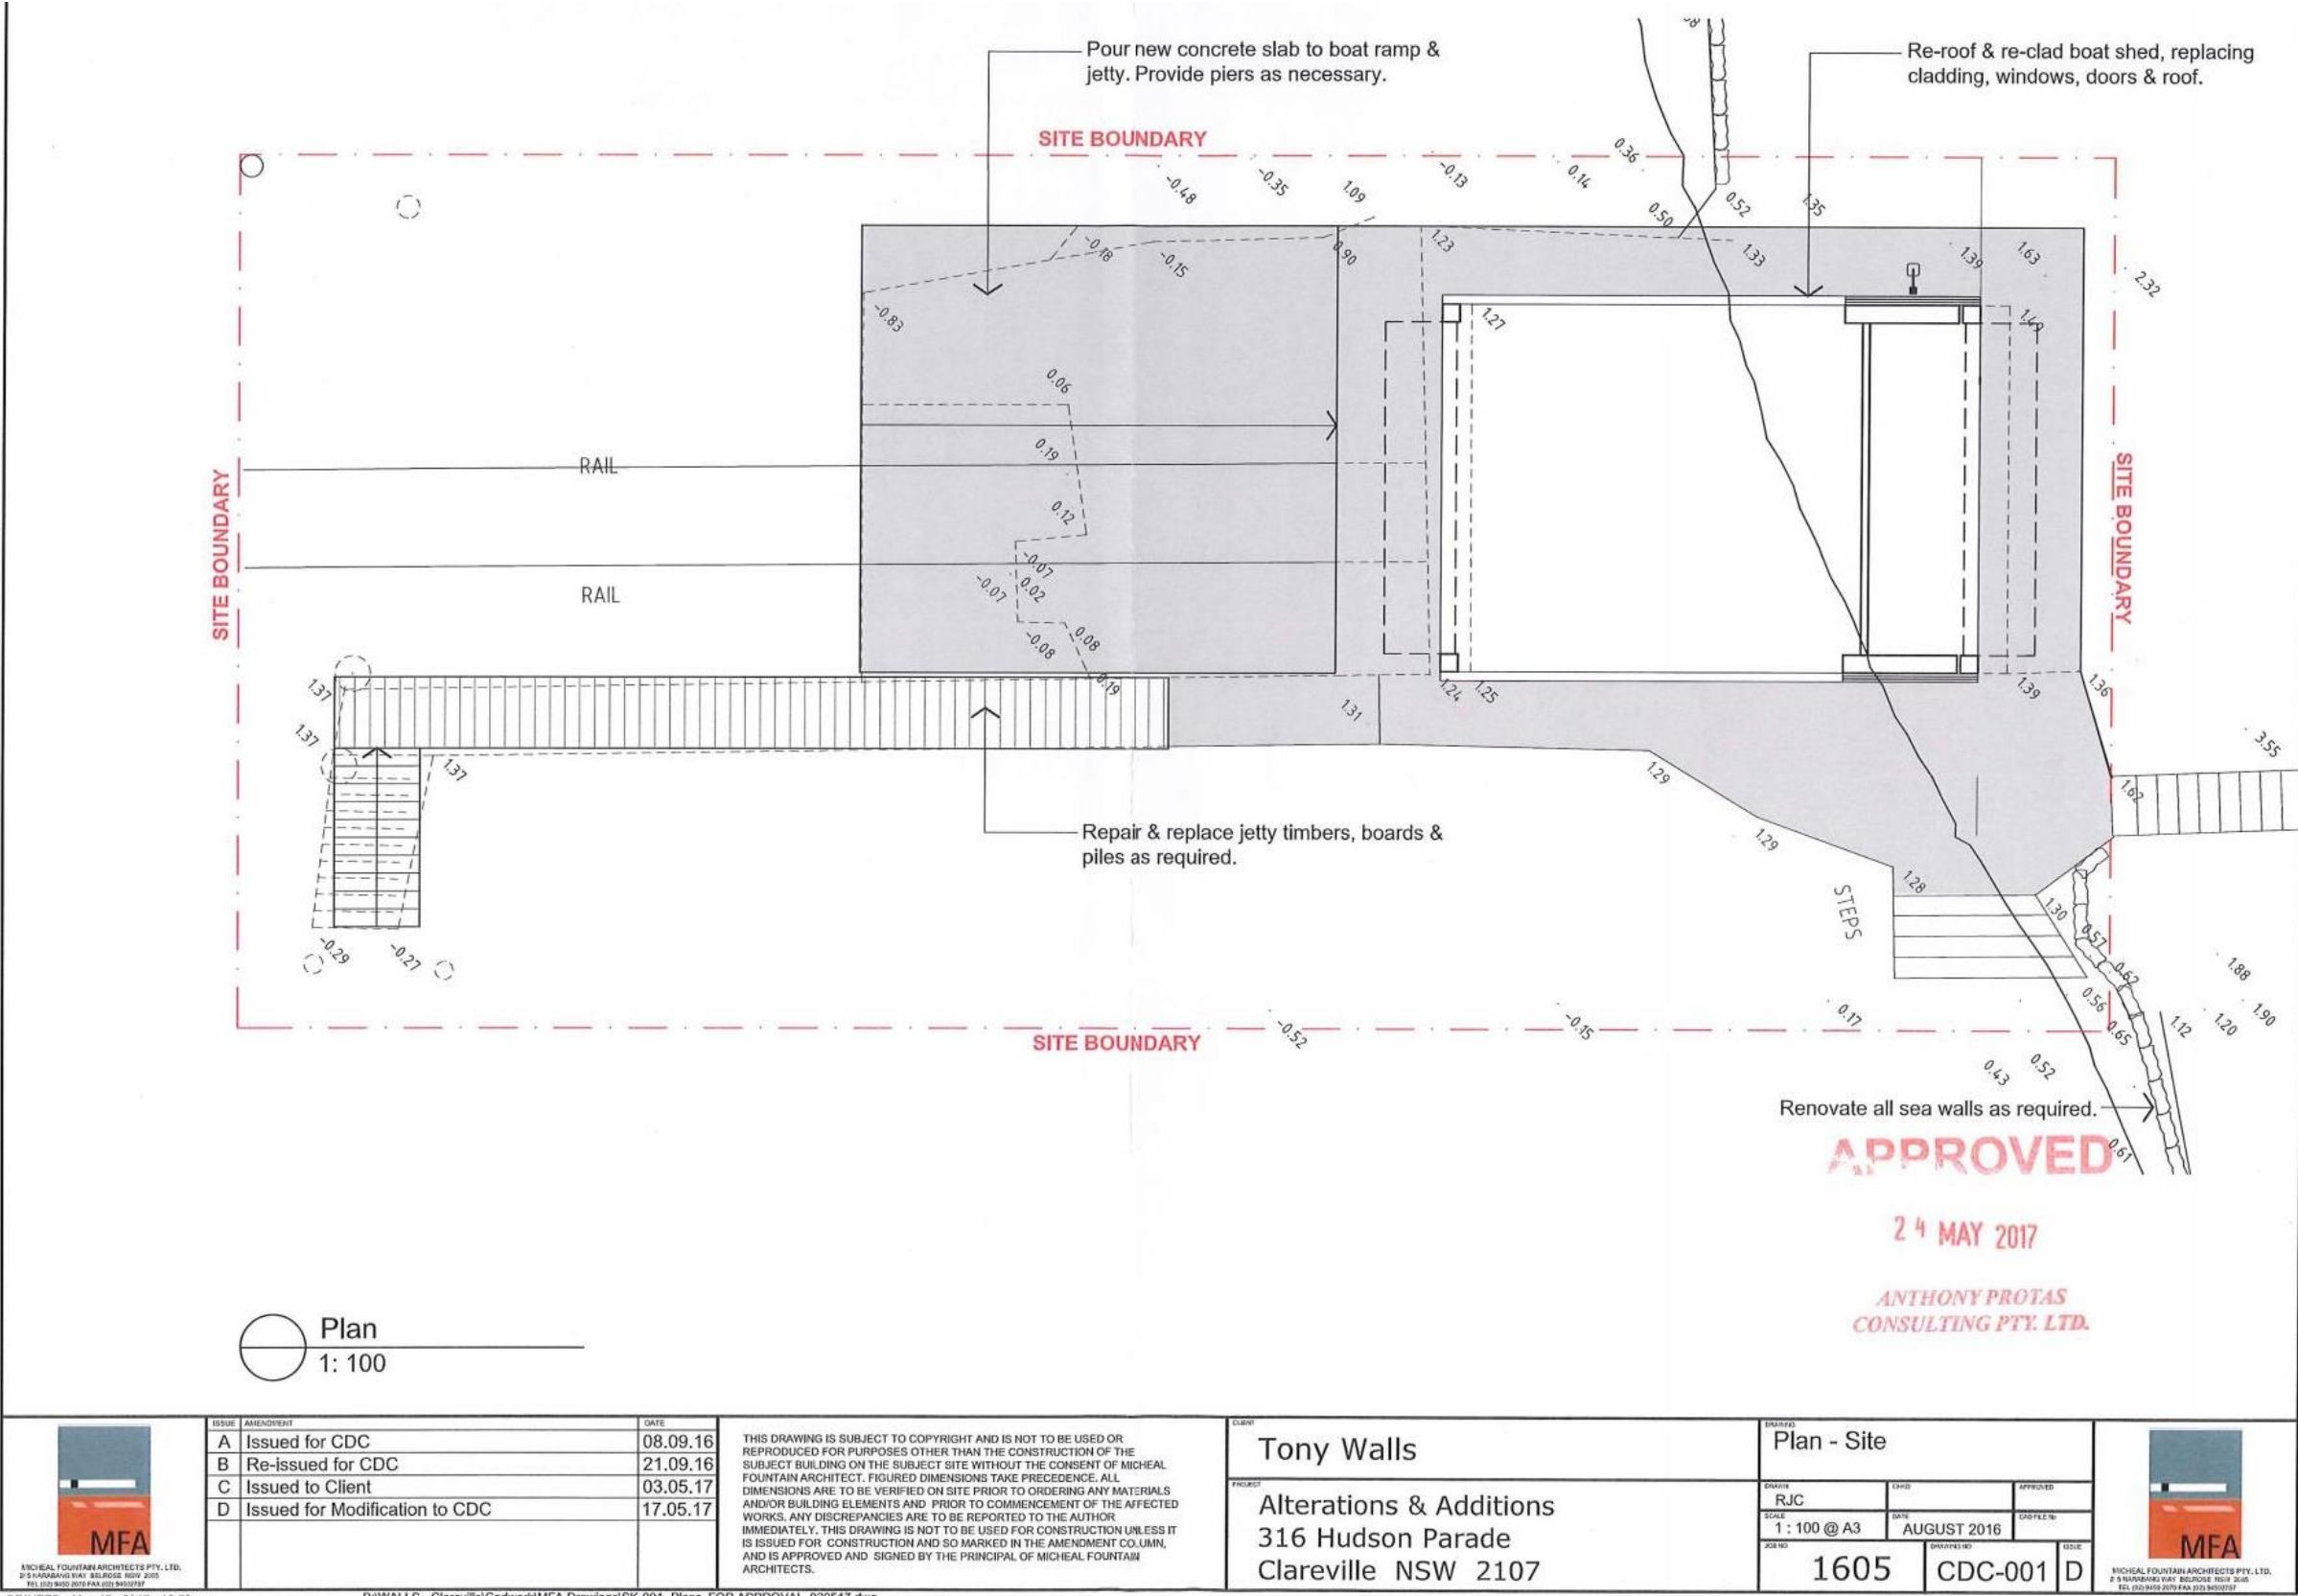
Figure 2 Approved CDC drawing

3. *The works carried out are not in accordance with the Complying Development Certificate issued by certifier Anthony Protas for “Repairs and restoration of existing marine structures” on 15 November 2016 (as modified on 24 May 2017) which is a breach of Section 4.2(1)(b) of the Environmental Planning and Assessment Act 1979.*
