## *Arboricultural Impact Assessment & Tree Protection Plan*

Commissioned by: Dick Crampton

Site: 918 Barrenjoey Road Palm Beach 2108

Date of Inspection: 18 August 2021

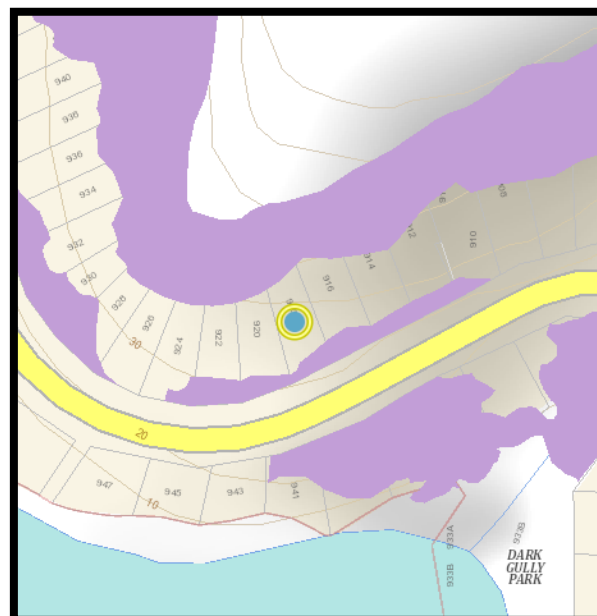
Figure 2 - Biodiversity Values Map indicating Sensitive Vegetation in Purple.

The site has been identified on the Biodiversity Values Map and Threshold Tool as a parcel containing sensitive vegetation, Threatened species or communities with potential for serious and irreversible impacts (figure 2).

The site has been identified on the Biodiversity Values Map and Threshold Tool as a parcel containing sensitive vegetation, threatened species or communities with potential for serious and irreversible impacts (figure 2). Tree protection measures to protect these areas identified within biodiversity mapping tool are required.
