# Geotechnical Assessment

**Project:** Alterations & Additions  
1 Kimo Street, North Balgowlah NSW

**Ref:** AG 25280  
4 July 2025

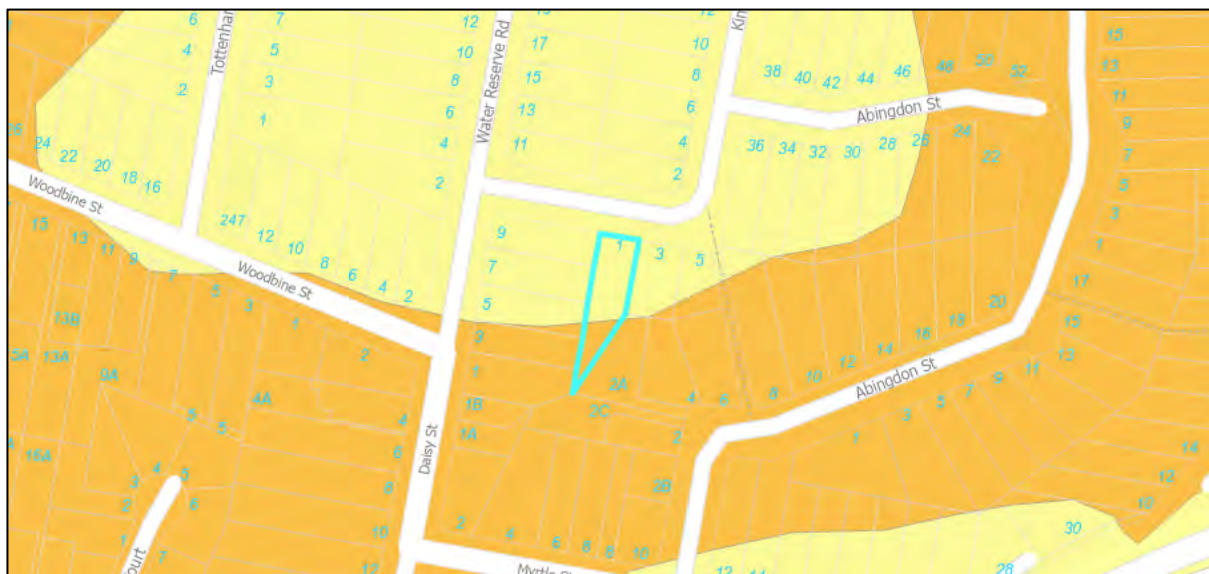
**Image 2.** Warringah Landslip Risk Map:  
1 Kimo Street, North Balgowlah NSW (© NBC Maps)

- No evidence of significant soil creep, tension cracks or landslip instability were identified across the site or on adjacent properties as viewed from the subject site at the time of our inspection.
- The escarpment is comprised of massively bedded Hawkesbury Sandstone with no significant vertical joining or bedding defects observed within the subject site.
- The proposed works are setback from the escarpment edges and undercut sections.
- The property is classified as **Area A & B** with reference to Northern Beaches Council WLEP – Warringah Landslip Risk Map (**Image 2**).
