J4349. 2<sup>nd</sup> November, 2022. Page 1.

### **GEOTECHNICAL INVESTIGATION:**

Alterations and Additions and balcony at 518 Barrenjoey Road, Avalon Beach

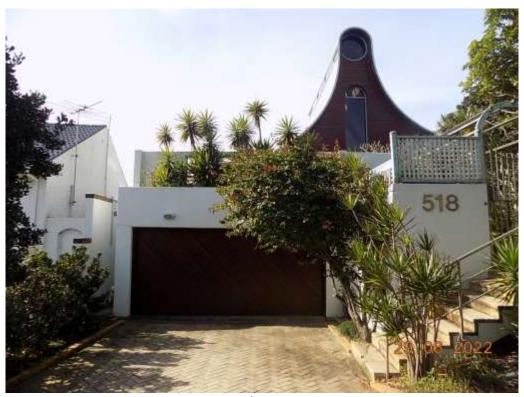
- 2.3 At the road frontage, a concrete driveway runs past a parking area to a garage attached to the W side of the house (Photo 1). A stable ~1.3m high timber crib wall supports a cut for the parking area and a fill for the level lawn area (Photo 2). The part three-storey steel framed and rendered masonry house is supported on concrete block walls and concrete block piers (Photo 3). The concrete block walls show no significant signs of movement and the visible concrete piers stand vertical. A level lawn area extends from the E side of the property to the E boundary (Photo 4). A

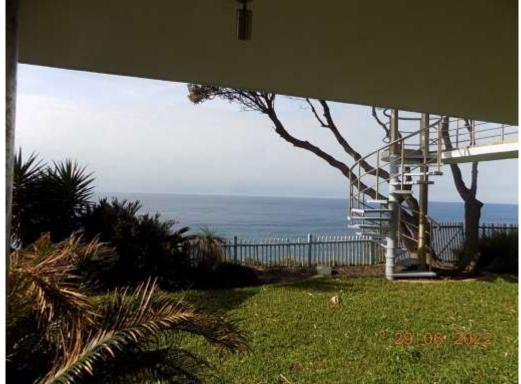
Photo 4

block walls and concrete block piers (Photo 3). The concrete block walls show no significant signs of movement and the visible concrete piers stand vertical. A level lawn area extends from the E side of the property to the E boundary (Photo 4). A ~1.5m high timber crib wall that encompasses the N common boundary and the E boundary supports the fill for this lawn area (Photo 5). The crib wall is almost entirely obscured by dense vegetation and could not be adequately assessed. A gentle to moderately sloping lawn extends shortly beyond the E boundary before dropping ~37m at vertical angles to a rock platform below (Photo 6). The cliff line is obscured by thick vegetation. From below it can be seen to be made up of thinly bedded shale and thicker bedded sandstone (Photo 7). The base of the cliff is armoured from the undercutting action of the waves by the rock platform and a build-up of slope debris (Photo 8). The cliff face to the north of the property has been undercut to ~2.0m across its base but adjacent to the subject property the cliff face has no significant defects (Photo 9). In the unlikely event of a failure the undercut will not impact the subject property. The weathering process of the cliff face occurs when the harder beds are undercut by the softer beds. Because the beds are relatively thin and jointed the resulting failures are small in scale. This weathering process is extremely slow, measured from the geological record to be in the order of 7 to 12 mm/year. The proposed works will be at least 8m from the uphill edge of the cliff. The estimated wave run-up height will reach 6.9AHD; ignoring any cliff face roughness. This is well below the site of the proposed works and only very minor spray would affect the site, as per the coastal report referenced above.

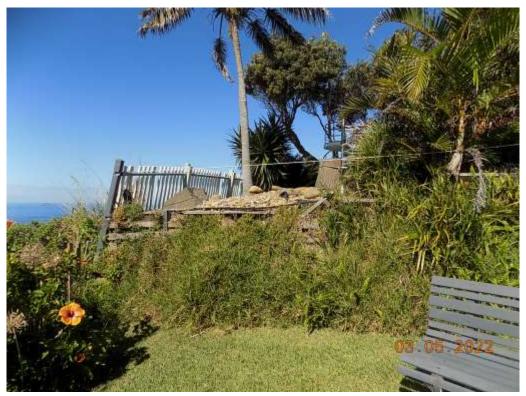
Photo 5

~1.5m high timber crib wall that encompasses the N common boundary and the E boundary supports the fill for this lawn area (Photo 5). The crib wall is almost entirely obscured by dense vegetation and could not be adequately assessed. A gentle to moderately sloping lawn extends shortly beyond the E boundary before dropping ~37m at vertical angles to a rock platform below (Photo 6). The cliff line is obscured by thick vegetation. From below it can be seen to be made up of thinly bedded shale and thicker bedded sandstone (Photo 7). The base of the cliff is armoured from the undercutting action of the waves by the rock platform and a build-up of slope debris (Photo 8). The cliff face to the north of the property has been undercut to ~2.0m across its base but adjacent to the subject property the cliff face has no significant defects (Photo 9). In the unlikely event of a failure the undercut will not impact the subject property. The weathering process of the cliff face occurs when the harder beds are undercut by the softer beds. Because the beds are relatively thin and jointed the resulting failures are small in scale. This weathering process is extremely slow, measured from the geological record to be in the order of 7 to 12 mm/year. The proposed works will be at least 8m from the uphill edge of the cliff.
