## **Geotechnical Assessment**

**Project:** Alterations & Additions

115 Narrabeen Park Parade, Mona Vale NSW

**Ref:** AG 21075

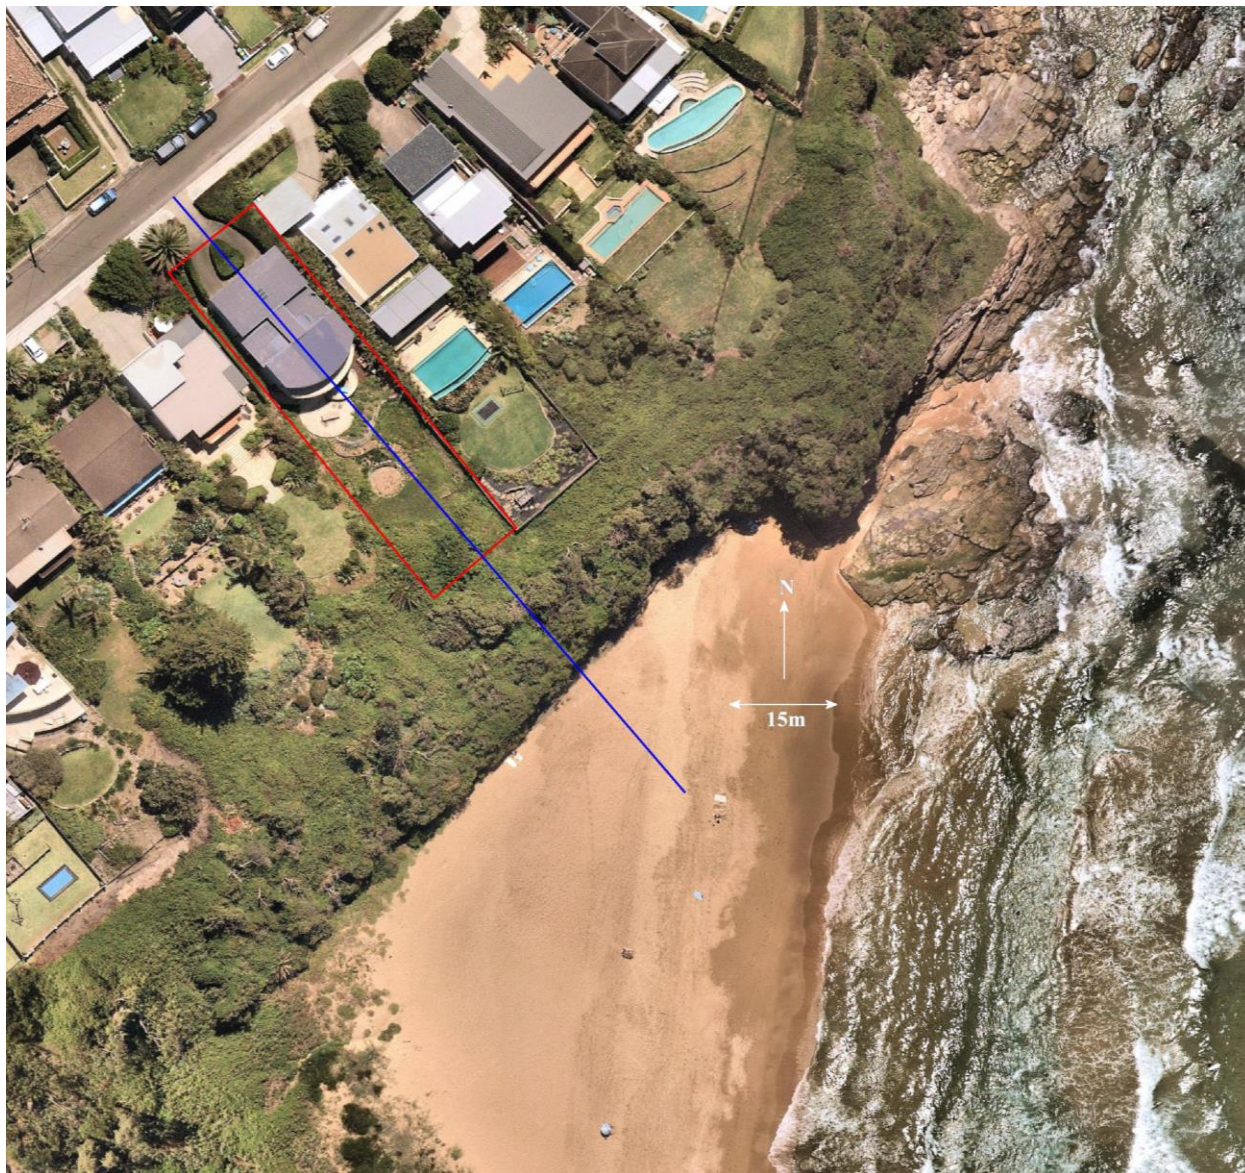
**Figure 1: Aerial view of subject property (red outline), with location of Section A shown in blue (aerial photograph taken 25 January 2021)**

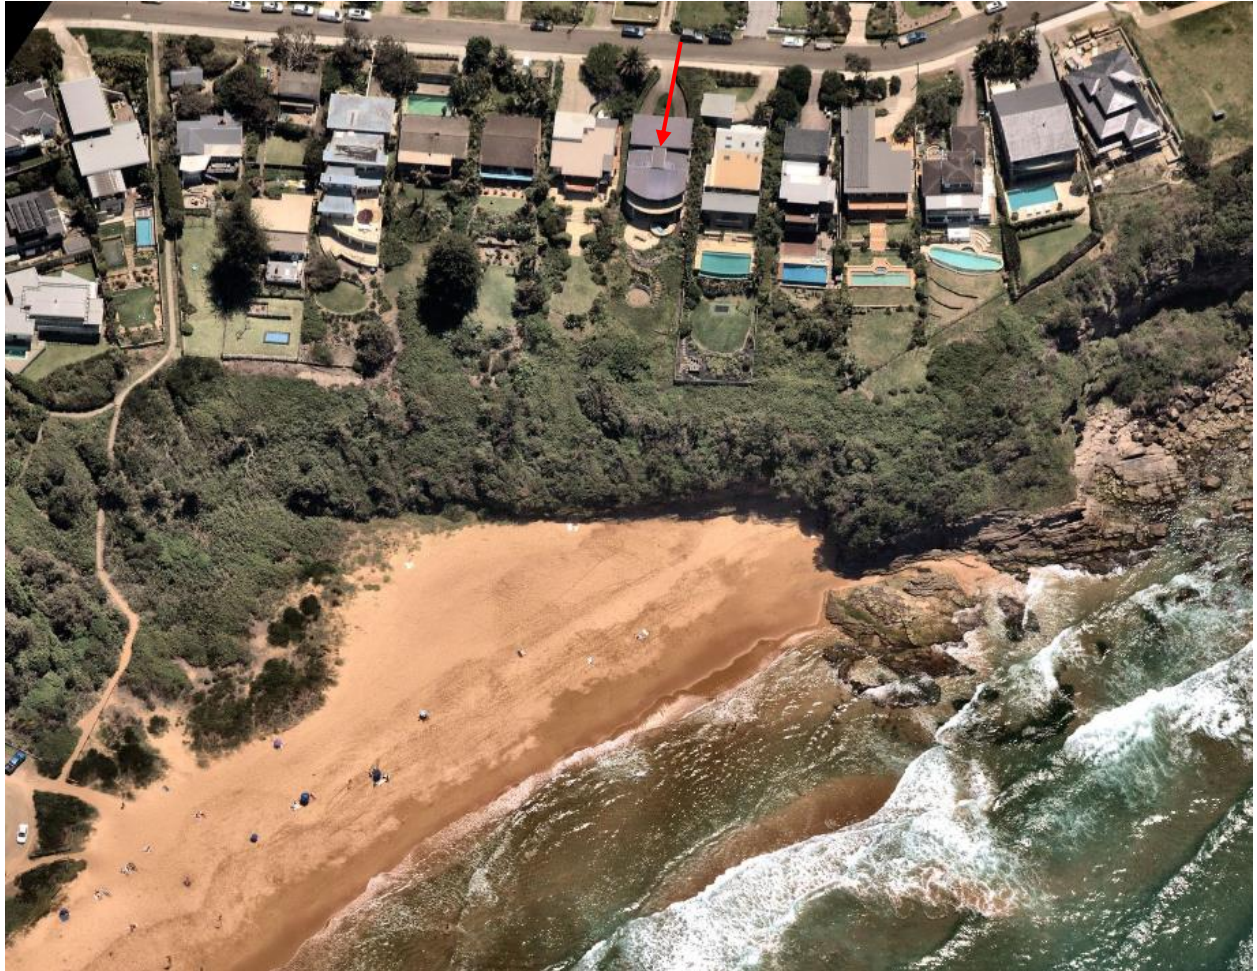
**Figure 2: Oblique aerial view of subject property (at arrow) on 25 January 2021, facing NW**
