## **GEOTECHNICAL INVESTIGATION:**

Alterations and Additions at **83-85 Bower St, Manly**

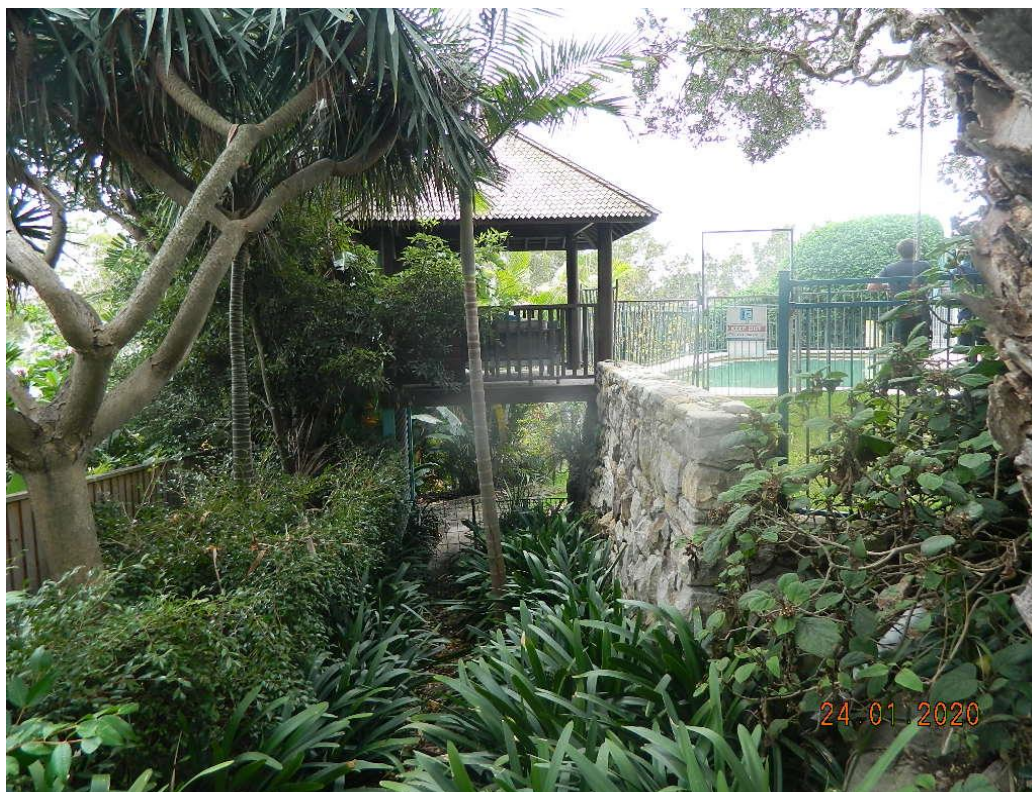
Photo 13

A stone path and steps lead up to the existing house (Photo 5). Sandstone is outcropping near the stone path (Photo 6). The existing two storey rendered brick, sandstone block wall and timber clad house is supported on brick piers, brick walls and sandstone block walls (Photos 7 to 9). The supporting piers and walls stand vertical and show no significant signs of movement (Photo 10). A timber deck is located at the NW corner of the existing house and along part of the W side of the existing house (Photo 11). At the SW corner of the property is a gently sloping lawn (photo 12). S of the deck is the existing pool and cabana (Photo 13). A stable sandstone retaining wall supports the slope S of the pool and a stack rock retaining wall terraces the slope to the W of the pool. A shared concrete parking area, with a rendered brick and timber clad garage is located at the Montpelier Place vehicle entrance (Photo 14).
