J0780. 8th April, 2016. Page 1.

GEOTECHNICAL INVESTIGATION:

Alterations & Additions at 56 Central Road, Avalon

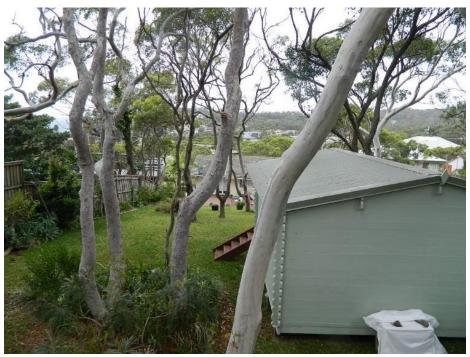
Photo 6

and it is currently considered stable. Another low cut to a maximum height of ~1.0m has been made upslope, above the deck. It is supported by a stable, mortared rock retaining wall. The land surface above is lawn covered with a scattering of sandstone exposed at the surface. A well-constructed timber framed studio is located near the upper boundary of the property and a large sandstone floater is located on the upper boundary (Photo 6 to 8). The floater is partially embedded in the slope and shows no signs of movement.
