## **REPORT ON GEOTECHNICAL SITE INVESTIGATION**

### **PROPOSED ALTERATIONS AND ADDITIONS**

**28 ETHEL STREET, BALGOWLAH, NSW**

**Project No.: 2021-198**

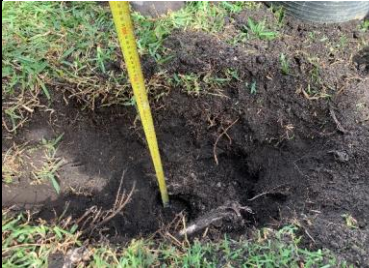
A test pit was excavated in the rear lawn to expose shallow bedrock underlying the fill soils. Inspection of the bedrock surface condition and nature showed extremely low strength sandstone at 0.50m depth grading to sandstone of at least very low strength from 0.80m depth.
