## **PRELIMINARY GEOTECHNICAL ASSESSMENT:**

### **12 Collaroy Street, Collaroy**

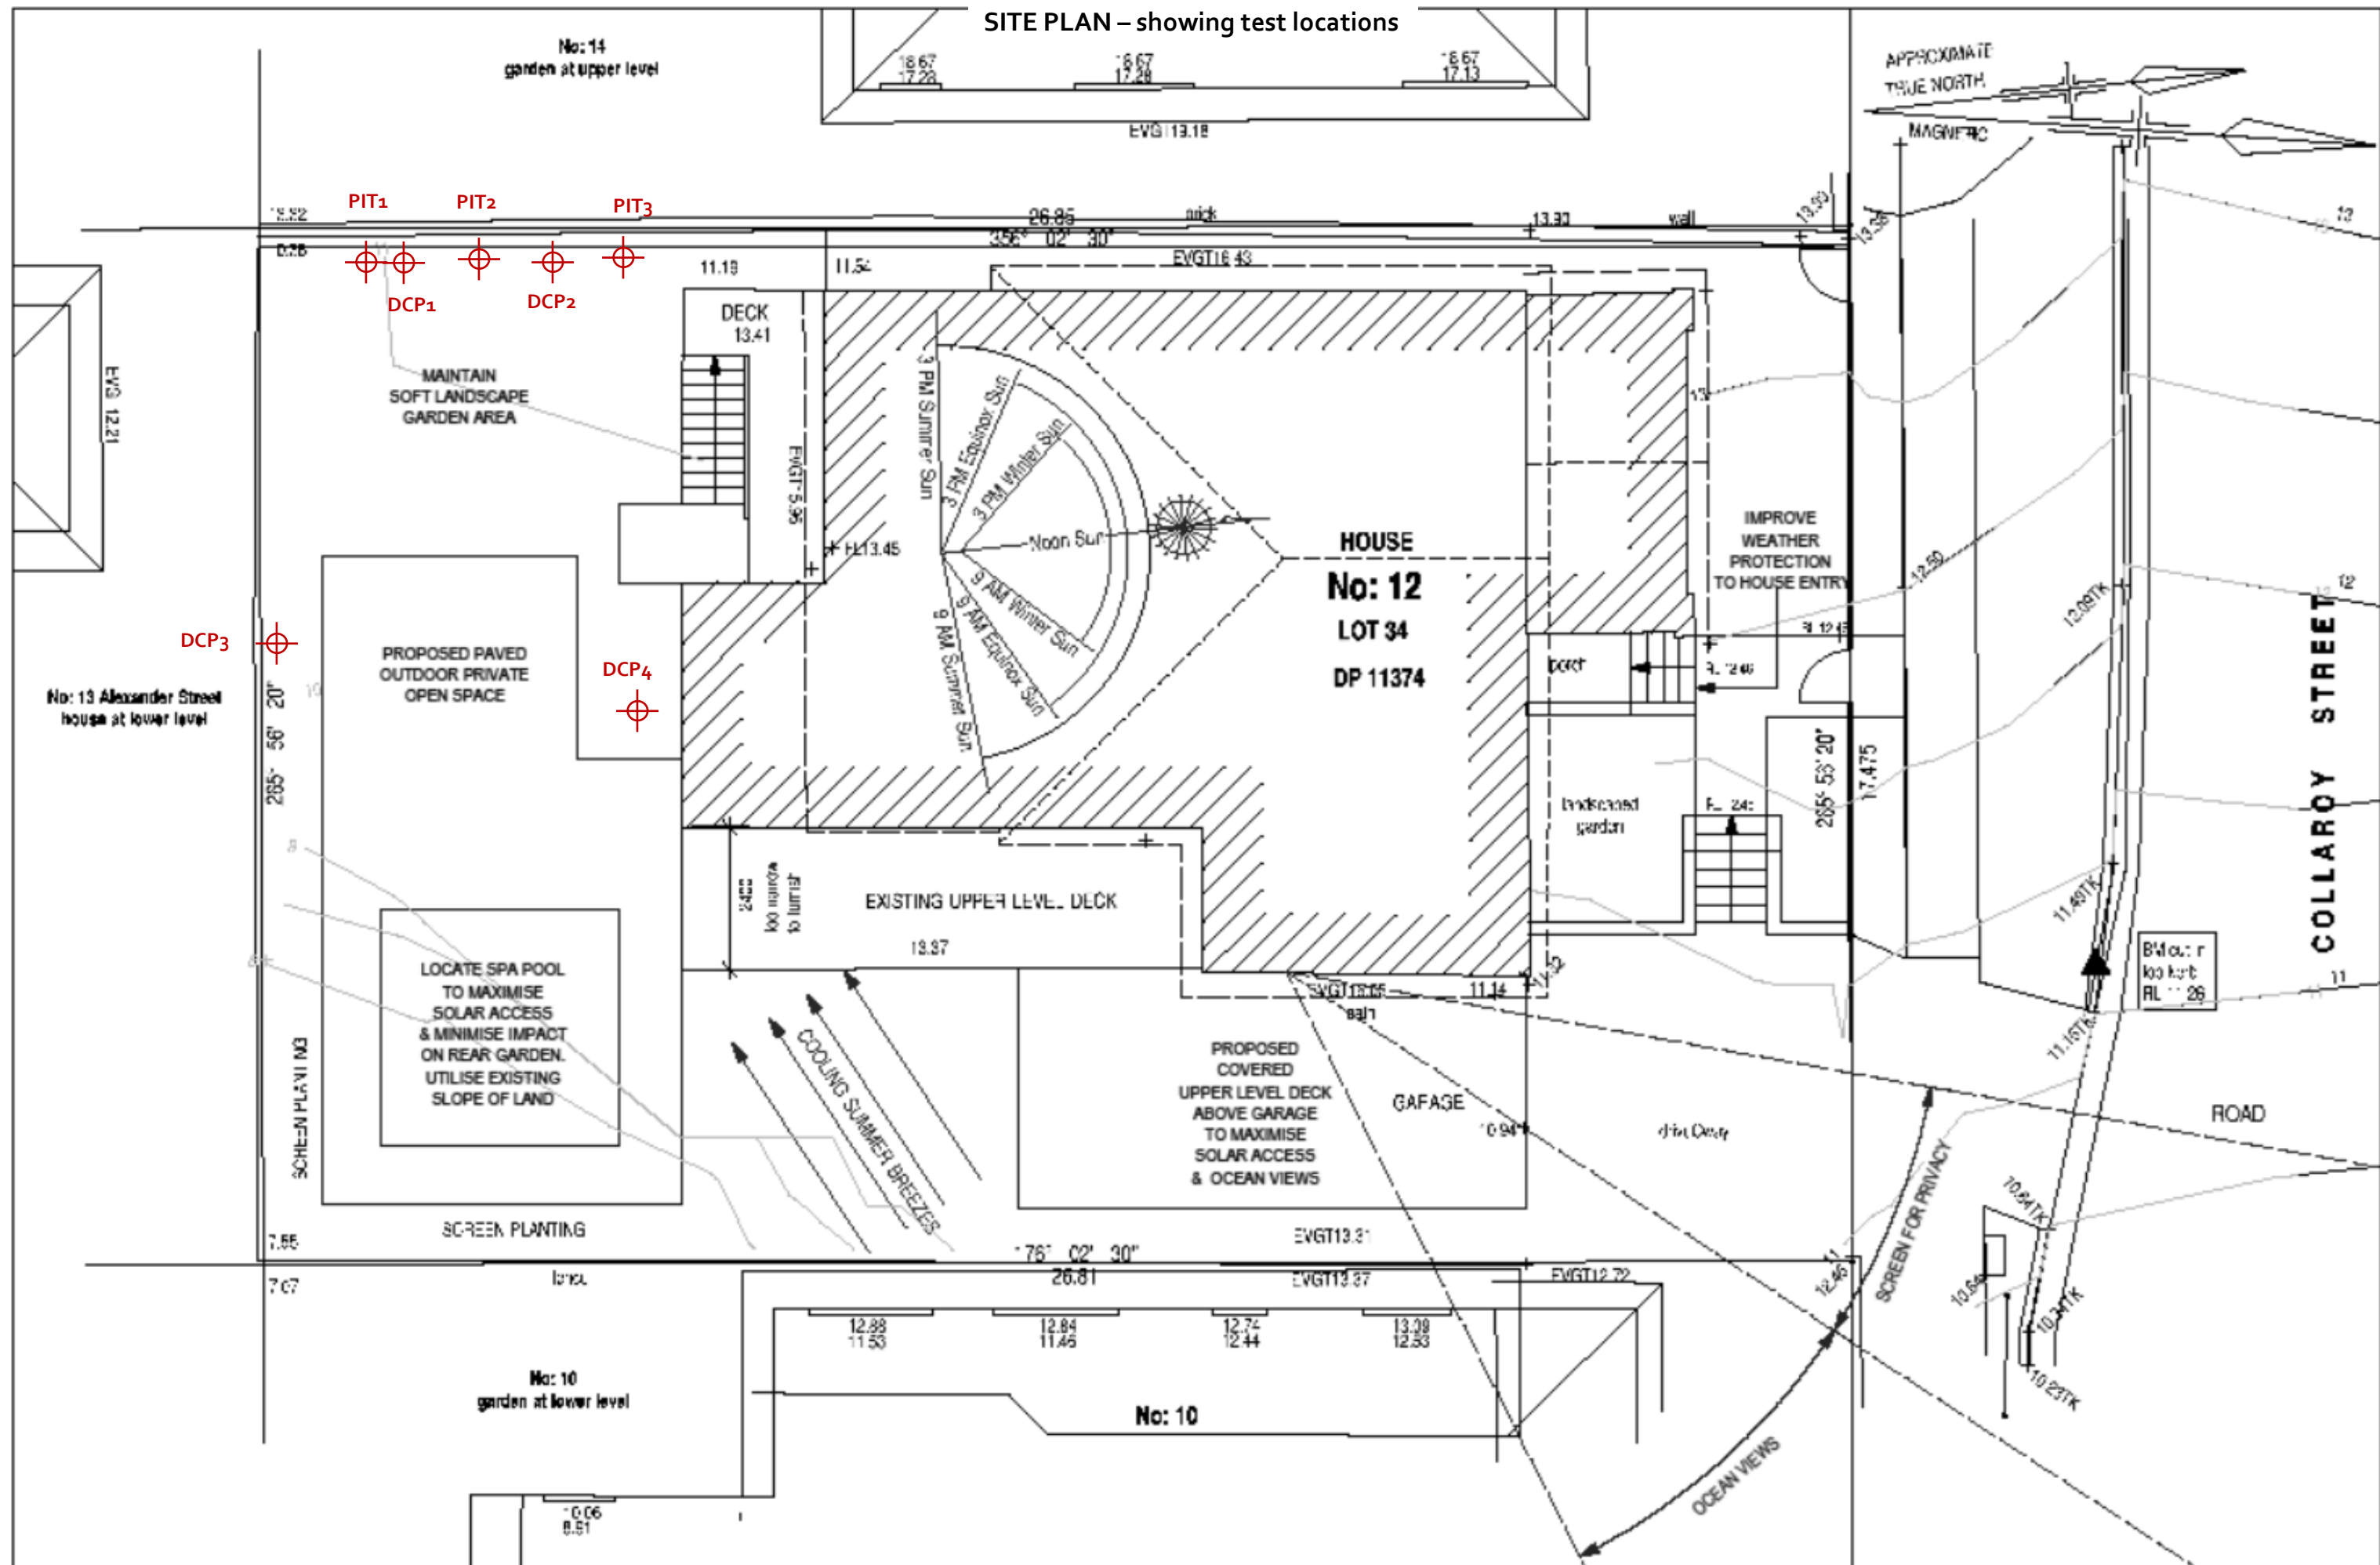
# SITE PLAN – showing test locations

Three small pits had been dug by the owner along the large brick retaining wall (Photo 1) to expose the existing foundation depth and subsurface materials. The ground materials of the pits were recorded. Four Dynamic Cone Penetrometer (DCP) tests were put down to determine the relative density of the overlying soil and the depth to weathered rock. The locations of the tests are shown on the site plan. It should be noted that a level of caution should be applied when interpreting DCP test results. The test will not pass through hard buried objects so in some instances it can be difficult to determine whether refusal has occurred on an obstruction in the profile or on the natural rock surface. This is not expected to be an issue for the testing on this site and the results are as follows:
