Project name	8 RYRIE AVE FORRESTVILLE
Project date	31/07/2024
Job End Date	31/07/2024

Section No.	US MH	DS MH	Date of inspection	Address/Location	Material	Inspected Length	Pipe Asset ID
1	SPP00846	SPP12487	31/07/2024	RYRIE AVE	Concrete reinforced	67.17	SPI13382

## Section Inspection - 31/07/2024 - SPI13382

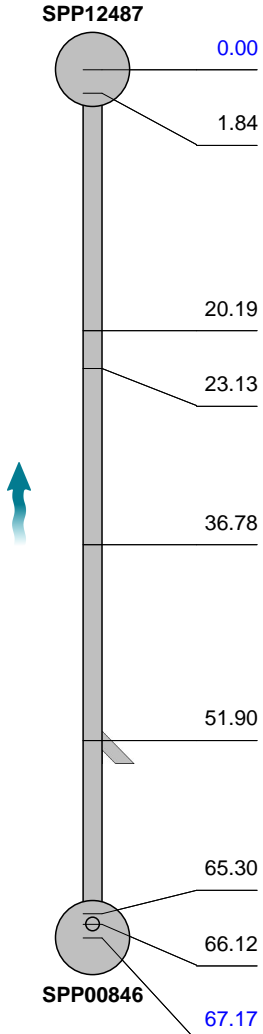
0.00	STGP	Start node, grated inlet pit, Nodename:, SPP12487	00:00:00		
	1.84	JDR	Displaced joint, radial displacement, radial displacement: 11-20mm at 6 o'clock	00:00:45

20.19	RM	A mass of mostly fine roots, which has developed into an interwoven clump, at joint, Obstruction: 5-20% at 7 o'clock	00:06:35	SPI13382_7292854f-d61e-4683
