180 McCarrs Creek Rd, Church Point

Arbor Impact Assessment
Version 1.0
Client: Yu Choong Then
c/o Sydney Earth & Tree Works

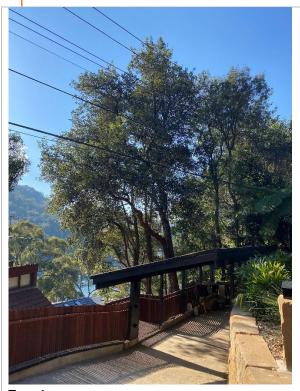
Tree 1

Canopy Cassut Malata								SIONAL	CTARC								
NO#	Genus	Species	Common Name	Age	Vigor	Growth Habit	Crown Form	Height (m)	Spread (m)	DBH	DRB	SRZ	TPZ	STARS Rating	DW %	Defects	General Comments	Encroachment
1	Syncarpia	glomulifera	Turpentine	М	Av	U	B, Sy	15	9	680	800	3013	8160	М	<5%	Included junctions with flaring @7m and 8m	Very slight lean to W	3.3m from proposed inclinator docking station - 4% encroachment within TPZ
2	Glochidion	fordin an dii	Change Trans		Δ.,	CD	۸۵	0	,	3/0	560	2594	3120	ı	<5%	Tree has been significantly lopped on S side. Moderate caterpillar damage in upper	3 x leaders @ 1.8m	Not affected by surrout development
	Giocniaion	ferdinandii	Cheese Tree	М	Av	CD	As	9	6	260	560	2594	3120	L	<5%	crown	3 x leaders @ 1.8m	Not affected by current development
3	Syncarpia	glomulifera	Turpentine	М	G	U	As	16	6	550	710	2866	6600	Н	<5%			Not affected by current development
																Moderate lean to SW, full canopy	/
