Report Title: Geotechnical Report **136 Pacific Road, Palm Beach**

Report Date: **27/9/24**

## **GEOTECHNICAL INVESTIGATION:**

House Extension, Pool, and Lift at **136 Pacific Road, Palm Beach**

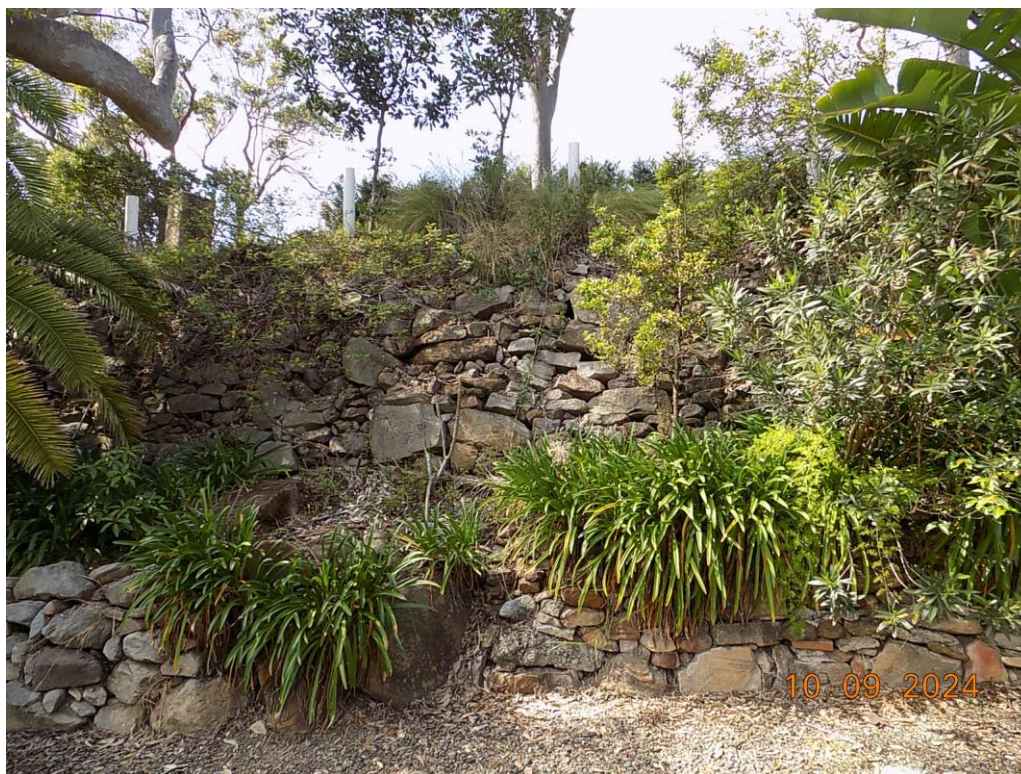
Photo 2

- 2.1** The site was inspected on the 18<sup>th</sup> September, 2024.
- 2.2** This residential property is accessed by a Right of Carriageway (ROW) off the downhill side of Pacific Road. It is on the low side of the ROW and has a NW aspect. It is located on the steeply graded middle reaches of a hillslope. The natural slope falls steeply across the property at an average angle of 27°. The slope above the property continues at similar angles before easing at the crest of the hill. The slope below increases to very steep angles.
- 2.3** At the road frontage, a concrete ROW and concrete and sandstone paved driveway run to a carport attached to the uphill side of the house (Photo 1). The fill for Pacific Road is well-vegetated and the surface is lined with stacked sandstone boulders (Photo 2). The fill batter is currently considered stable. Fill for the ROW and

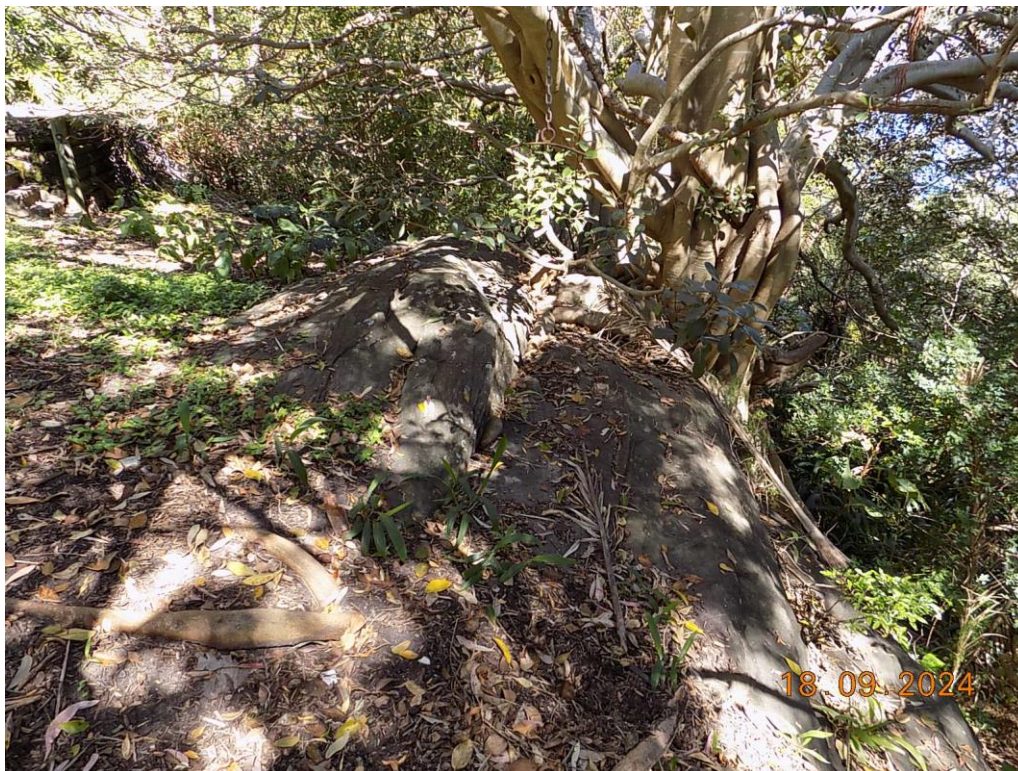
Photo 5

various cuts for the house are supported by mortared sandstone block retaining walls reaching up to ~2.3m high (Photo 1 & 3). These walls also comprise the supporting walls of the three-storey house and were observed to be at least partially supported on outcropping competent Medium Strength Sandstone. Cracking in the mortar was measured up to ~5mm in width. The cracking is likely due to settlement that will have occurred shortly after construction and the walls are considered stable. No significant signs of movement were observed in the supporting brick walls of the house. Fill for landscaping on the downhill side of the house is supported by a mortared sandstone block and brick retaining wall reaching ~2.2m high (Photo 4). A large detached joint block has come to rest on the slope in this location. This joint block as well as a scattering of other smaller boulders (Photo 5) on the slope below were observed to be resting/embedded in stable positions (Photo 6).
