**GEOTECHNICAL RISK MANAGEMENT POLICY FOR PITTWATER  
FORM NO. 1 – To be submitted with Development Application**

| Address of site _____ 85 Grandview Drive, Newport, NSW | |

| Report Title: <i>Geotechnical Assessment for Proposed Alterations and Additions</i> | |
| Report Date: <i>27 May 2025</i> | Report Ref No: <i>37607YMrpt</i> |

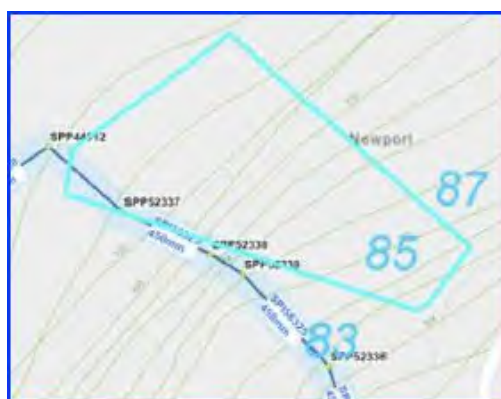
*Extract 1- from supplied msp Asset Location Report (2025-0393 dated 1/5/2025)*

To the south of the site is 83 Grandview Drive. The nearside of this property has a gully with slopes of 20° to 30° and numerous palm trees on the slopes. The trough of the gully is reasonably well indicated by the location of the 450mm diameter stormwater pipe shown on the extract below. A derelict garage is located in the gully about 10m up from Grandview Drive and about 5m from the site boundary.

At the high end of the site, behind (south-west of) the garage is a stormwater pit with a broken lid. The pipe appeared serviceable with water observed to be flowing during a day of light to moderate rain.

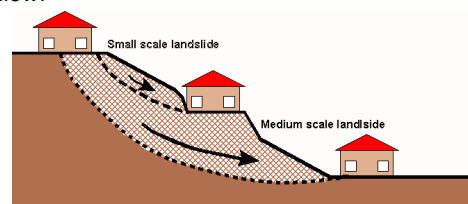
Figure 1

**Rotational or circular slip failures (Figure 1)** - can occur on moderate to very steep soil and weathered rock slopes (Table 1). The sliding surface of the moving mass tends to be deep seated. Tension cracks may open at the top of the slope and bulging may occur at the toe. The ground may move in discrete "steps" separated by long periods without movement. More rapid movement may occur after heavy rain.

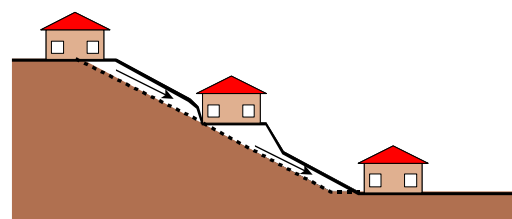
Figure 2

**Translational slip failures (Figure 2)** - tend to occur on moderate to very steep slopes (Table 1) where soil, or weak rock, overlies stronger strata. The sliding mass is often relatively shallow. It can move, or deform slowly (creep) over long periods of time. Extensive linear cracks and hummocks sometimes form along the contours. The sliding mass may accelerate after heavy rain.

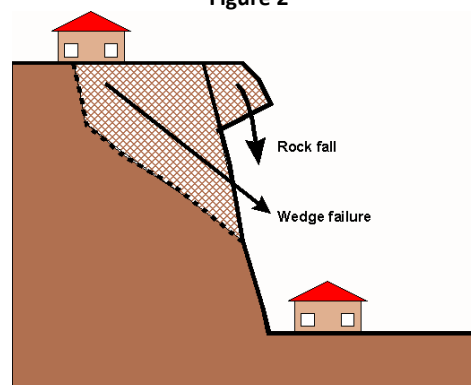
Figure 3

**Wedge failures (Figure 3)** - normally only occur on extreme slopes, or cliffs (Table 1), where discontinuities in the rock are inclined steeply downwards out of the face.

**Rock falls (Figure 3)** - tend to occur from cliffs and overhangs (Table 1).

Cliffs may remain, apparently unchanged, for hundreds of years. Collections of boulders at the foot of a cliff may indicate that rock falls are ongoing. Wedge failures and rock falls do not "creep". Familiarity with a particular local situation can instil a false sense of security since failure, when it occurs, is usually sudden and catastrophic.

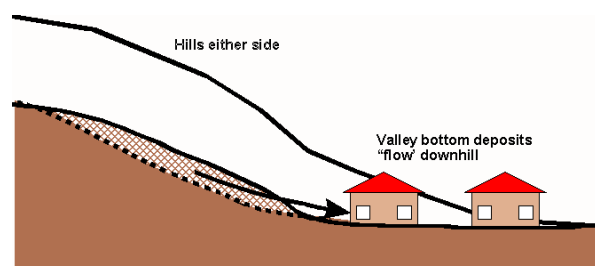
Figure 4

**Debris flows and mud slides (Figure 4)** - may occur in the foothills of ranges, where erosion has formed valleys which slope down to the plains below. The valley bottoms are often lined with loose eroded material (debris) which can "flow" if it becomes saturated during and after heavy rain. Debris flows are likely to occur with little warning; they travel a long way and often involve large volumes of soil. The consequences can be devastating.

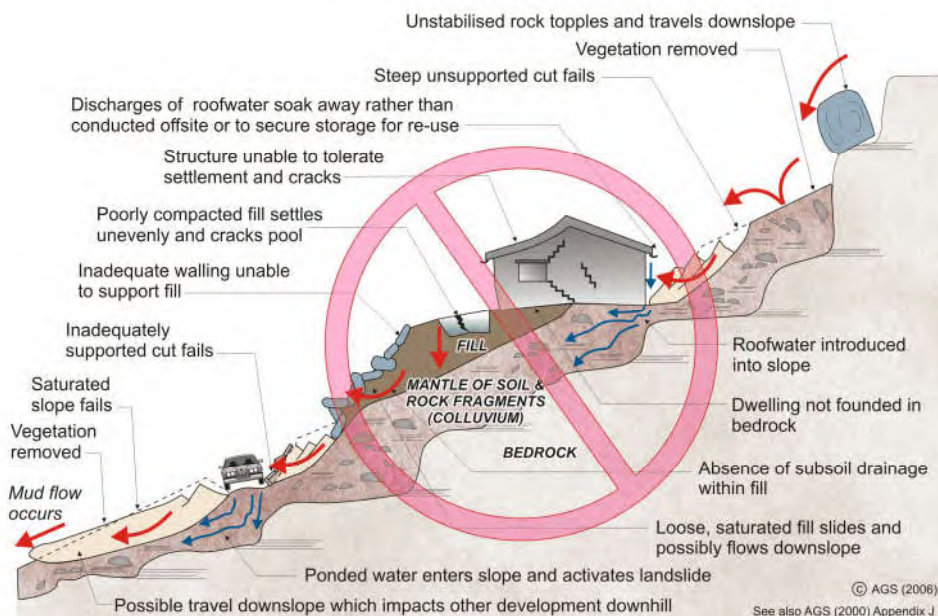
### WHY ARE THESE PRACTICES POOR?

**Roadways and parking areas** - are unsurfaced and lack proper table drains (gutters) causing surface water to pond and soaks into the ground.
