Arboricultural Impact Assessment Report For Development Application Submission.

December 2023 Prepared for; Cameron Mcgeachie.

Site Address, 179 Plateau Road Bilgola Plateau NSW 2107.

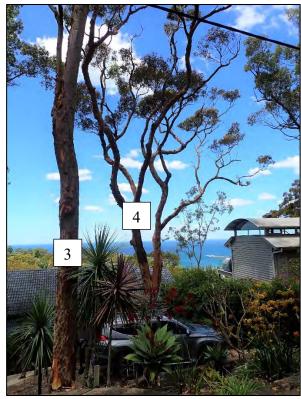
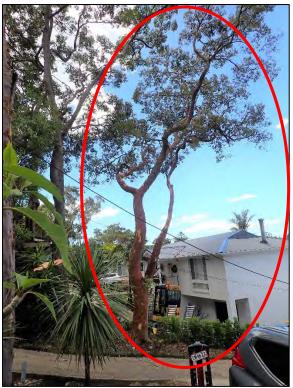
Tree 4 Is located adjacent to the proposed below ground Rainwater retention tank. For the instillation of the tank, major root severance <20cmfrom the base of the tree on the East (E) side will be required, as a consequence of the root severance to tree will have a unacceptable likelihood of failure. The tree has a minor TPZ incursion of approximately 3.1% or 5.3m² and an SRZ incursion of approximately 13.3 % or 3.6m². The SRZ incursion is **Not Acceptable** under the guidelines set out in AS 4970–2009 *Protection of trees on development sites*.

Image 14, Trees 3 & 4. Location.

The Author recommends that **Tree 4** is **Not Viable** for retention due to **major SRZ Incursion** that will impact the health, vitality, and stability of the tree. The impact is considered major. This tree should be replaced in the landscape plan for the proposed construction.

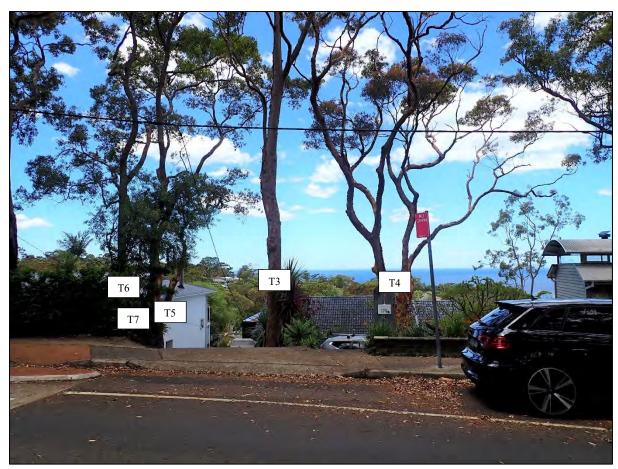
Image 21, Tree 7. Location.

Tree 7 is classified as an invasive environmental weed in NSW. It is recommended that the client discuss the removal and replacement of the tree with the property owner 177 Plateau Road for permission to replace the tree.
