Report Title: Geotechnical Report 129 Riverview Road, Avalon

Report Date: 29/5/19

## **GEOTECHNICAL INVESTIGATION:**

### **New Inclinator at 129 Riverview Road, Avalon**

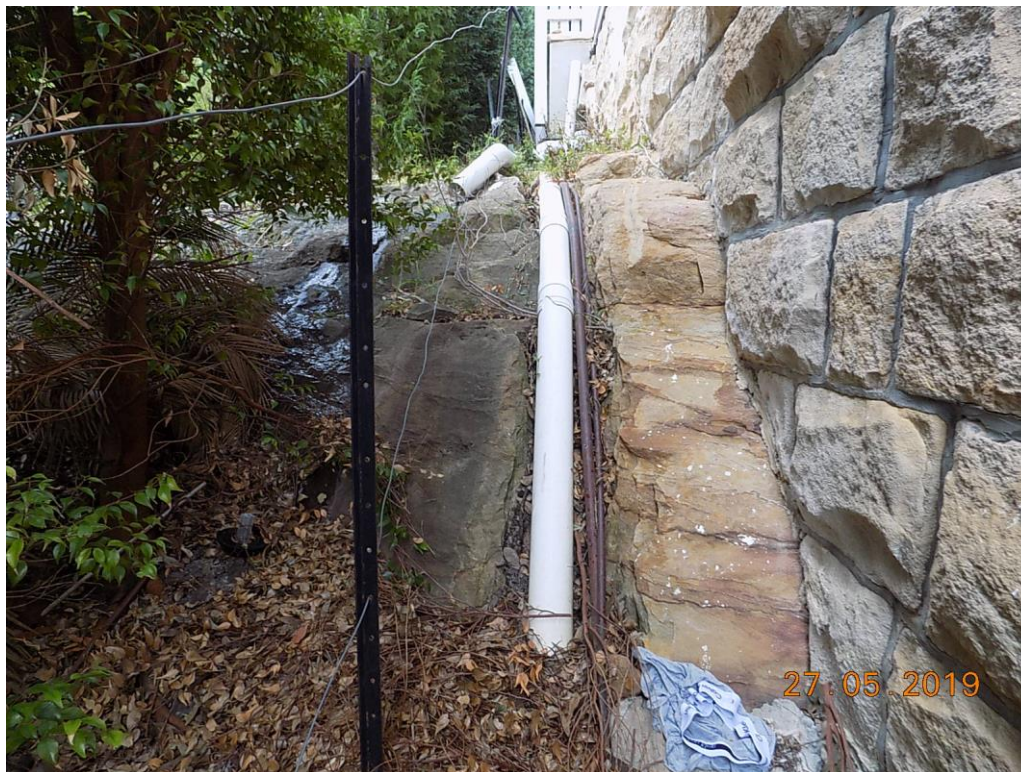
Photo 4

Concrete slabs supported directly off Low Strength Rock are suitable footings for the proposed inclinator landings. This ground material is expected to be exposed across the entire base of the excavation, and exposed at the surface in the location of the proposed upper landing (Photo 4).
