Report Title: Geotechnical Report 133 Riverview Road, Avalon Beach

Report Date: 23/5/25

## **GEOTECHNICAL INVESTIGATION:**

Alterations and Additions and New House and Garage at **133 Riverview Road, Avalon Beach**

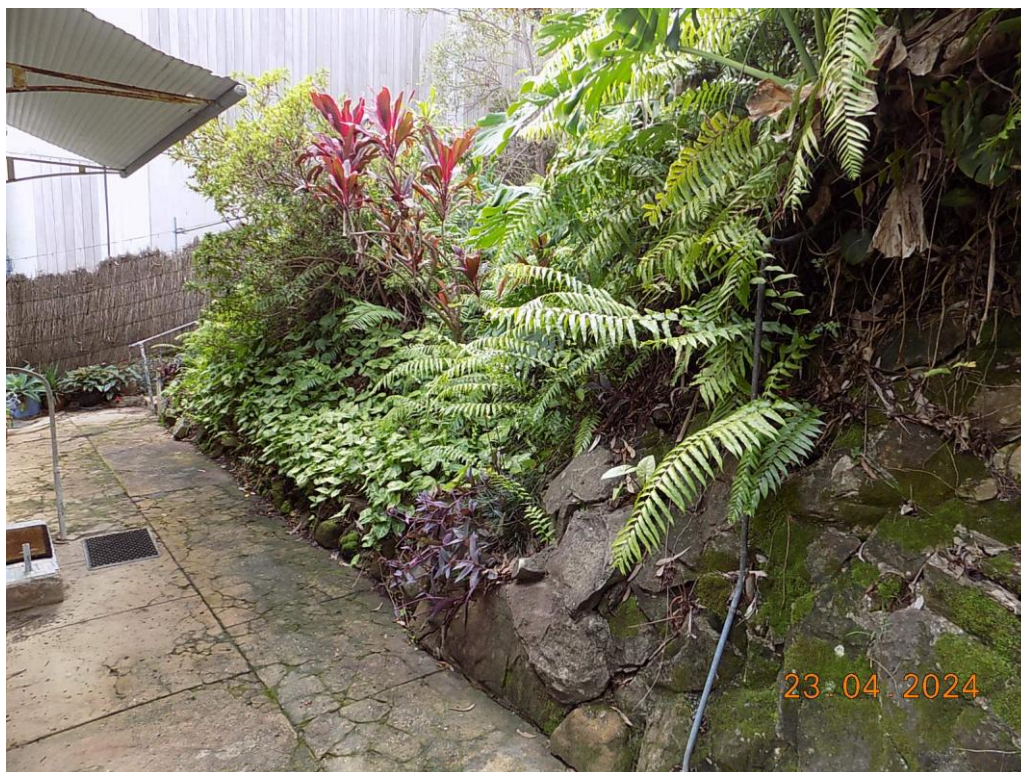
Photo 5

Riverview Road is supported by a low stable timber retaining wall (Photo 2), or is battered at stable angles (Photo 3). Between the parking space and the house is a moderately graded lawn (Photo 4). The cut for the house is battered at stable angles, has a covering of dense vegetation (Photo 5), and is partially supported by a mortared rock retaining wall (Photo 6). The retaining wall exhibited cracking in the mortar, however it will be demolished as part of the proposed works. The single-story fibreboard house is supported on sandstone block walls and sandstone piers. The house will also be demolished for the proposed works. Sandstone boulders are scattered across the steep slope below the house (Photo 7), and were observed to be sufficiently embedded in stable positions. This slope continues for some ~20m before increasing to very steep angles (Photo 8). The very steep slope in this location consists of alternating bands of thinly-bedded Very Low Strength Shale and thicker bands of Low Strength Sandstone (Photo 9). The majority of the slope consists of thin sandstone beds. The weathering process of the bedrock is that the softer beds undercut the harder beds. Because the bedding is thin and tightly jointed, the resulting failures are very small in scale. There is evidence of these failures occurring in the past and they are expected into the future, particularly during and immediately after heavy rainfall. Additionally, the weathering process is slow and the failures are not considered a threat to life or property. A near level shelf of Low to Medium strength sandstone extends from the base of this cliff to the waterfront (Photo 10).
