# SCHEDULE OF CONSERVATION WORKS

*Façades of*

6 The Corso and 50 East Esplanade, Manly NSW

September 2023 | J5235

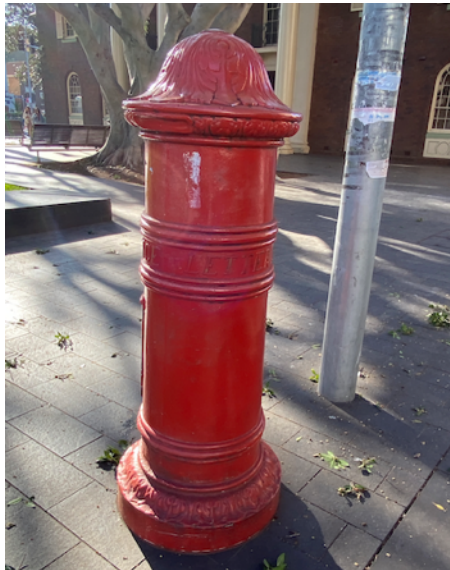
| Sheet No: | CM-03 | Space No: | Heritage Items in The Corso Plaza |
|---|---|---|---|
| | <p><b>LOCATION:</b> <i>Item 114</i> Cast Iron Letter Box</p> <p><b>REQUIRED PROTECTION:</b><br/>To comply with the protection requirements of Term 21 of Northern Beaches Council Deferred Commencement Conditions (DA2019/0997) The following is to be proved.</p> <p>Protection installed shall consist of layers of 'bubble wrap' surrounded by plywood or timber boarding. The plywood or timber boarding is to be coated on all sides prior to installation so it will not bleed and stain the surroundings when wet. The protection material is to be fixed to itself and not to the heritage item it is protecting. Heritage items are not to be adhered to or fixed to under any circumstances. This work is to be executed by an experienced carpenter with a proven record of satisfactory work to heritage items.</p> | | |

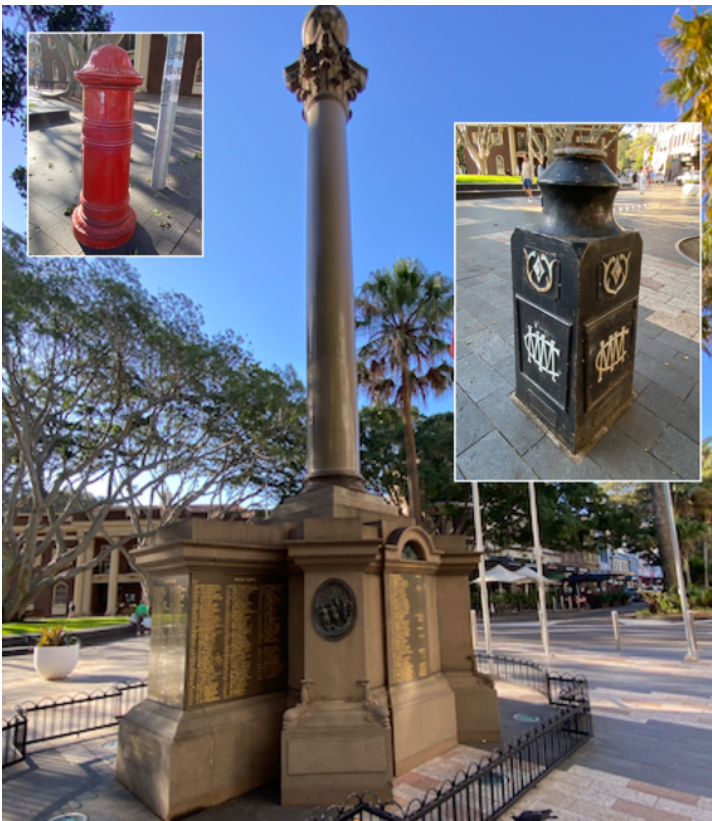
| | | | <p><b>LOCATION:</b> The Corso Plaza</p> <p><b>REQUIRED PROTECTION:</b><br/>Signage of durable material is to also be provided in lettering of not less than 35mm high stating:</p> <p>THIS BOARDING HAS BEEN INSTALLED TO PROTECT A VALUED HERITAGE ASSET FROM POSSIBLE DAMAGE.<br/>THIS PROTECTION IS REMAIN UNTIL ADJACENT CONSTRUCTION ACTIVITY HAS CONCLUDED.</p> |

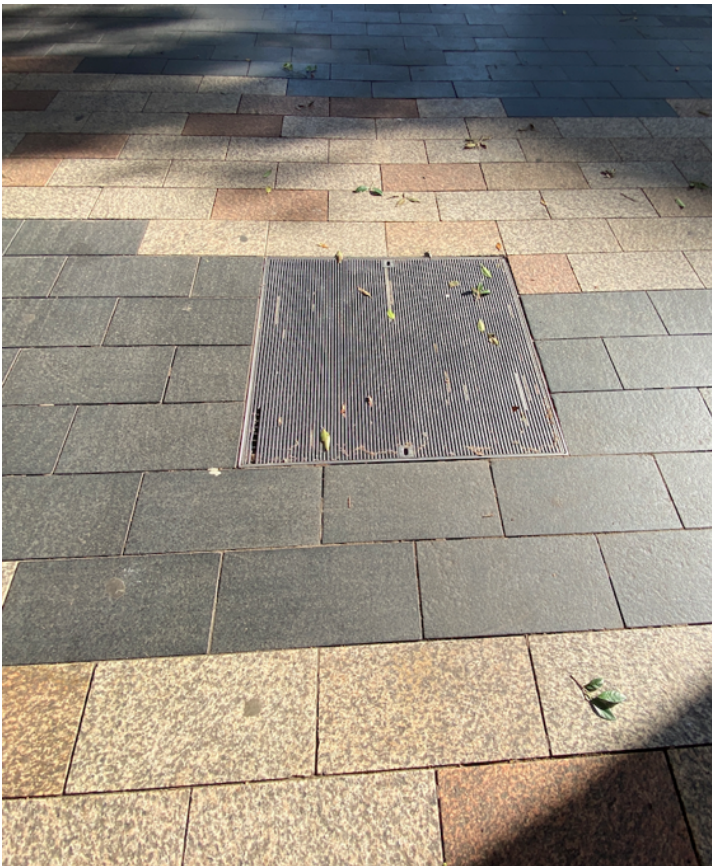
| | | | <p><b>LOCATION:</b> The Corso Plaza</p> <p><b>REQUIRED PROTECTION:</b><br/>The plaza paving and pedestrian storm-water grate adjacent to the works are to be protected from splatter and impact damage.</p> <p>The pedestrian stormwater drain is to be protected from possible contaminated water that may emanate from the works</p> |

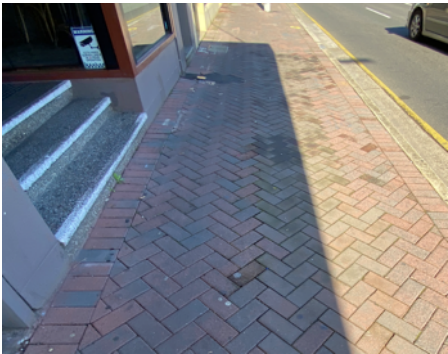
| | <p><b>LOCATION:</b> 50 East Esplanade - Façade</p> <p><b>REQUIRED PROTECTION:</b><br/>The paving and stormwater drainage adjacent to the works are to be protected from splatter and impact damage.</p> <p>The stormwater drain is to be protected from possible contaminated water that may emanate from the works</p> | | |
