## **73 Pacific Road, Palm Beach**

### Geotechnical Comments for Section 4.55

## **GEOTECHNICAL INVESTIGATION:**

### **Alterations and Additions and New Garage at 73 Pacific Road, Palm Beach**

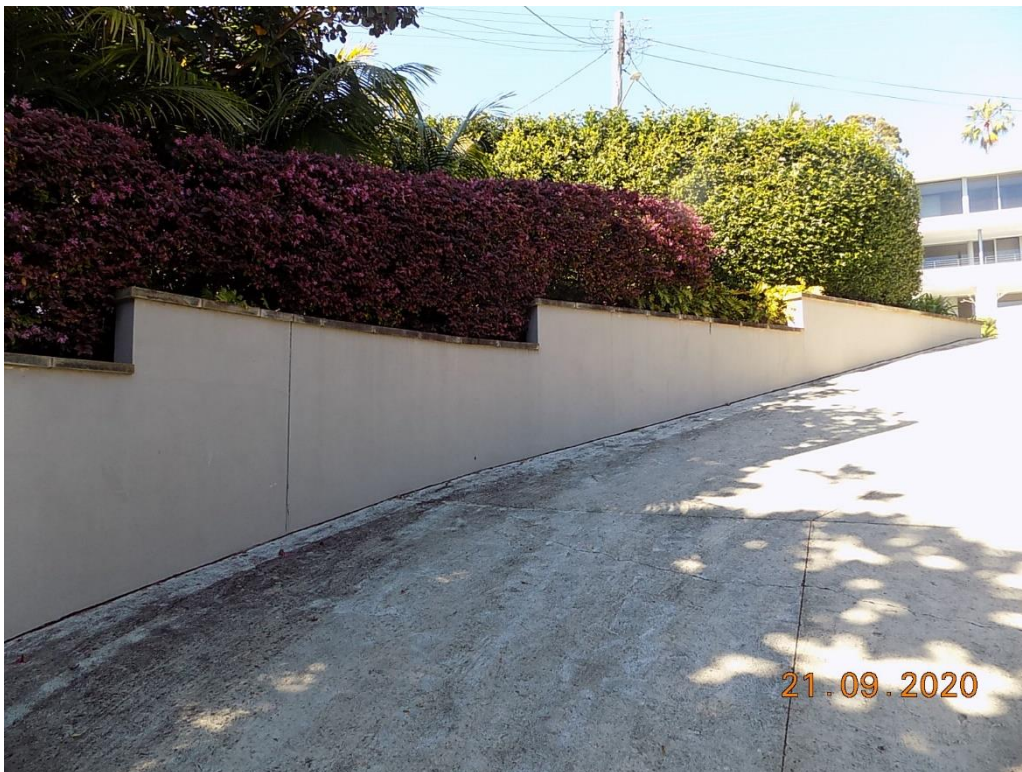
Photo 2

- 2.1** The site was inspected on the 21<sup>st</sup> September, 2020.
- 2.2** This residential property has dual access. It is on the downhill side of Pacific Road and on the uphill side of Mitchell Road. The property has a NW aspect. The block is located on the moderate to steeply graded upper reaches of a hillslope. The natural surface falls across the property at an average angle of ~20°. The slope above the property gradually eases. The slope below the property gradually increases in grade.
- 2.3** At the road frontage to Pacific Road, a concrete driveway runs down the slope to a garage on the ground floor of the house (Photo 1). The cut for the driveway is supported by a stable rendered masonry retaining wall reaching ~2.0m high (Photo 2). Between the road frontage and the house is a gently sloping garden area (Photo 3).

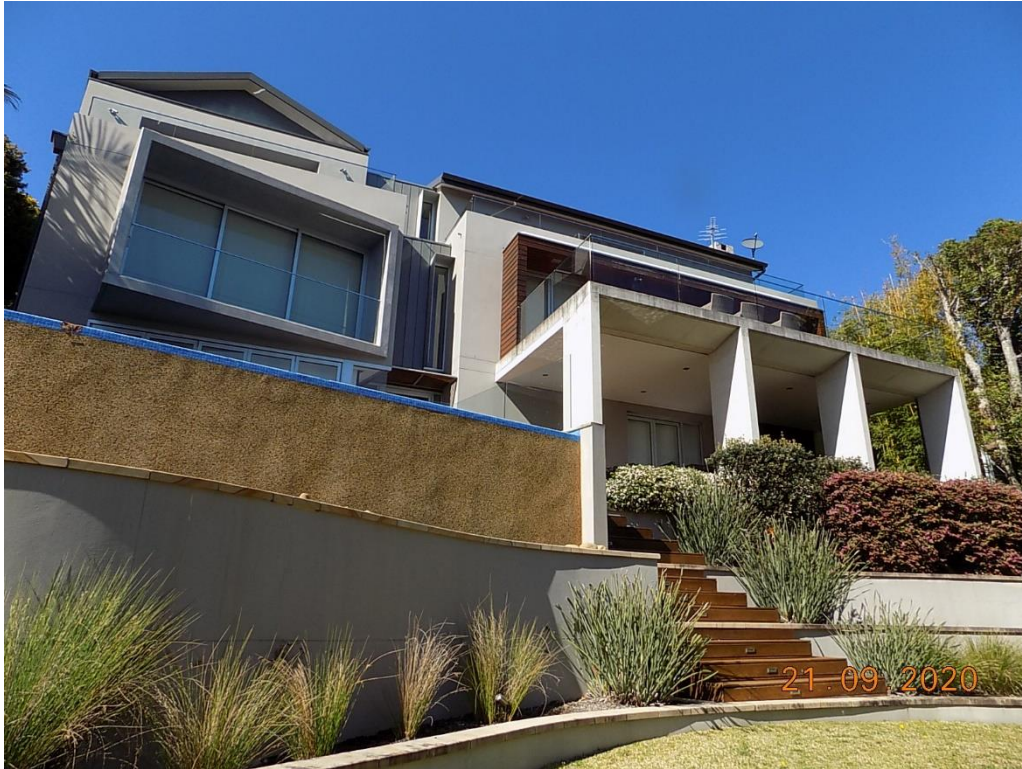
Photo 5

An excavation has been made through this slope for the uphill side of the house. The cut is supported by a stable rendered masonry retaining wall ~1.1m high (Photo 4). The part three-storey rendered brick house is supported on brick walls and brick piers (Photos 5 & 6). No significant signs of movement were observed in the supporting walls of the house and the supporting piers stand vertical. Some of the walls and piers were observed to be supported directly off competent Medium Strength Sandstone bedrock within the foundation space of the house. An excavation has been made in the slope for the lower ground floor of the house. The ~2.0m cut has been taken entirely through competent Medium Strength Sandstone (Photo 7). No significant geological defects were observed in the cut face and it is considered stable. A pool has been constructed on the downhill side of the house (Photo 8). The water level of the pool indicates no ground movement has occurred in the shell of the pool since its construction. A small terraced garden slope falls from the downhill side of the house and pool to a gently sloping lawn area below (Photo 9). The terraces are supported by stable rendered masonry retaining walls reaching ~1.4m high. At the E end, the walls were observed to be supported directly off outcropping Medium Strength Sandstone (Photo 10). The outcrop steps down the slope ~1.7m. No significant geological defects were observed in the outcrop and it is considered stable. A concrete parking area has been constructed below the outcrop and beside the lawn (Photo 11). A concrete driveway provides access to the parking area from Mitchell Road (Photo 12). Between the road frontage to Mitchell Road and the parking area and lawn is a terraced garden (Photo 13). The terraces are supported by stable sandstone block retaining walls reaching ~1.0m high.

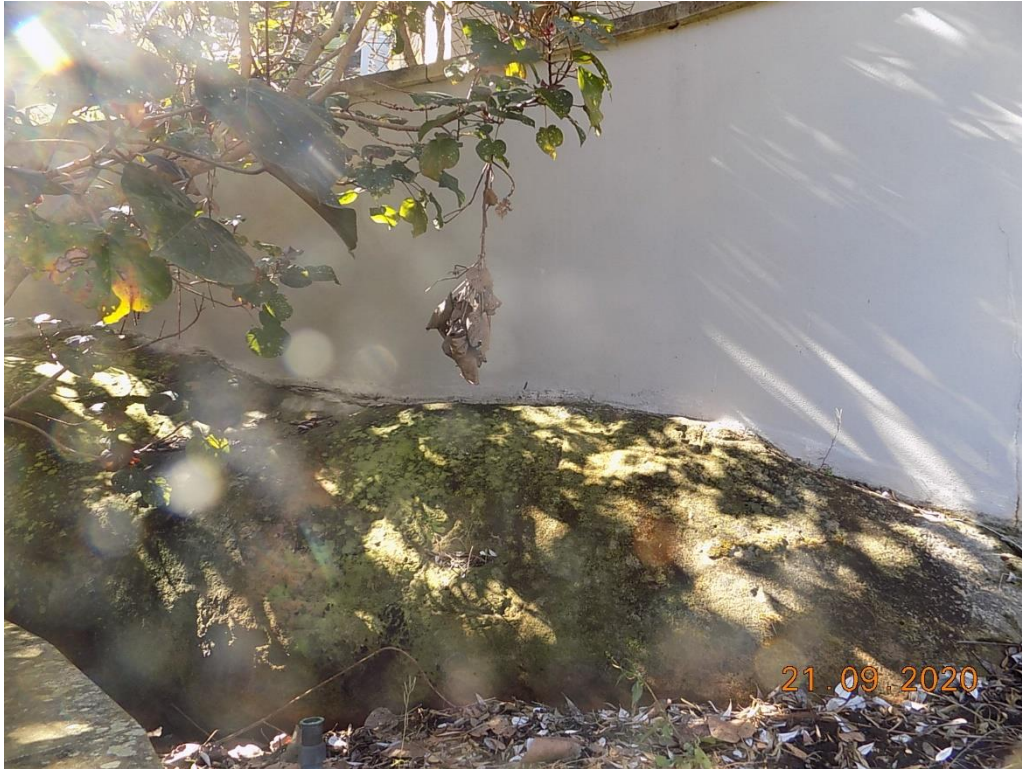
Photo 10

One corner of the excavation will come close to flush with the rendered masonry retaining wall above and another corner will be set back a minimum of ~1.0m from the E common boundary. However, the retaining wall above was observed to be supported directly onto outcropping Medium Strength Sandstone (Photo 10) and where the excavation comes closest to the E common boundary, the rock was encountered at a depth of just 0.4m. Additionally, all remaining sides of the excavation are sufficiently set back from the surrounding structures and boundaries. Thus, no structures or boundaries (including the retaining wall and E common boundary) will be within the zone of influence of the proposed excavation.
