**GEOTECHNICAL RISK MANAGEMENT POLICY FOR PITTWATER**  
**FORM NO. 1 – To be submitted with Development Application**

Address of site 31-33 Sturdee Lane, Elvina Bay

## **GEOTECHNICAL INVESTIGATION:**

New Inclined Lift at **31-33 Sturdee Lane, Elvina Bay**

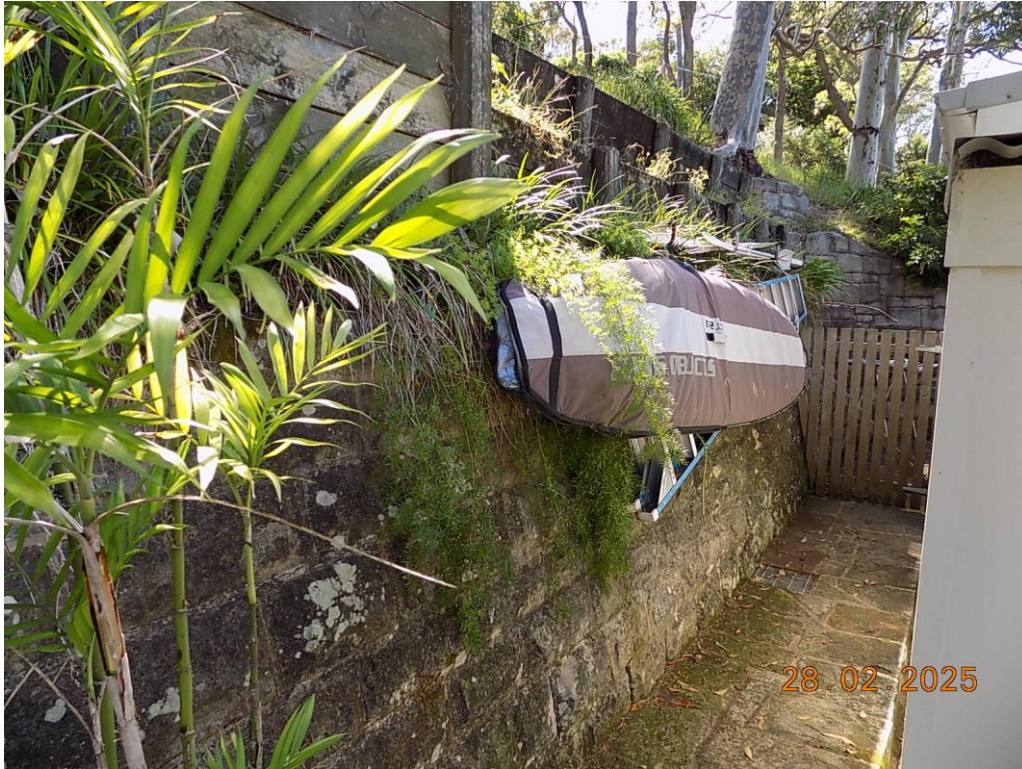
Photo 3

reaching ~1.5m high (Photo 2). The lower portion of the very steeply graded slope between the boat shed and the house is terraced with stable timber retaining walls of mortared sandstone block and timber construction and reaching a combined height of ~2.5m (Photos 3 & 4). Where the slope is not supported above, it is well vegetated. The grade of the slope eases immediately below the house (Photo 5). The two-story timber clad house is supported on sandstone and concrete block walls and steel posts. No significant signs of movement were observed in the visible supporting walls, and the supporting post stands vertical. The land surface surrounding the house is lawn covered.

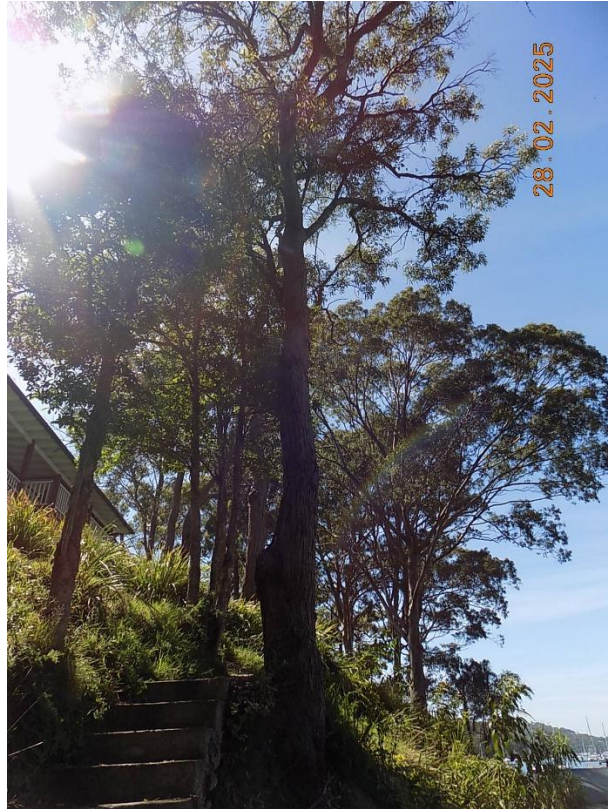
Photo 12

- ~Flush with the staircase for No. 31 on the E side of the cut (Photo 7)
- ~1.0m from a eucalyptus tree on the uphill side of the cut which is shown on the plans to remain. (Photo 12)
- ~1.1m from the staircase for No.33 on the uphill side of the cut. (Photo 13)
