#### **DILAPIDATION REPORT**

#### **COUNCIL ASSETS**

# 16 SUMMIT AVENUE, DEE WHY

**Job No 621**

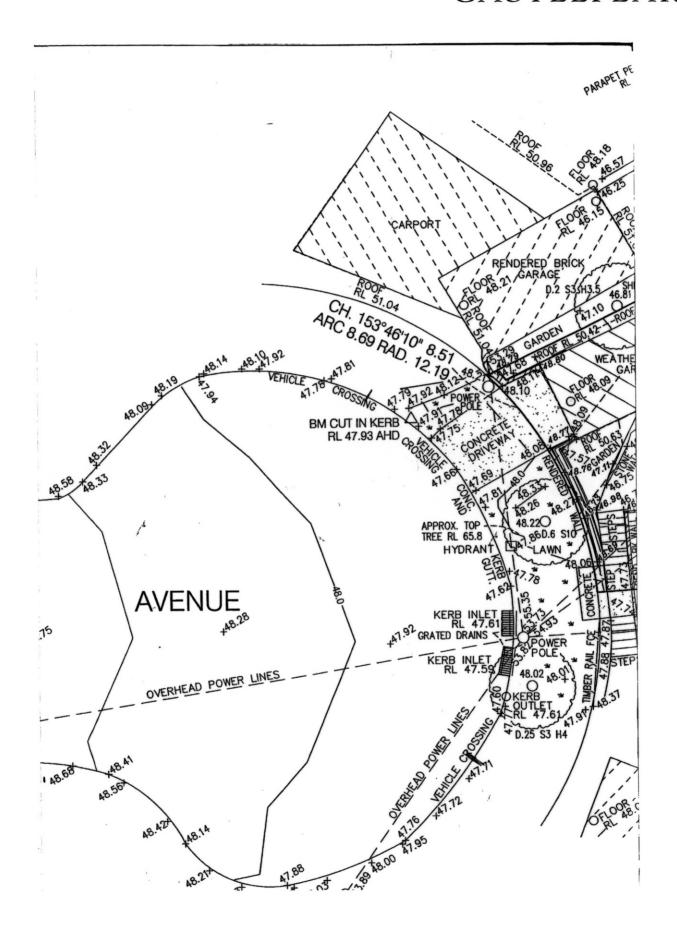
**PHOTO 20**

5.06	The lids to the grated drains in the gutters, along the southern side of the subject property are in reasonable condition. See Photos 19 & 20.
6.00	STREET TREES
