## 48 Tatiara Crescent, North Narrabeen

Geotechnical Comments for Section 96.

## **GEOTECHNICAL INVESTIGATION:**

### **Alterations & Additions and Secondary Dwelling at 48 Tatiara Crescent, North Narrabeen**

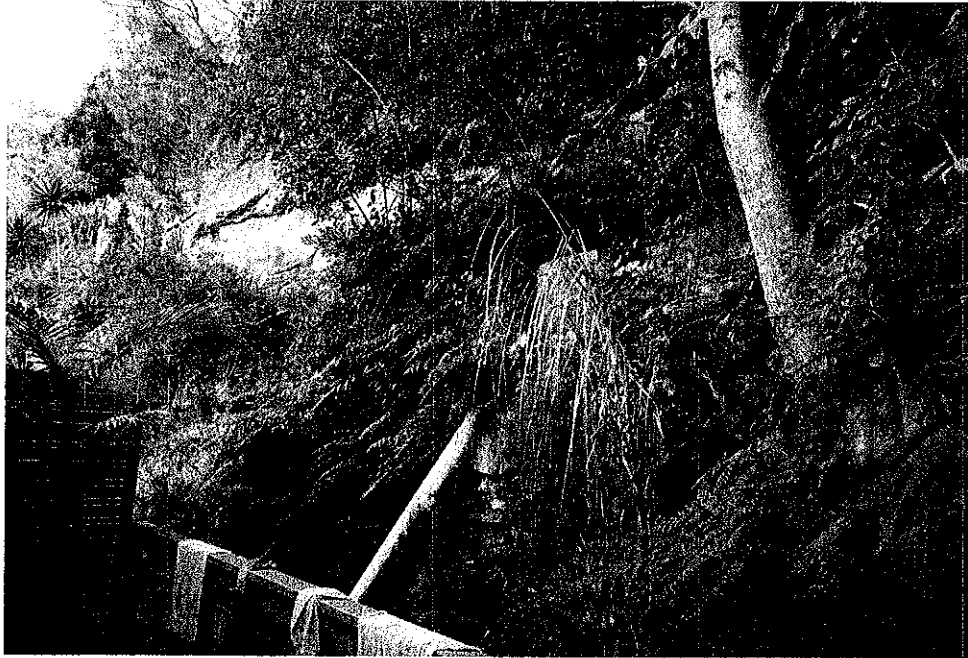
Photo 6

the slope above to a pipe that runs to the street drainage system below (Photo 5 & 6). Piped water from above also discharges into the channel and we were informed on site by the owner that the pipe extends from the neighbouring property above. The land surface above the house rises at steep angles and a band of competent, medium strength sandstone outcrops and forms a cliff face (Photo 7 & 8). Some lower strength seams were observed around jointing and bedding planes that were more prevalent towards the base of the rock face. Minor erosion through soil and clay was observed immediately below a section of the exposed bedrock (Photo 9 & 10). The erosional process appears to be due to surface flow from the slope above and any potential failure is expected to be very small scale and limited in extent by the shallow underlying bedrock. The surrounding land surface consists of native undisturbed trees and vegetation (Photo 11). A right of carriageway lines the upper boundary of the subject property (Photo 12).
